Marine Engineering Inspection Report

**Fisher Island
Mainland Terminal
and Residential
Ferry Landing**
Fisher Island, Florida

March 2021

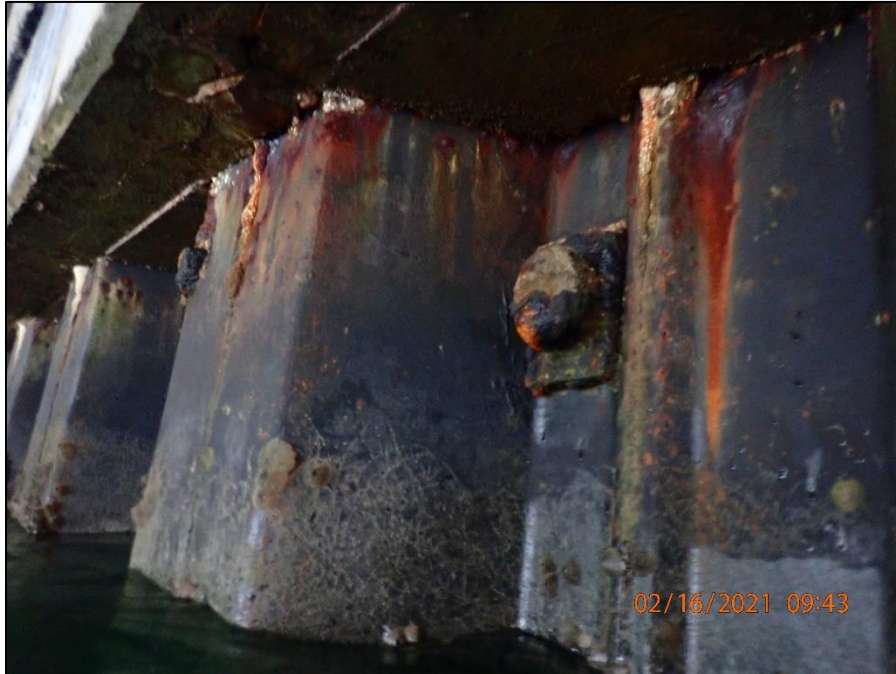
A.1: View of steel sheet pile exhibiting minor corrosion at the steel sheet pile and anchor heads.

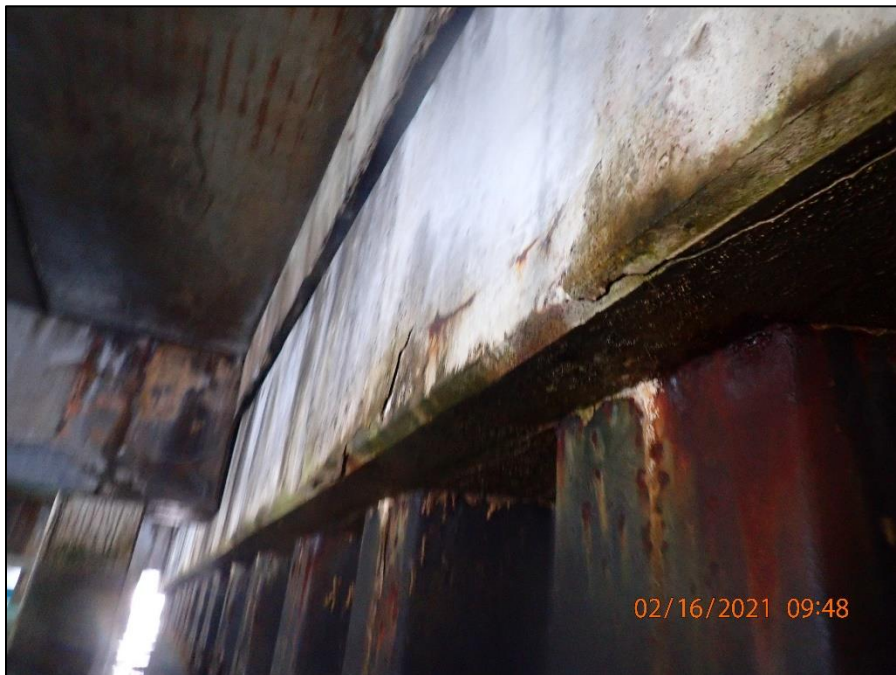
A.2: Typical concrete cracking along the wet face and soffit of the bulkhead cap.

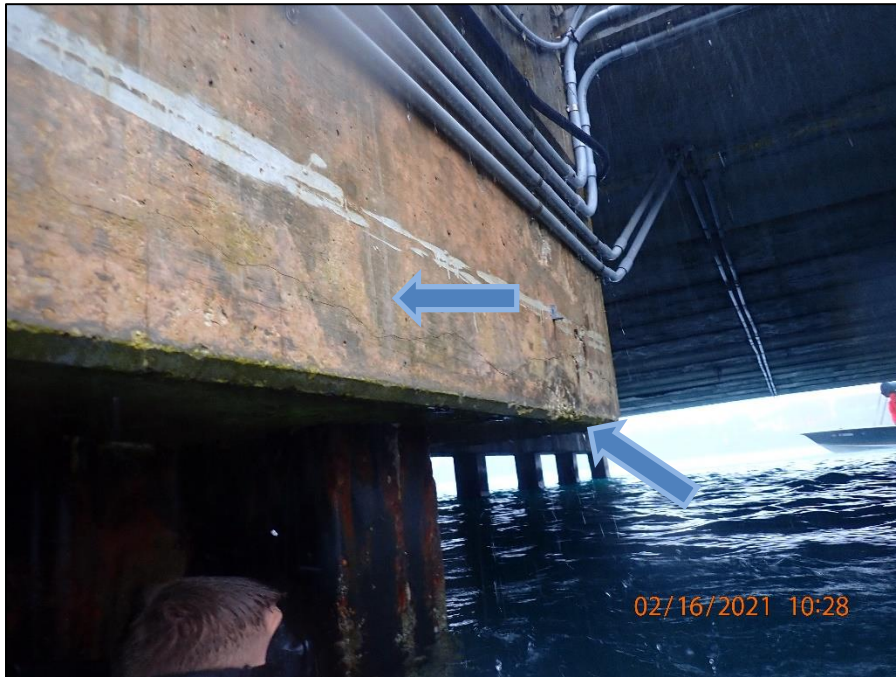
A.3: View of concrete spall and cracks in bulkhead cap adjacent to pile bent 4.

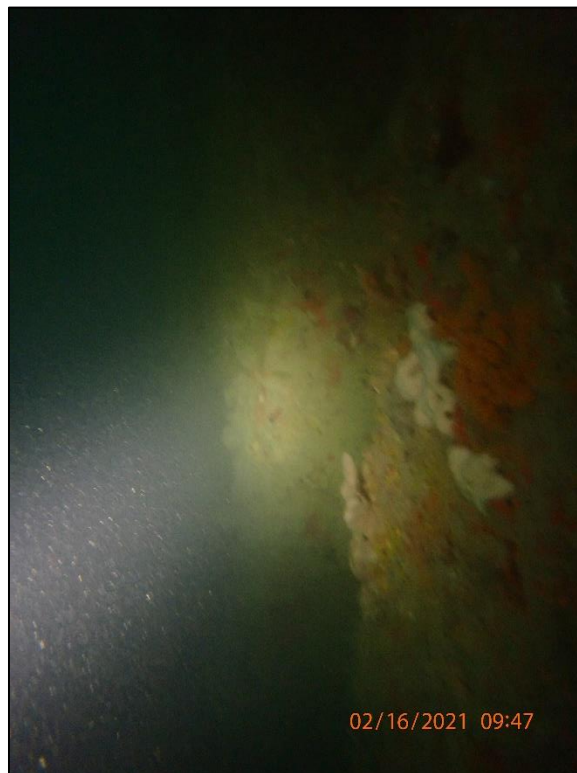
A.4: View of sheet pile bulkhead within tidal zone. Note sheets appear plumb and heavy marine growth was observed.

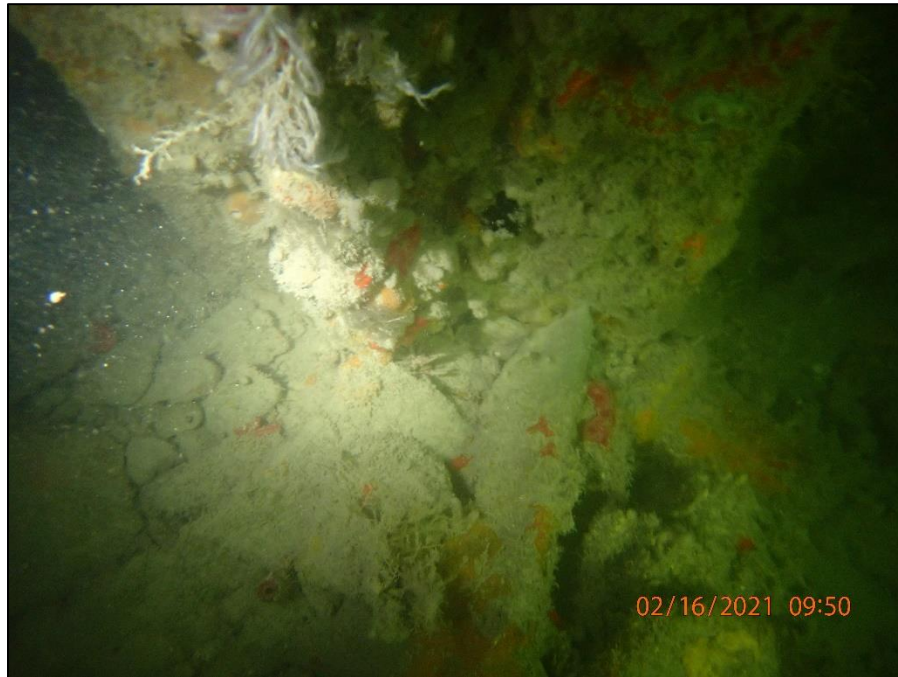
A.5: View of sheet pile bulkhead at the mudline. Note remnants of construction material and debris along the toe of the bulkhead.

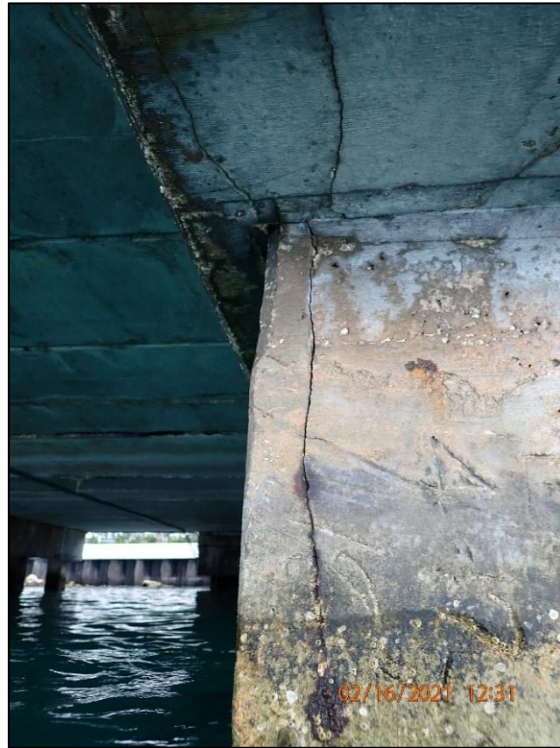
A.7 Typical cracking at concrete pile head and concrete cap soffit connection.

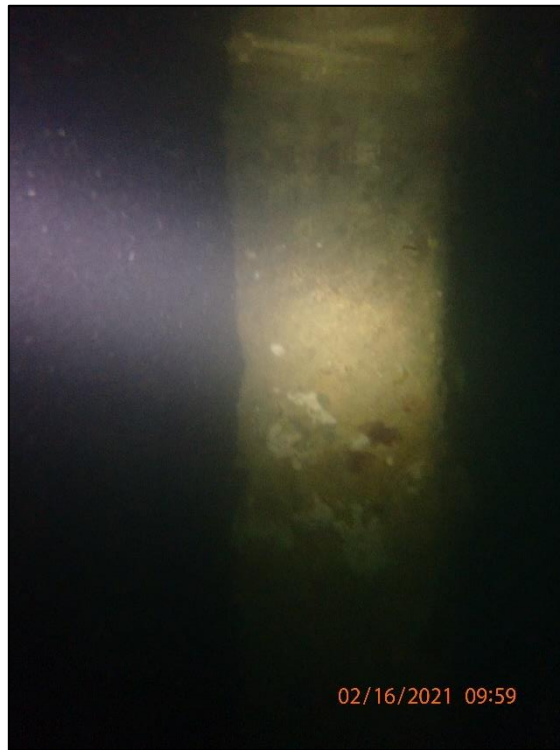
A.8: Typical concrete pile within tidal and submerged zone. Note minimal section loss.

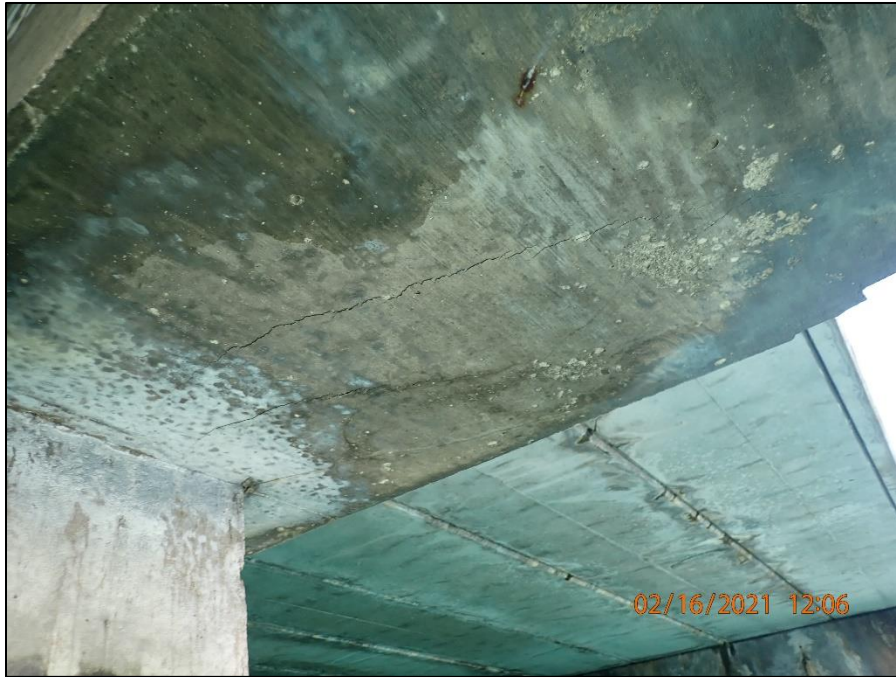
A.9: Typical cracking at cap soffit observed adjacent to concrete pile head connection to cap.

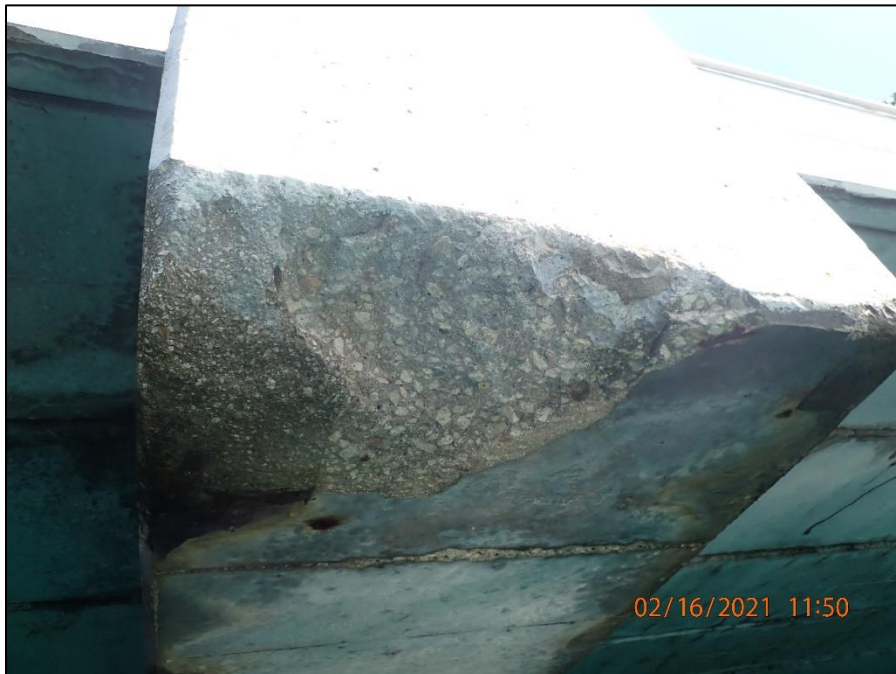
A.10: Spalling at concrete pile cap observed on the south face of pile bent one.

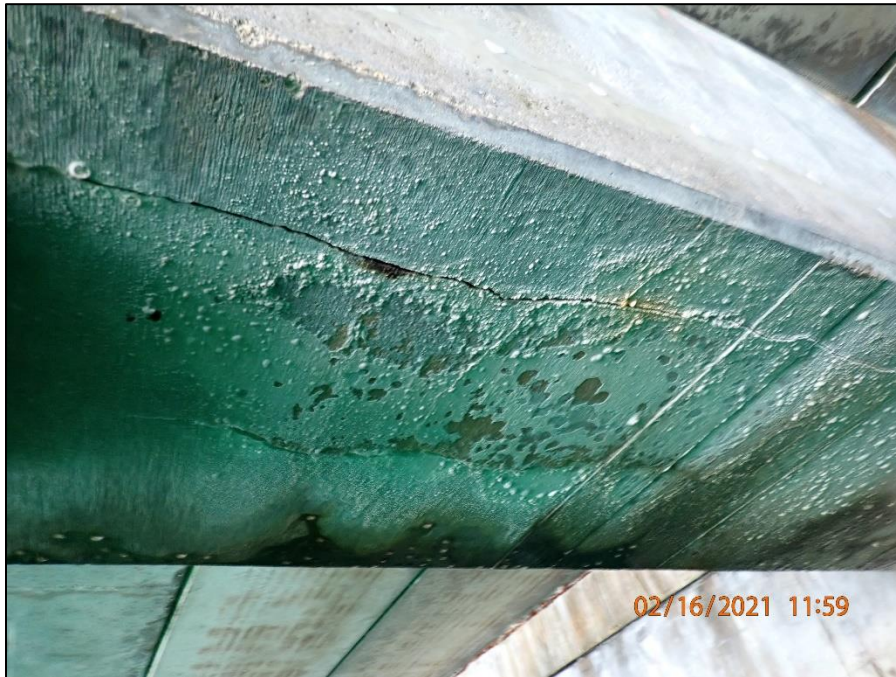
A.11: Typical cracking along pile cap soffit with minor concrete delamination.

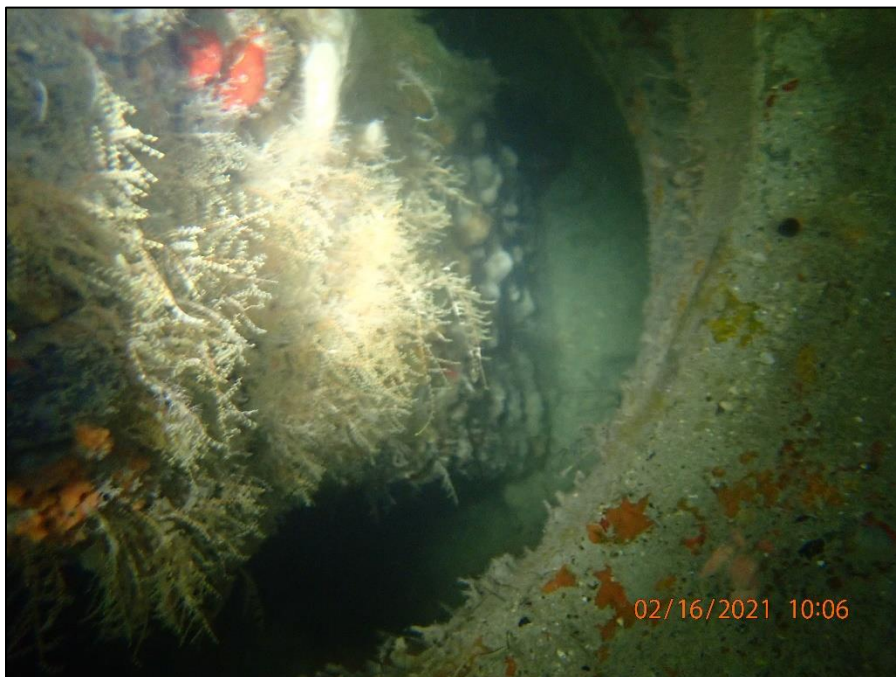
A.12: View of concrete pile at the mudline. Note tires at the base of piles and minimal scour at the base of the pile.

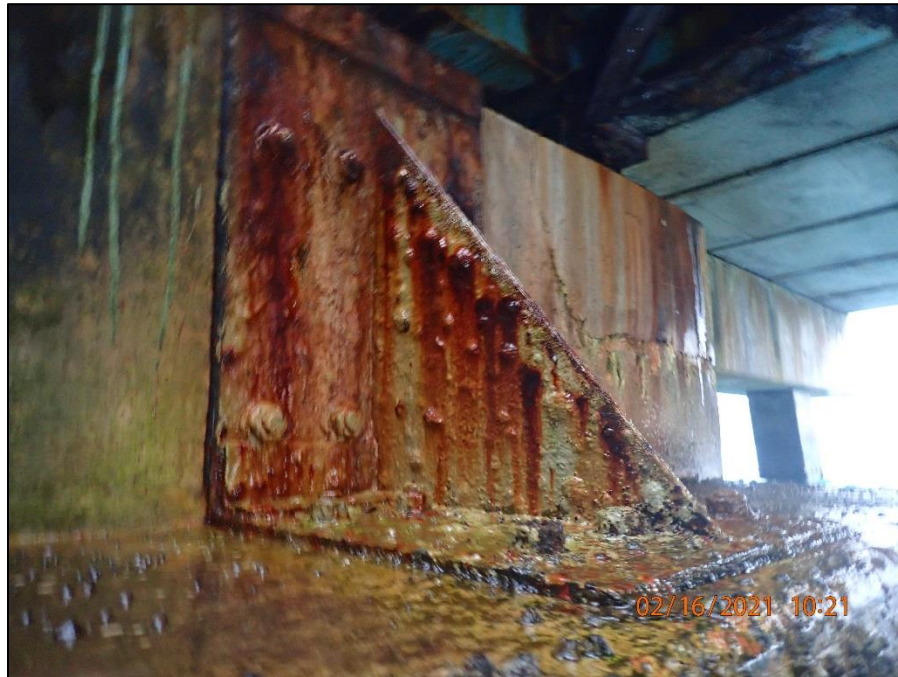
The bridge seat typically exhibited minor to moderate cracking and spalling at the cap with concrete deterioration on the western face of the seat, likely from ferry wash. The steel seat gussets, bridge deck beams, and cross-bracing exhibited moderate to severe corrosion.

A.13: View of corrosion at the steel gussets at the wharf bridge seat.

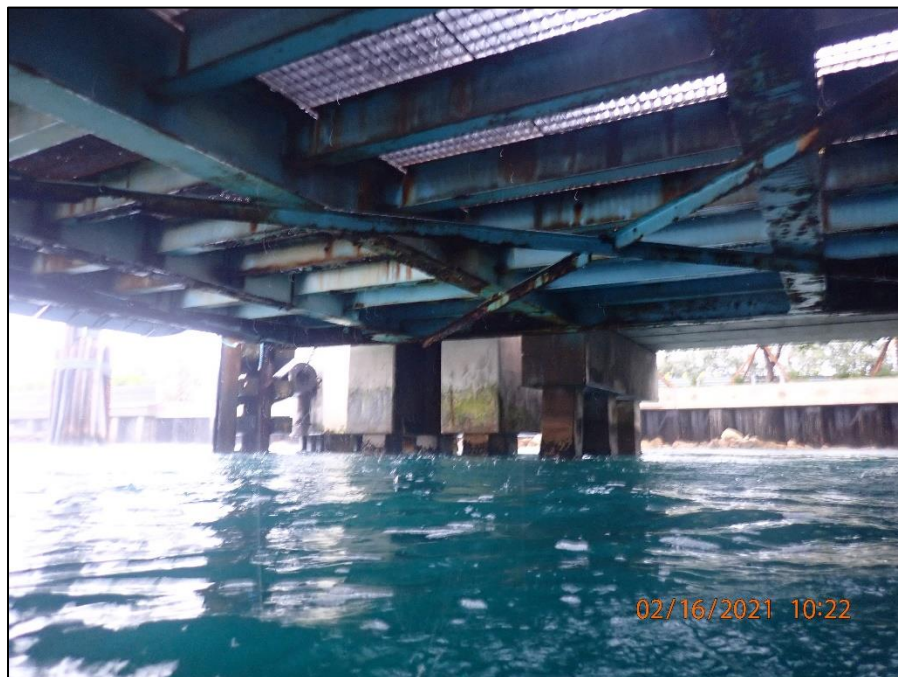
A.14: View of steel framing at wharf bridge with severe corrosion at the cross-bracing.

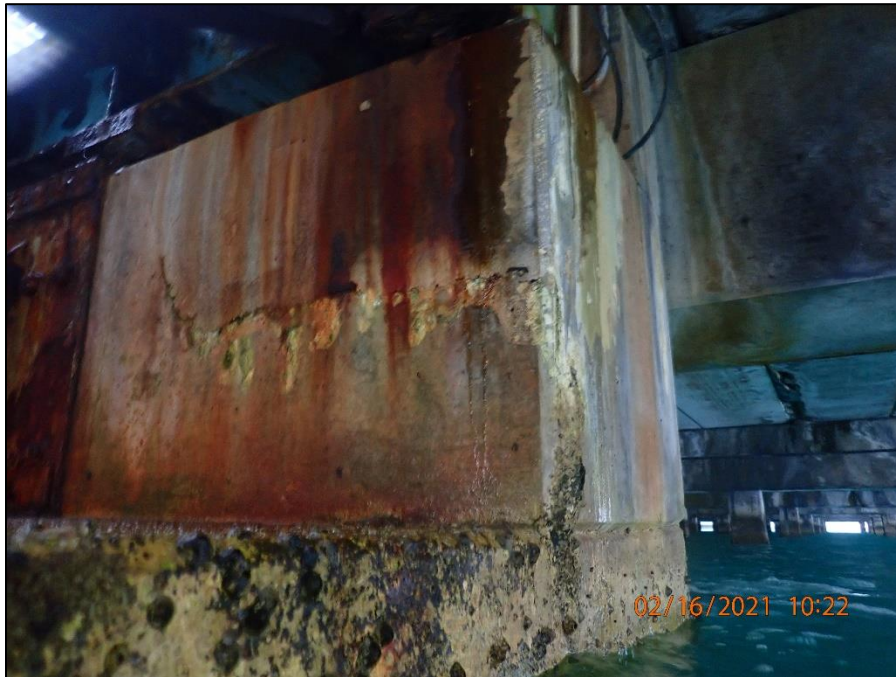
A.15: Concrete chemical deterioration, spalling, and corrosion staining at the bridge seat. Note steel beams from ramp secure to top of bridge seat.

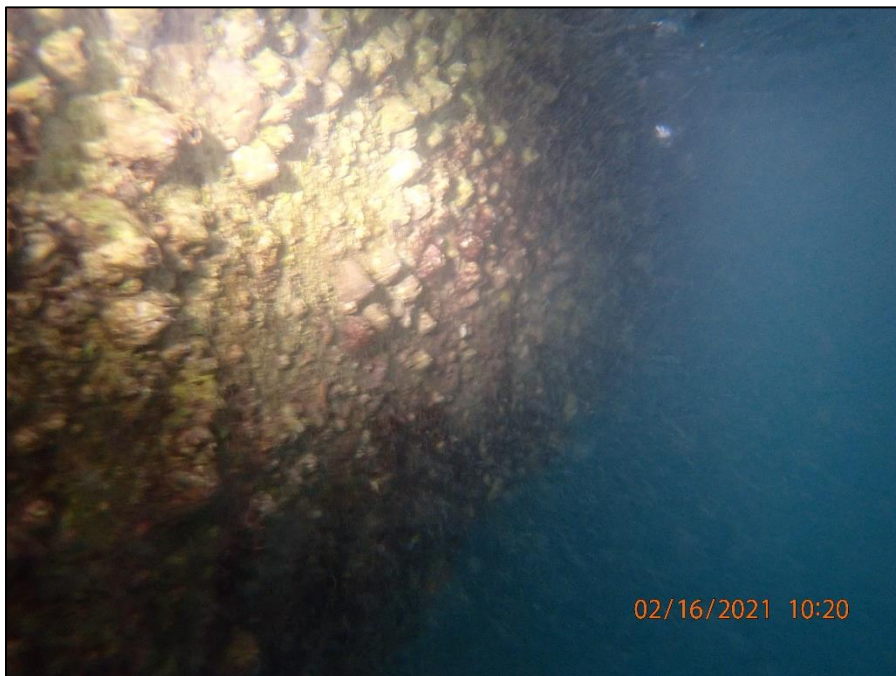
A.16: View of bridge seat pile cap within tidal zone. Note marine growth on concrete and minor corrosion staining.

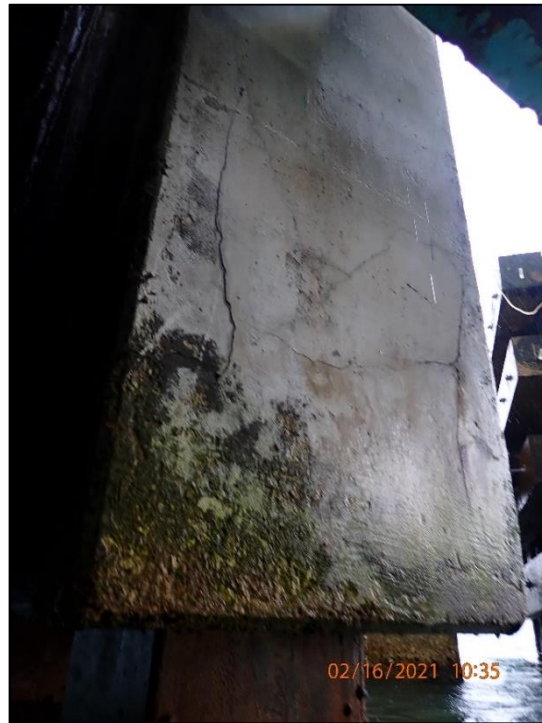
A.17: Concrete delamination on northern face of north hoist dolphin.

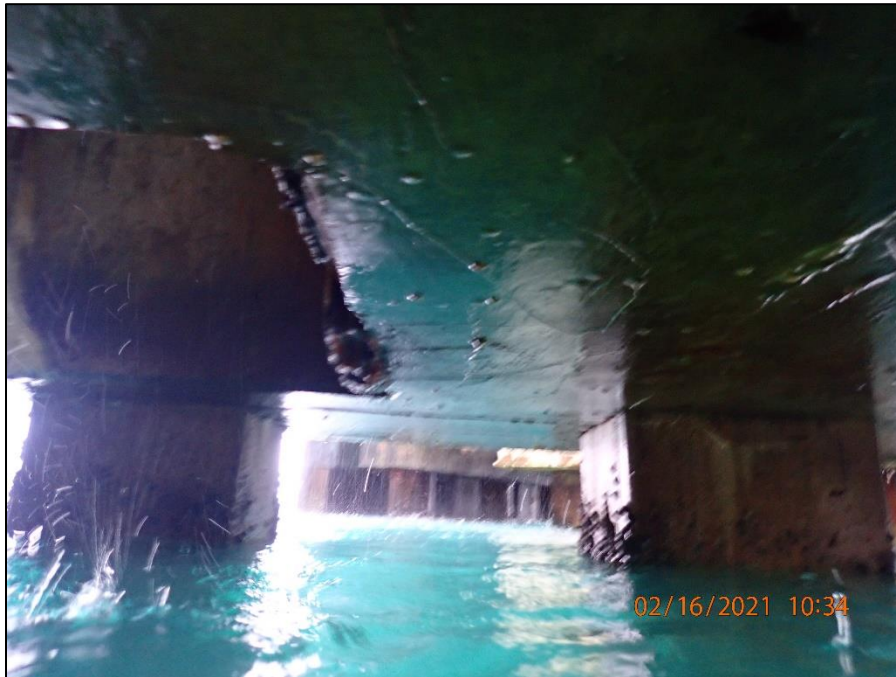
A.19: View of concrete cap soffit at hoist dolphin with typical concrete cracking.

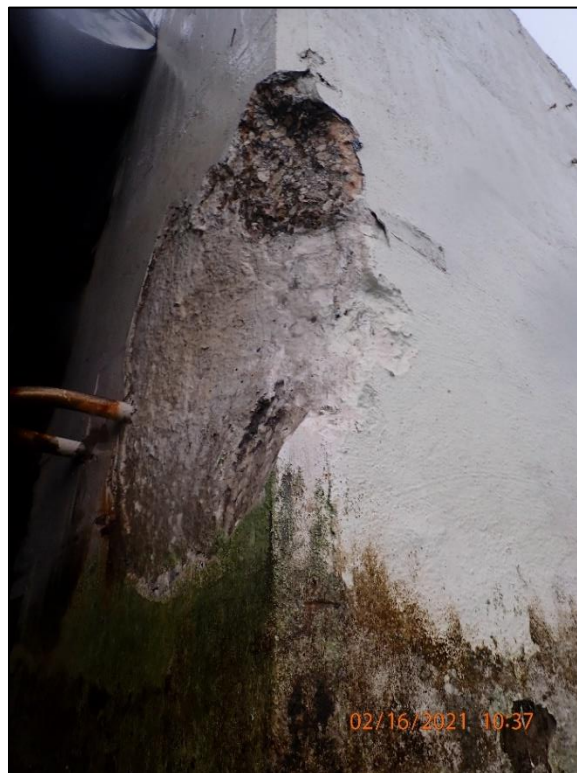
A.20: View of concrete spall on southern face of south berthing dolphin.

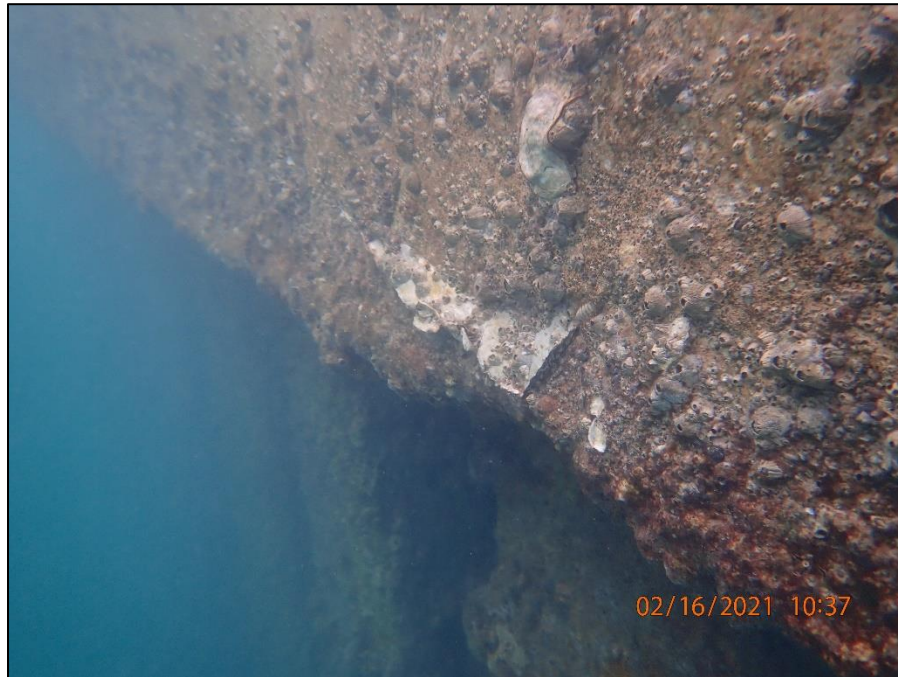
A.21: View berthing dolphins within the tidal and submerged zones. Note minor cap soffit spall and corrosion staining of concrete.

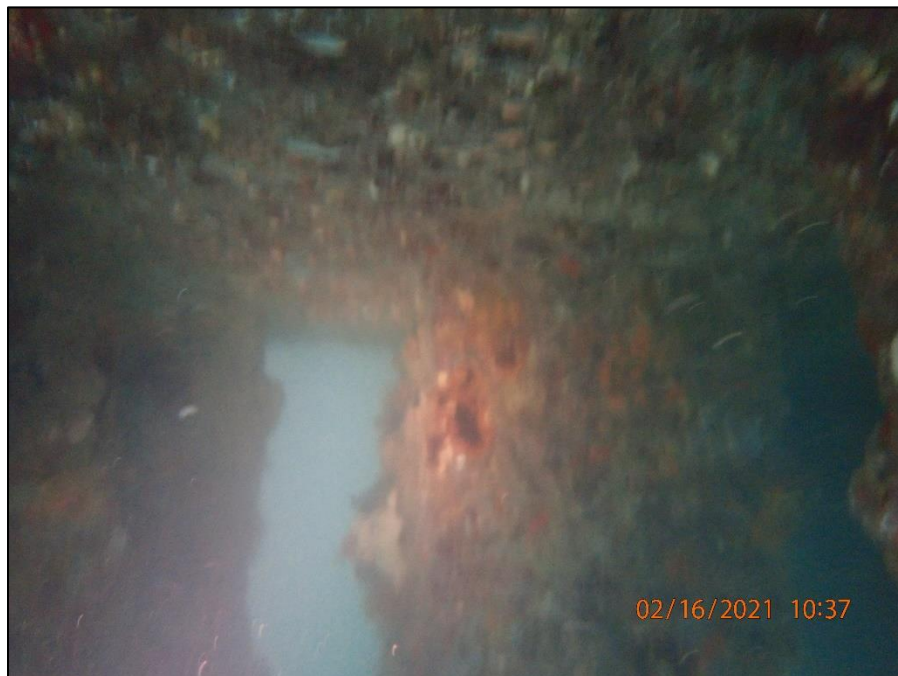
A.22: View of berthing dolphin concrete pile connection to pile cap. Note marine growth on concrete piles. Piles observed to have minimal section loss.

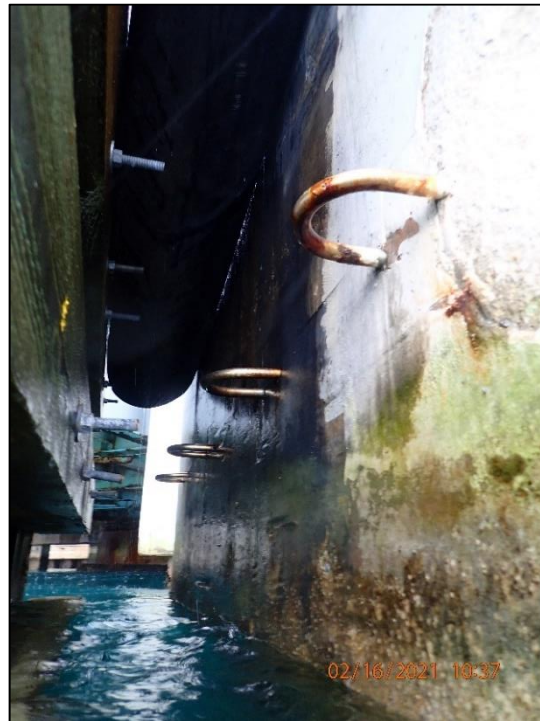
A.23: View of berthing dolphin timber fender system within the splash zone. Note concrete chemical deterioration. Note corrosion of steel elements.

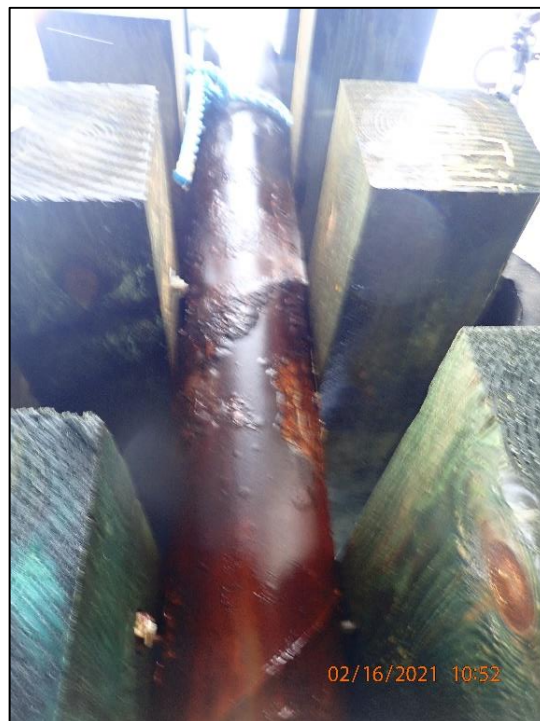
A.24: View of berthing dolphin timber fender system. Note corroded steel pipe piles.

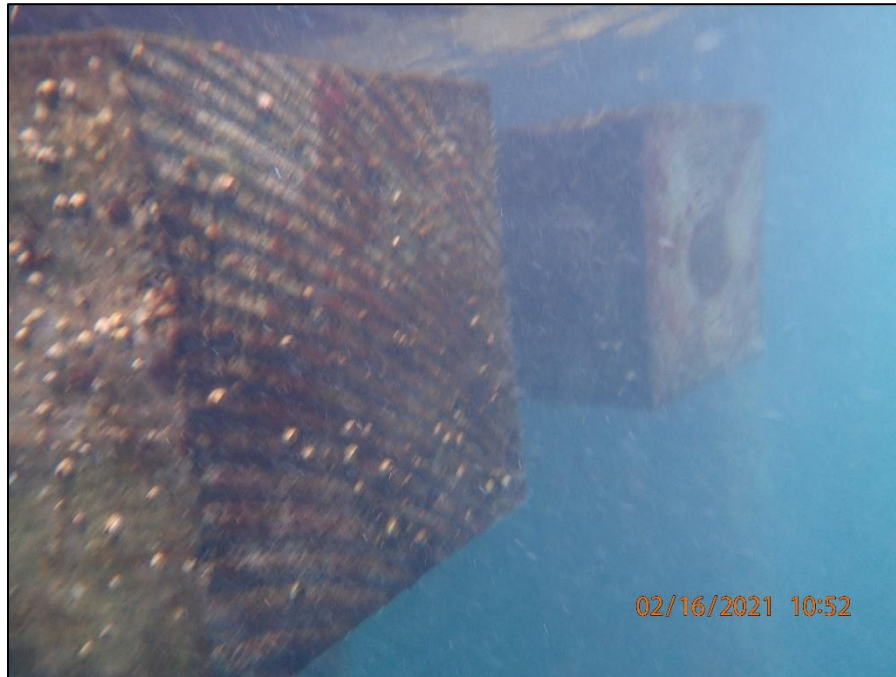
A.25: View bottom row of berthing dolphin timbers within tidal zone. Note no timber rot and minor marine growth.

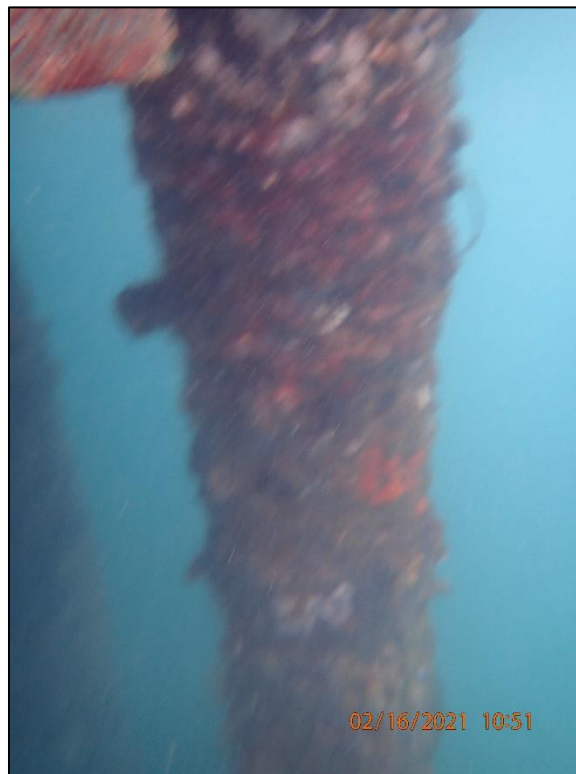
A.26: View steel pipe piles of berthing dolphins within tidal and submerged zone. Note steel corrosion and marine growth.

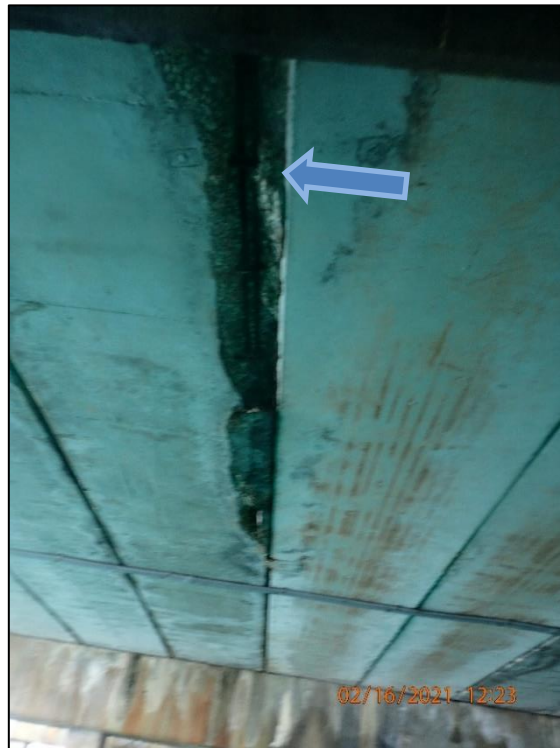
A.27: View of spalling at the concrete deck soffit.

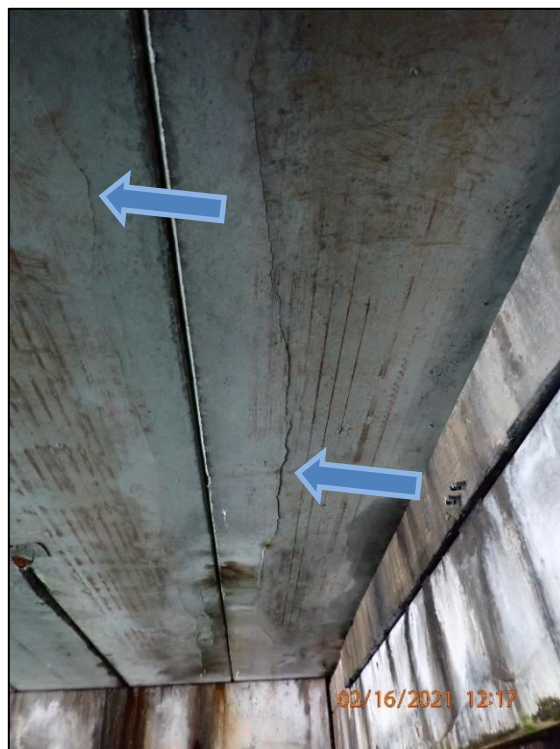
A.28: View of cracking along concrete deck soffit.

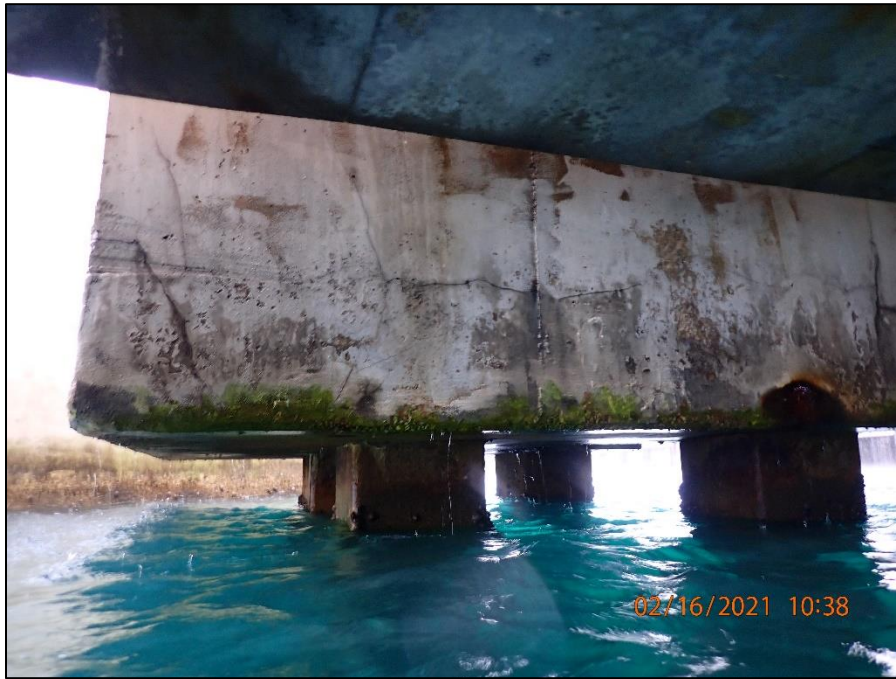
A.29: View of pile cap cracking at spanning across multiple piles in the bent.

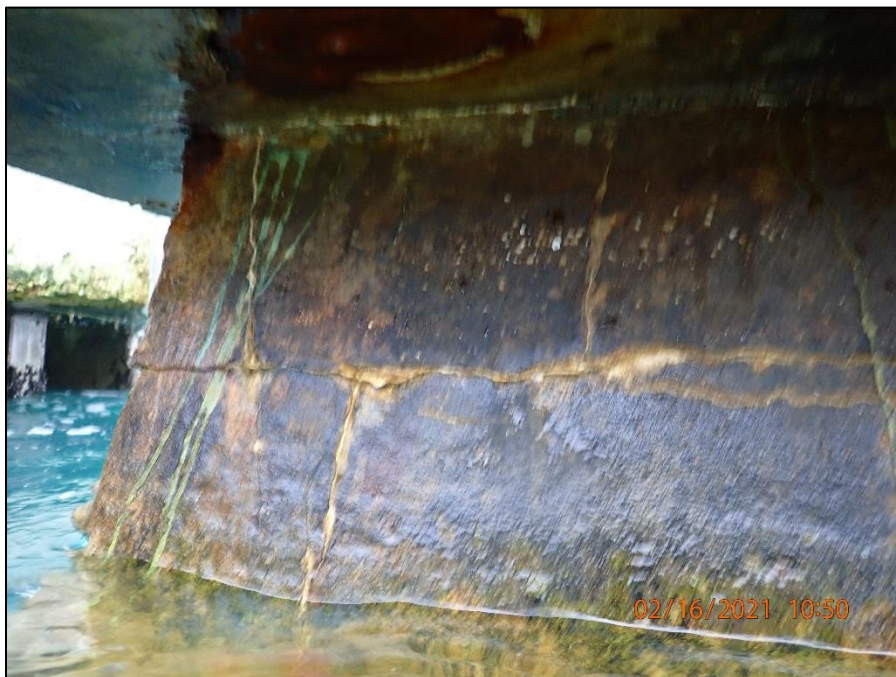
A.30: Typical concrete cracking of berthing dolphins piling.

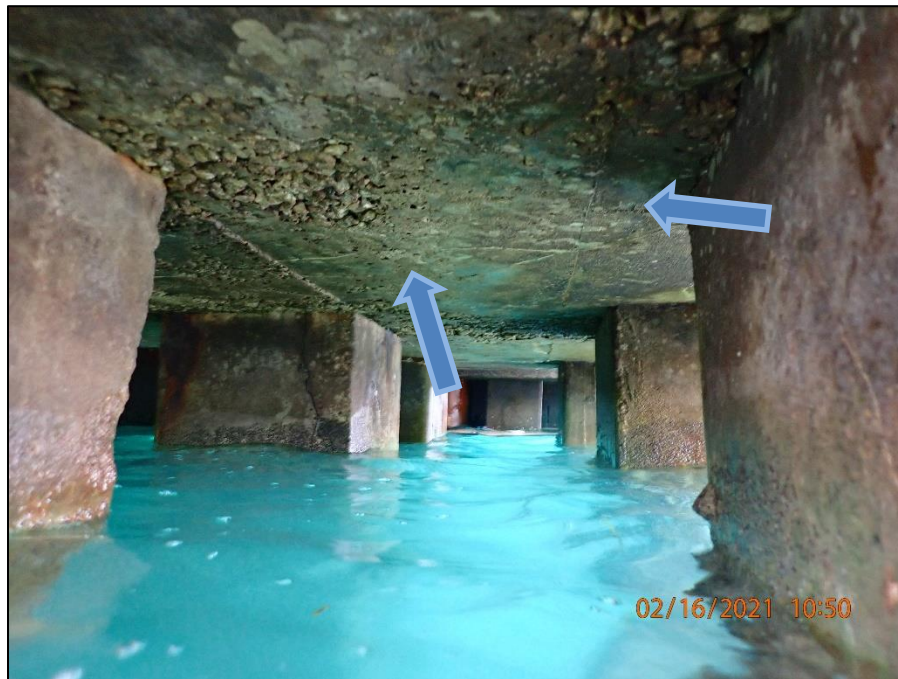
A.31: Typical concrete cracking at the berthing dolphin cap soffit.

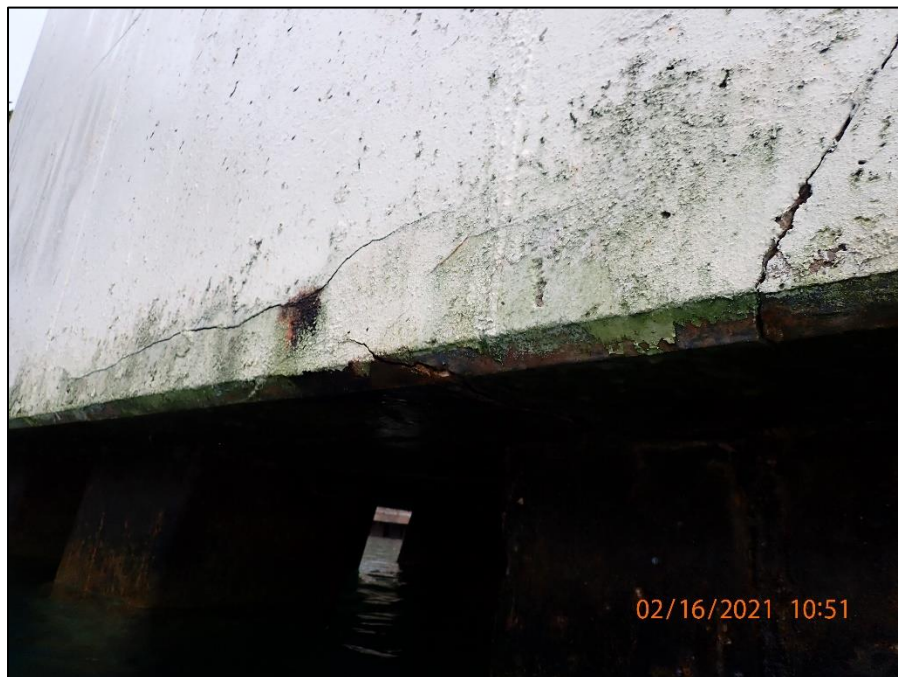
A.32: Typical concrete cracking of berthing dolphin pile cap edges.

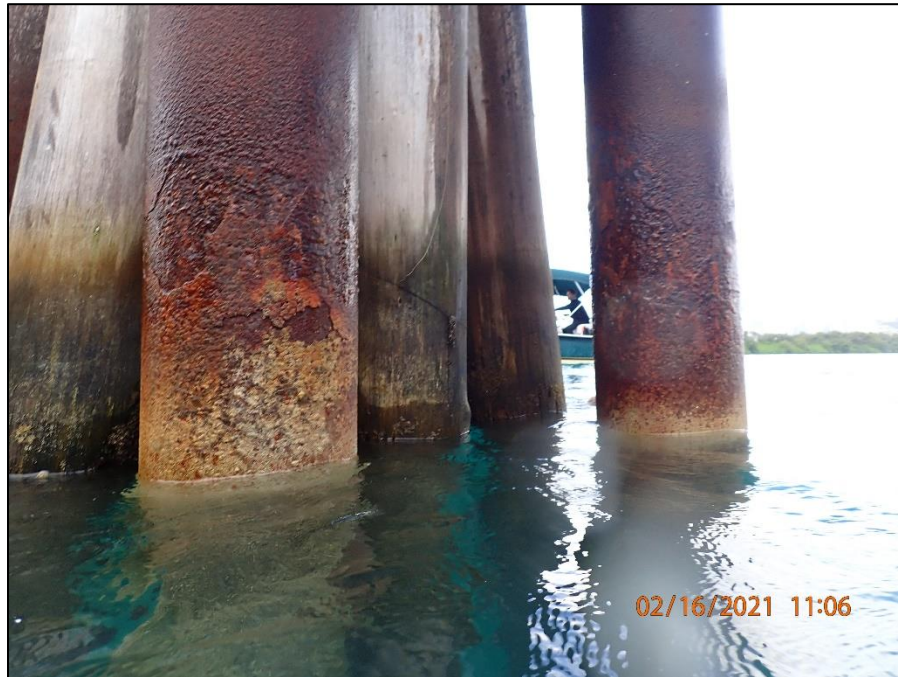
A.33: Corrosion at the steel pipe piles in splash zone at eastern timber dolphins.

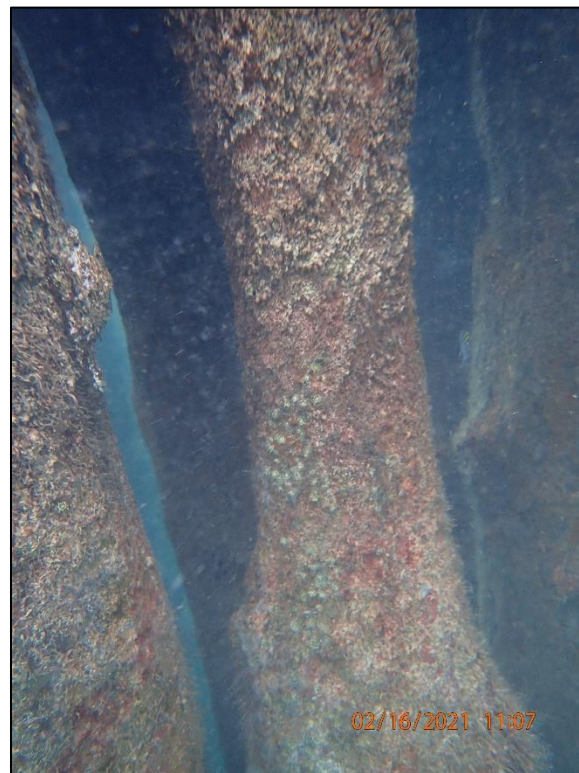
A.34: Section loss in tidal zone of timber piles at the east timber dolphin, typical condition. Approximately 50% section loss.

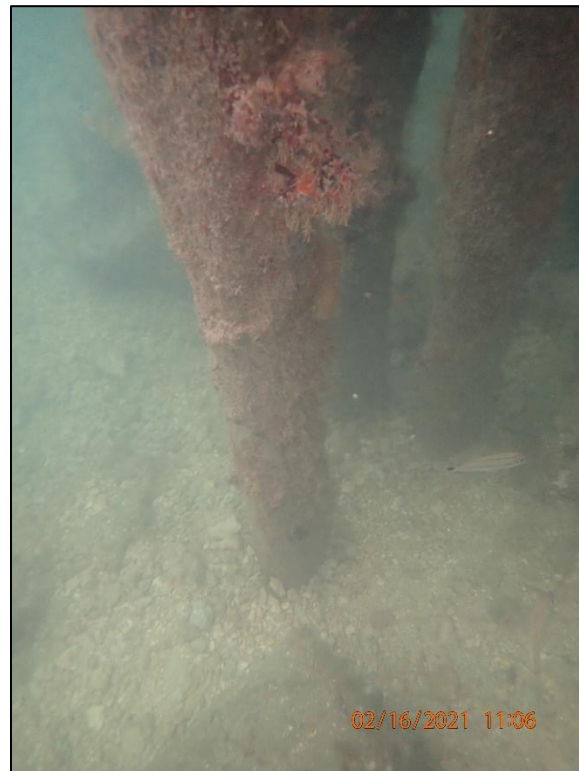
A.35: View of timber dolphin piling at mudline. Note typical section loss of about 50% near mudline.

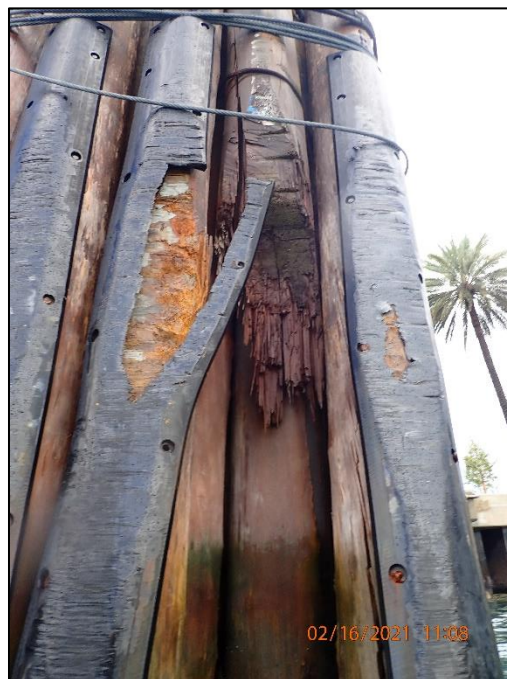
A.36: Southern face of west timber dolphin piling. Rubber fender pile damage and spilt pile observed within the ferry impact zone.

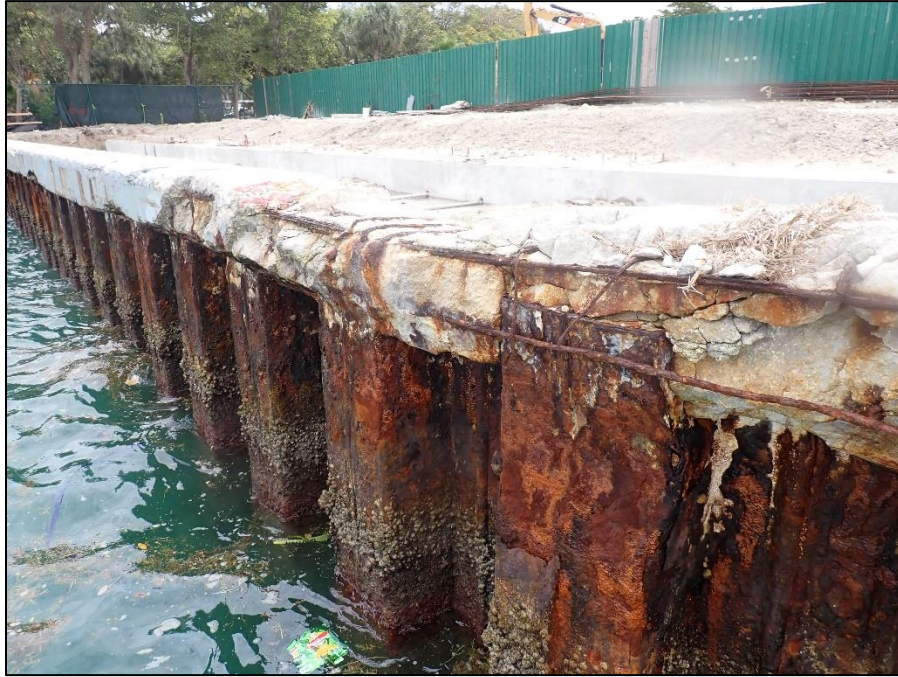
A.37: View of western-most corner of bulkhead within inspection scope. Note deep cap spalls exposing reinforcing steel and corroded steel sheet pile.

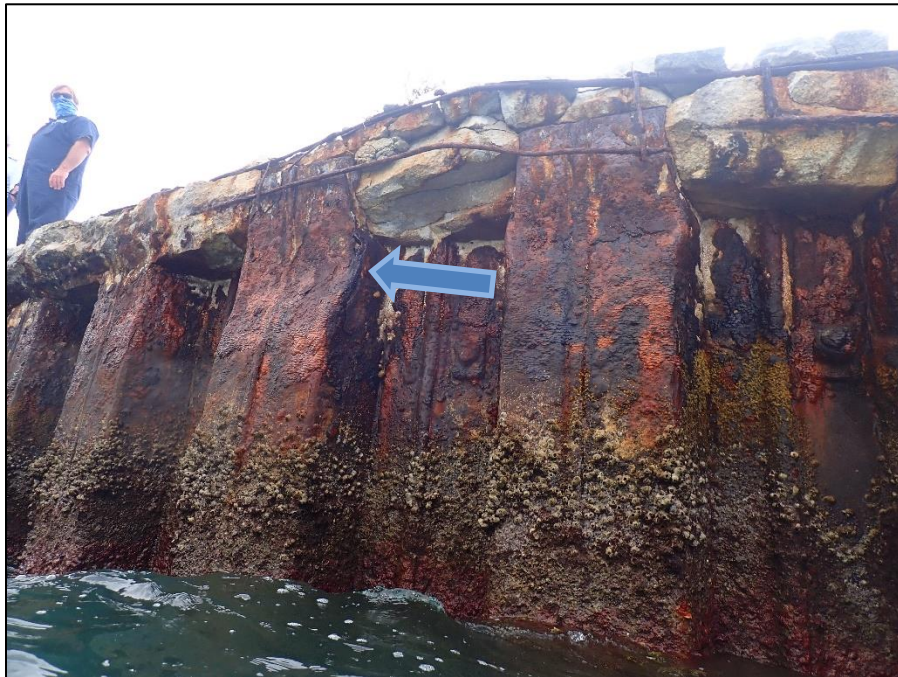
A.38: View of western-most corner of bulkhead within inspection scope. Note damage to steel sheet just below concrete cap, corrosion and marine growth in the splash zone.

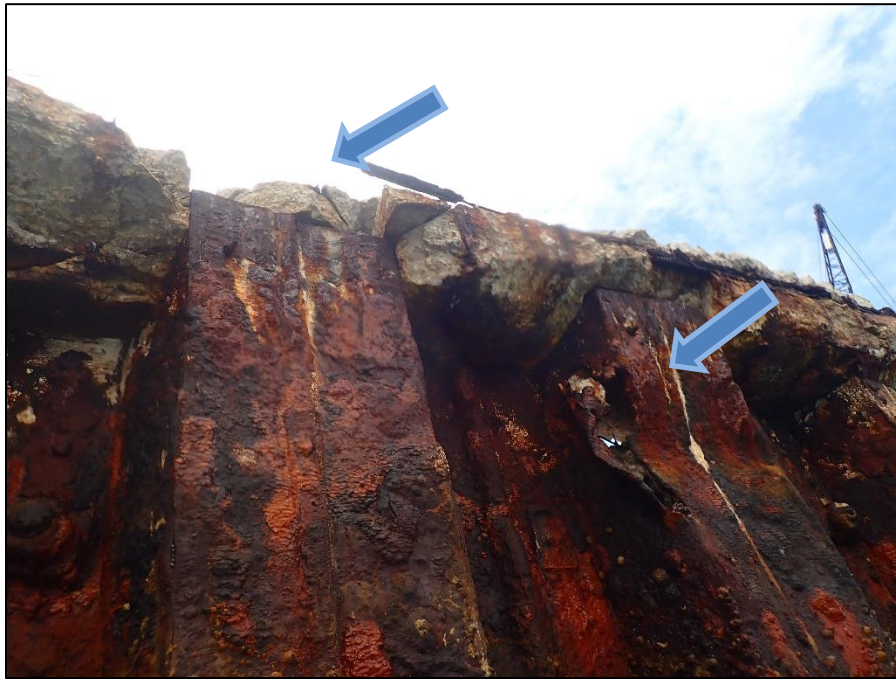
A.39: View of western bulkhead at 20th sheet pair or approximately 75 feet east of the most west bulkhead corner. Note damage in sheet pile causing void in sheet. Note cap spalled off.

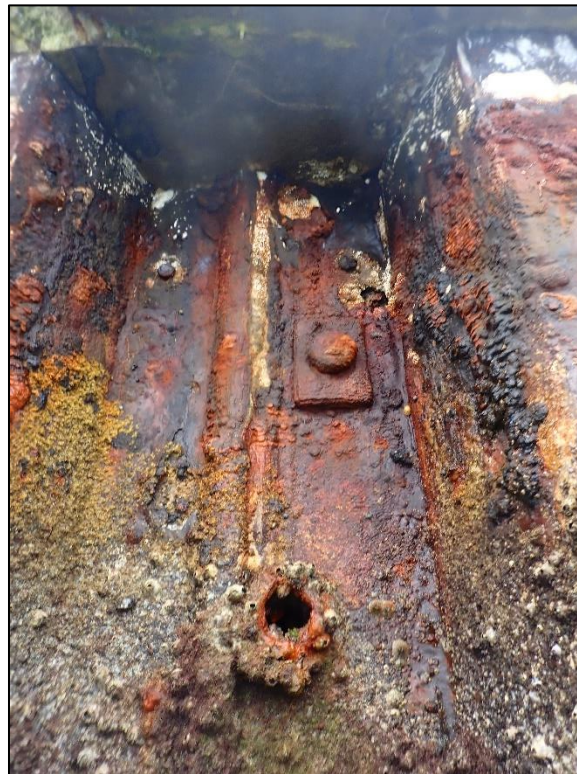
A.40: View of western bulkhead. Note minor corrosion holes in sheet pile, anchor rod plate and outfall, and cracking in the concrete cap soffit.

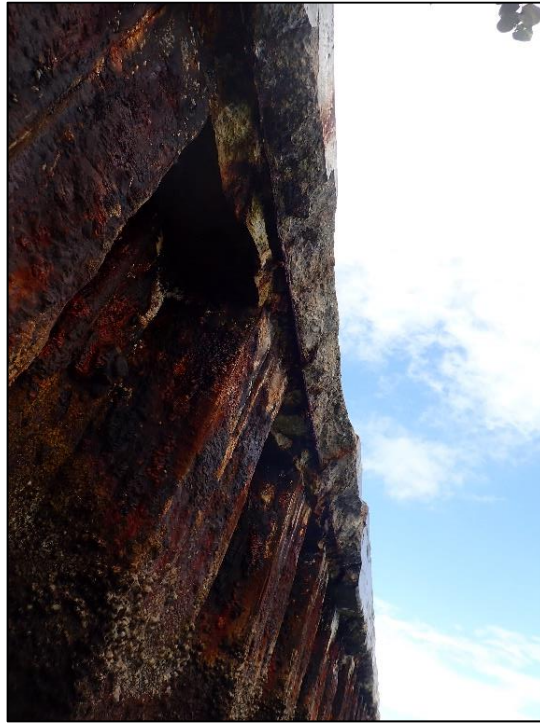
A.41: View of western bulkhead cap at the approximately 47th sheet pair from the west corner or 175 feet east of the west corner. Continuous spalling along the cap soffit exposing reinforcing steel.

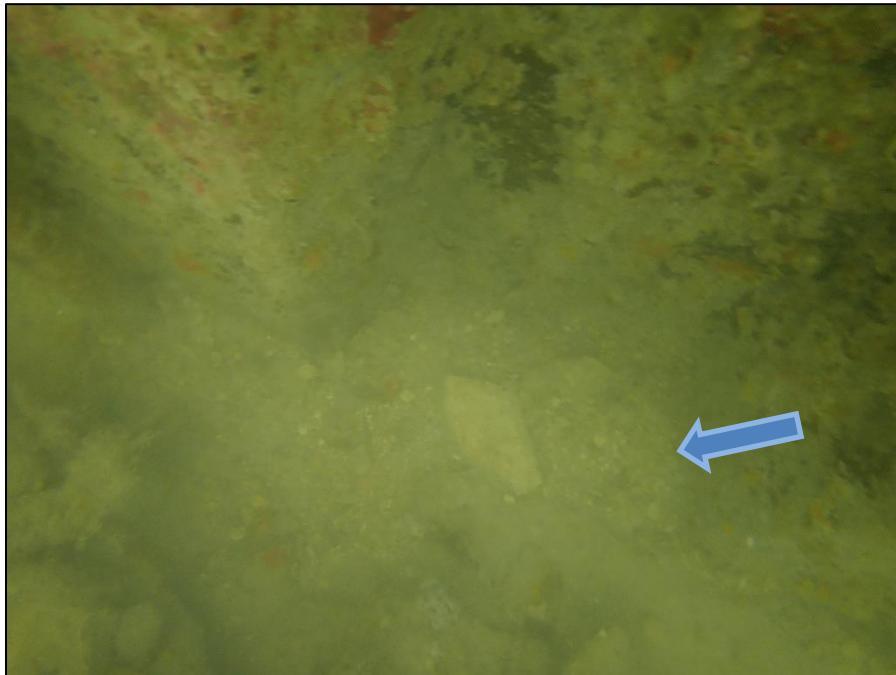
A.42: View of western bulkhead toe of wall. Note moderate sediment accumulation at toe of wall, suggesting possible undermining.

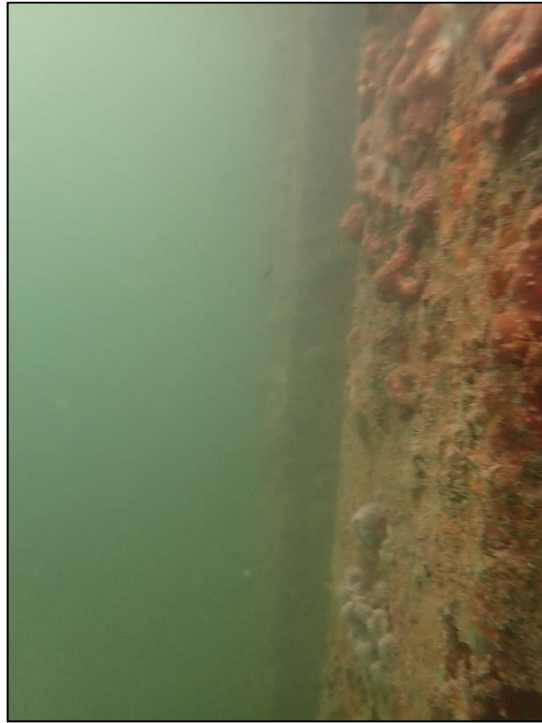
A.43: View of western bulkhead within tidal and submerged zone. Note corrosion of sheet piles and marine growth.
