Marine Engineering Inspection Report

**Fisher Island
Mainland Terminal
and Residential
Ferry Landing**
Fisher Island, Florida

March 2021

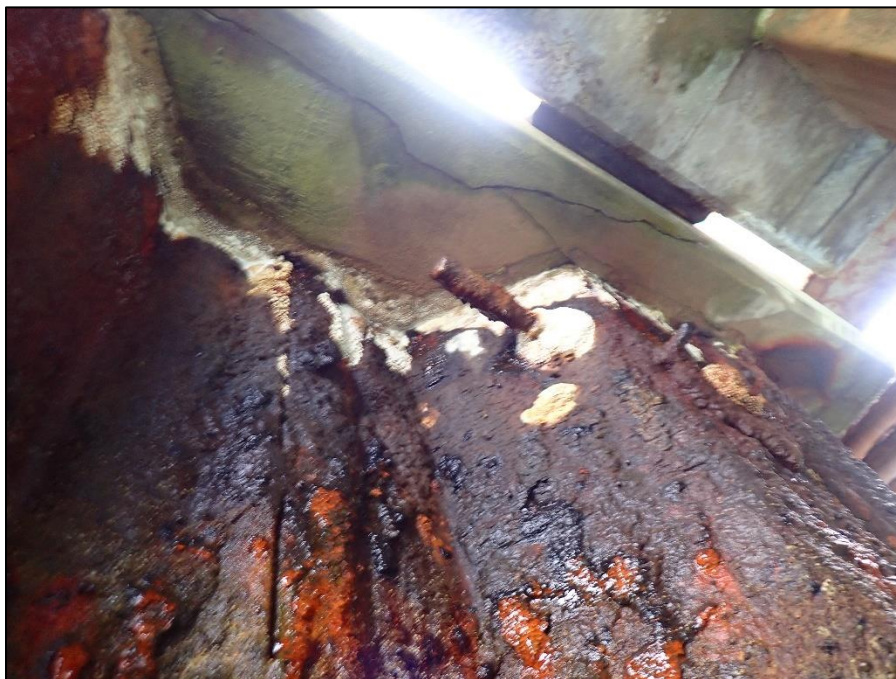
A.44: Eastern bulkhead at hoist dolphin connection to the concrete cap. Note cracking along the concrete soffit.

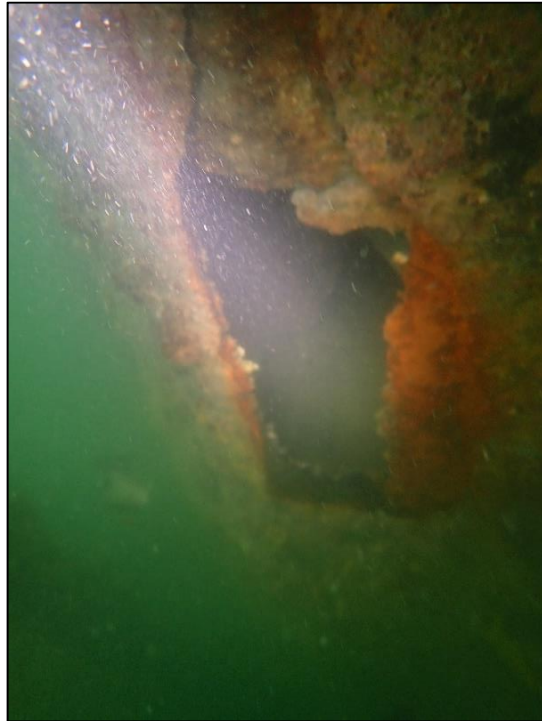
A.45: View of void through steel sheet pile wall approximately 2'x8" located halfway down the wall at the where the northern hoist dolphin meets the ferry ramp.

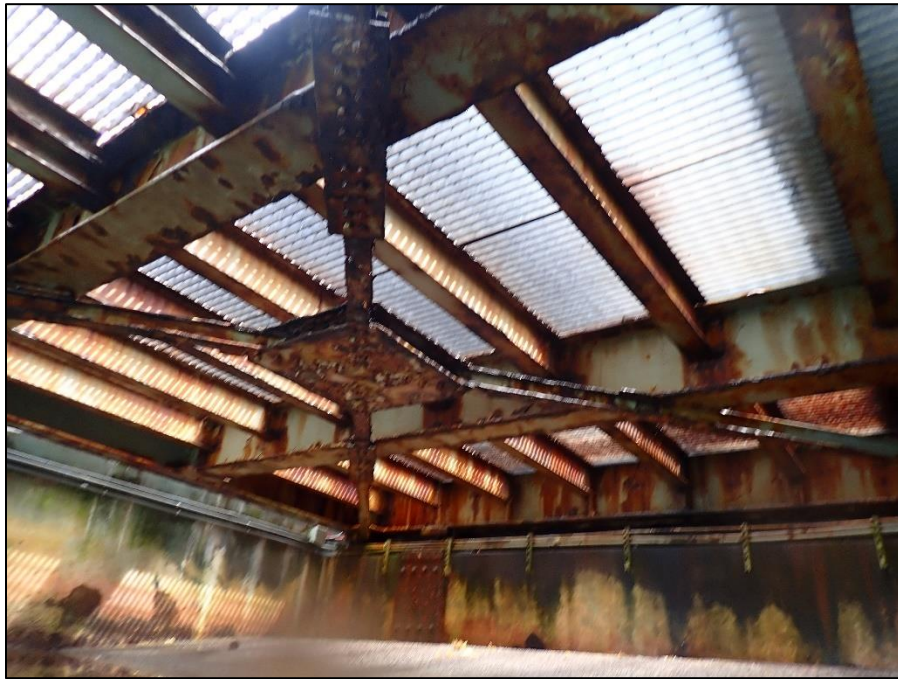
A.49: View of ferry ramp support. Note corrosion of steel beams and cross-bracing. Cross-bracing severely corroded.

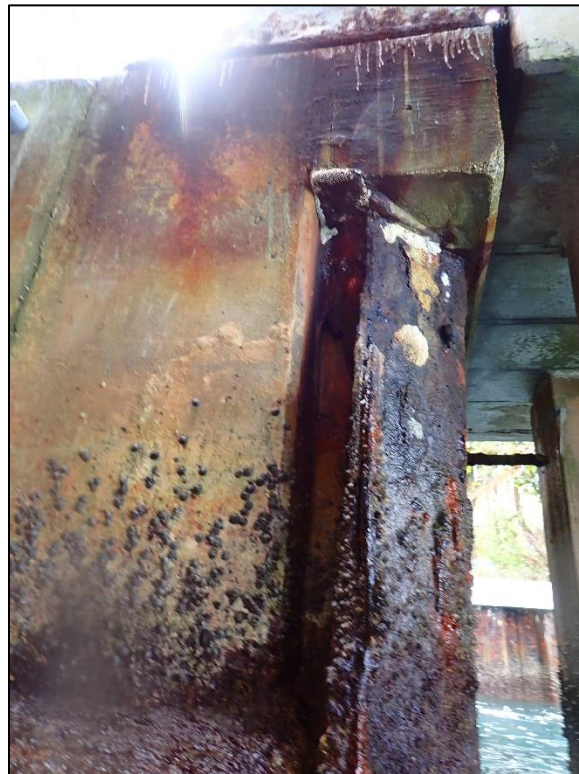
A.50: View of eastern sheet pile connection to southern hoist dolphin. Note connection appears generally intact.

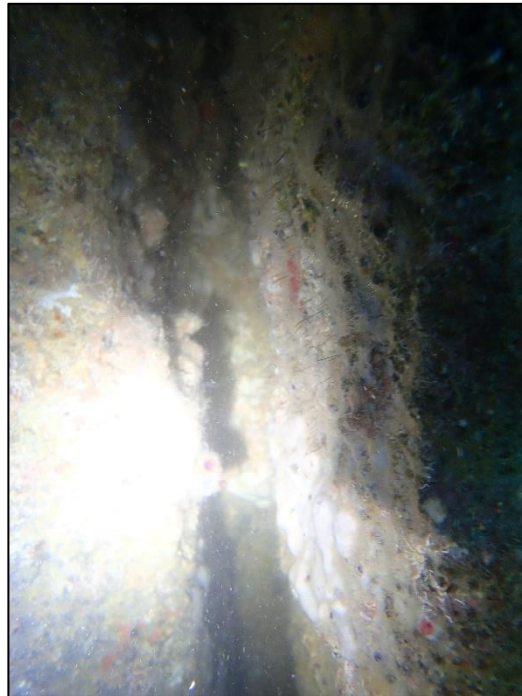
A.51: Underwater view of sheet pile wall connection with ramp wall at the southern hoist dolphin. Note seal appears to be generally intact and cavities were not observed at the time of inspection in this location, unlike the northern hoist dolphin sheet pile and ramp wall connection.

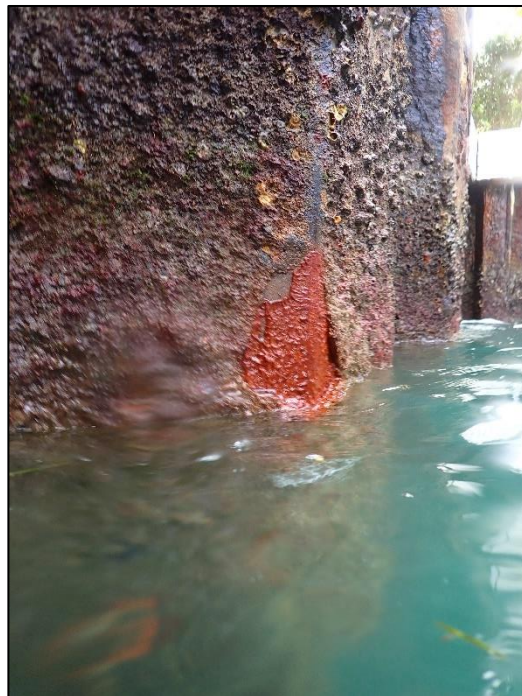
A.52: View of eastern bulkhead past southern hoist dolphin. Note soft erosion and section loss. Typical condition observed at the 4th and 5th sheet pile pairs south of the southern hoist dolphin and the 4th-6th sheet pile pairs west of the southeast corner of the bulkhead.

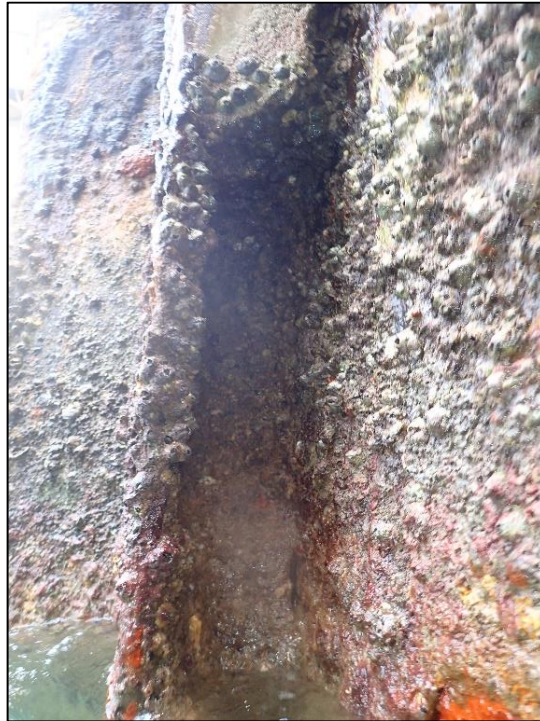
A.53: View of sheet pile wall void within the splash zone.

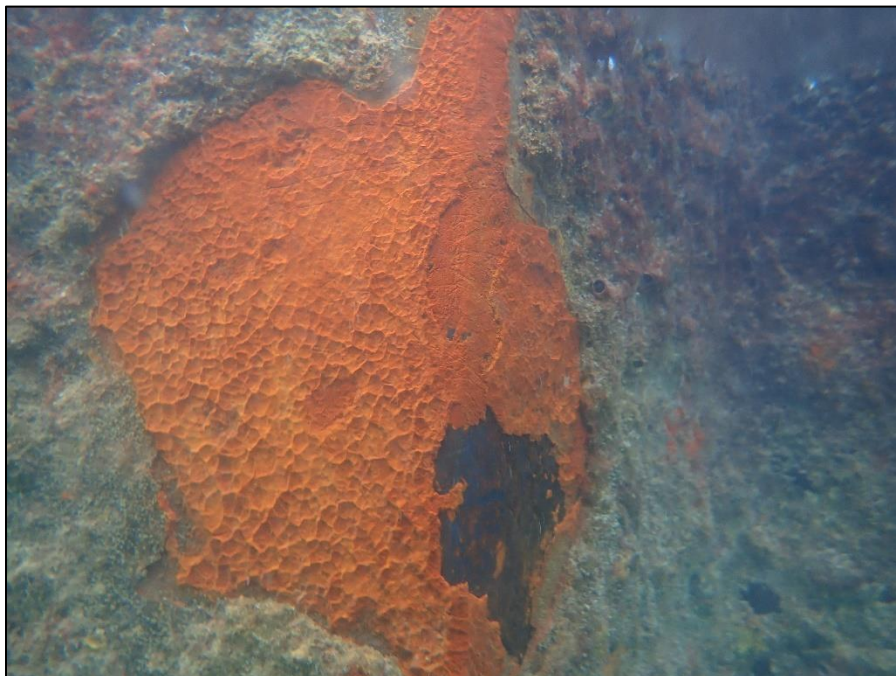
A.54: View of soft chemical deterioration and section loss of sheet pile within the tidal and low water zones.

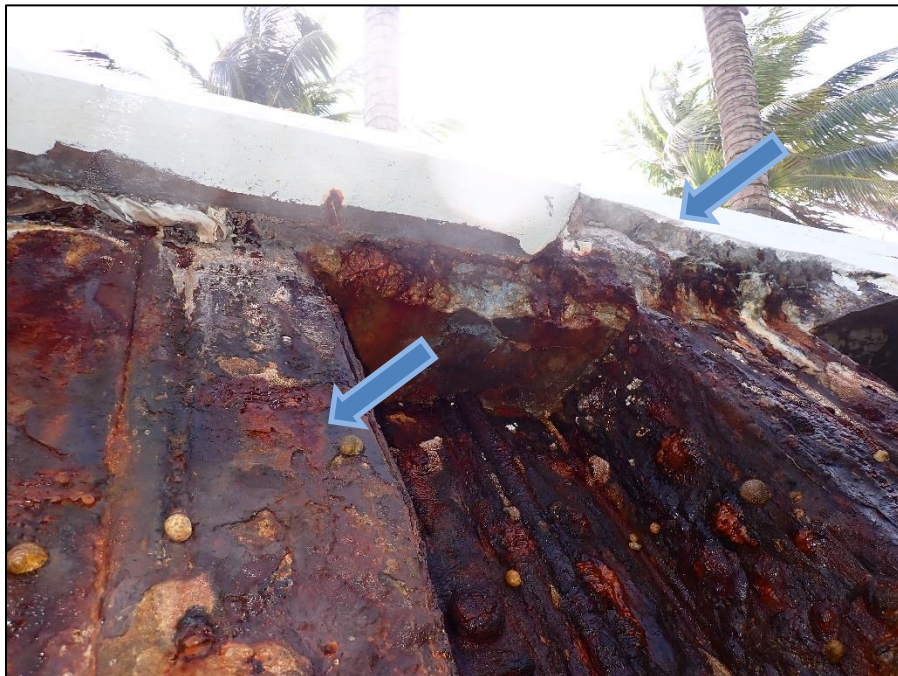
A.56: View of spalling along the concrete cap soffit along the eastern bulkhead at the 2nd sheet pile pair from the ladder. Note sheet pile corrosion scaling, typical within inspection scope.

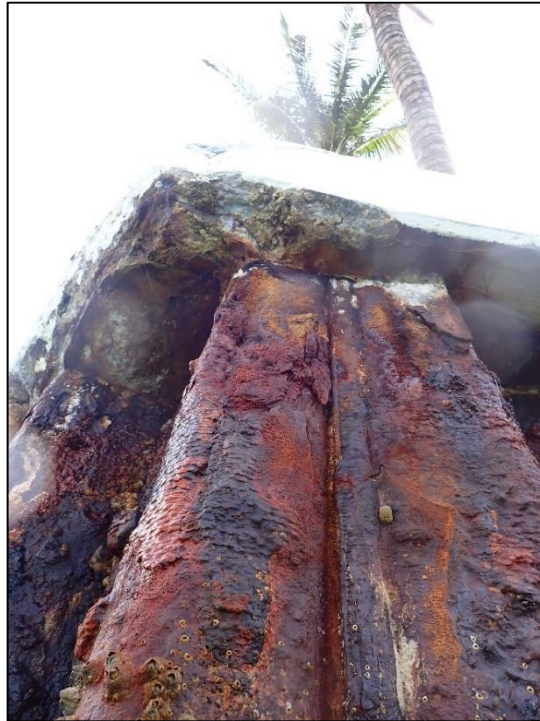
A.57: View of spalling at concrete cap at southern corner of bulkhead. Note exposed reinforcement in concrete cap and steel corrosion staining in cap.

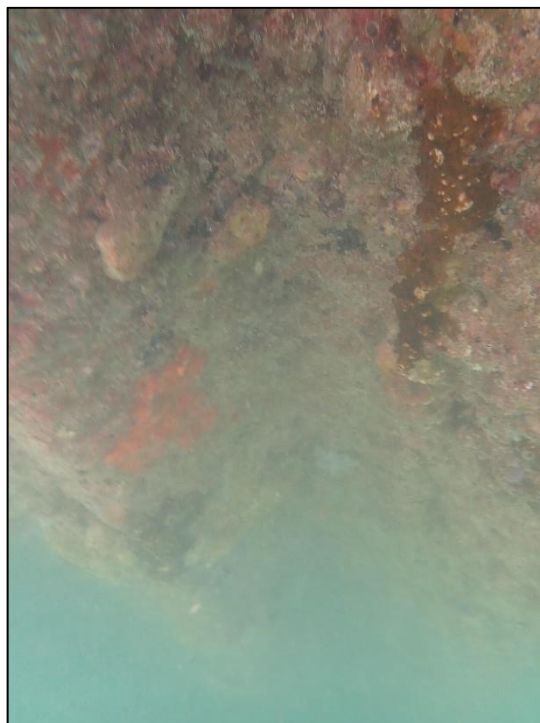
A.58: View of steel sheet pile at southern corner of bulkhead within the tidal and submerged zones. Note moderate corrosion and marine growth.

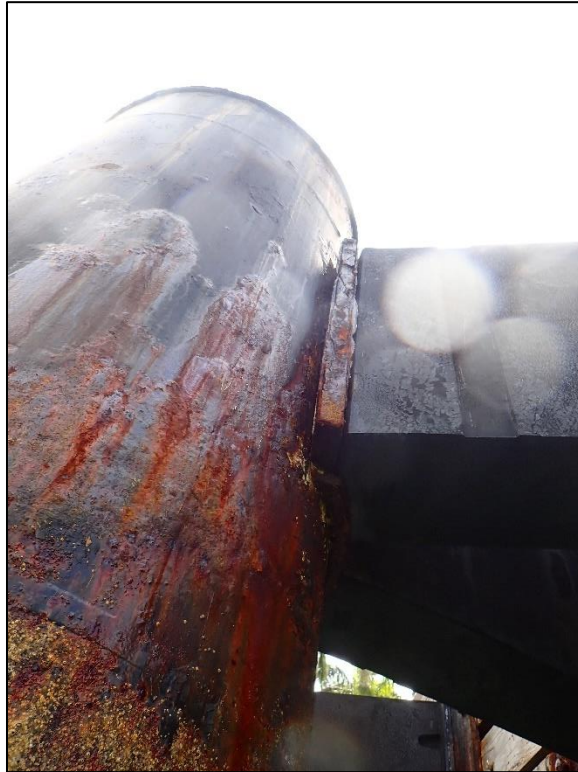
A.59: View of steel pipe pile approximately 48” in diameter at the berthing dolphins. Two piles were observed for each berthing dolphin. Note corrosion in the splash zone.

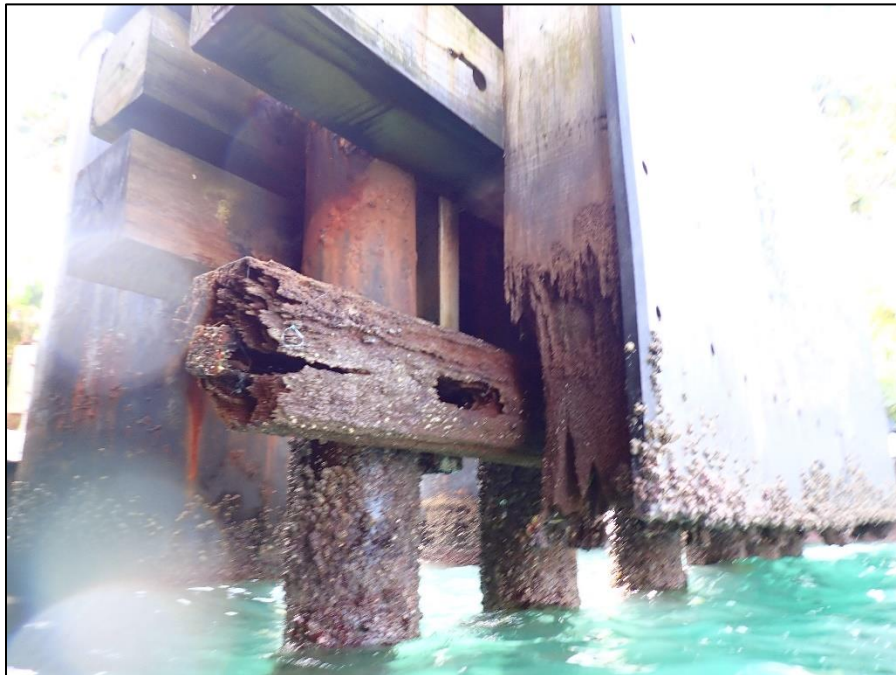
A.60: View of timber rot at bottom timber and timber fascia on the berthing dolphin. Typical condition for both north and south berthing dolphins.

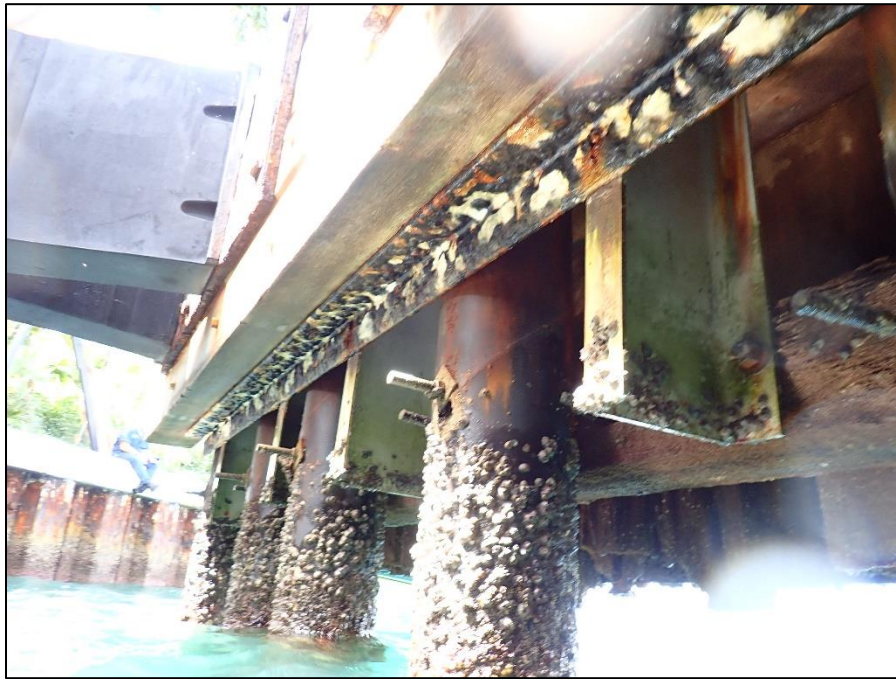
A.61: View of corrosion and marine growth within the splash zone for steel pipe piles and aluminum channels at the berthing dolphins.

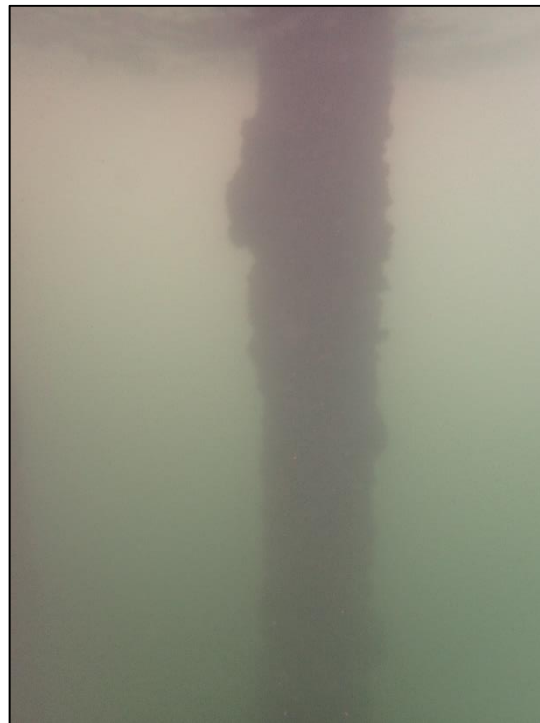
A.62: View of berthing dolphin steel pipe pile within the tidal and submerged zone. Note corrosion and marine growth on pile.

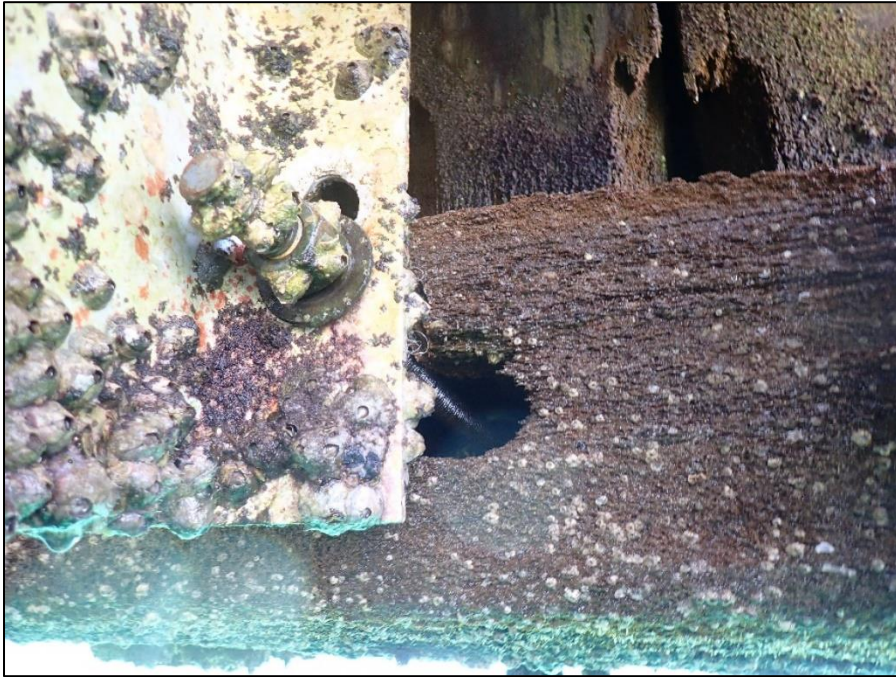
A.63: View timber rot surrounding steel fasteners at the aluminum channels to the bottom timber at the berthing dolphins.

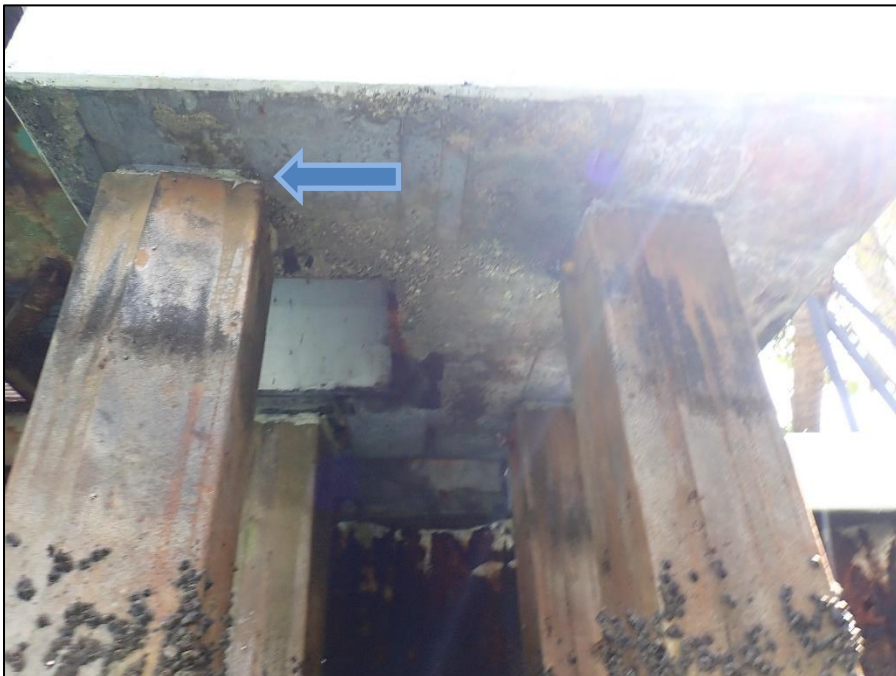
A.64: View of hoist dolphin. Note pile jackets on concrete piles.

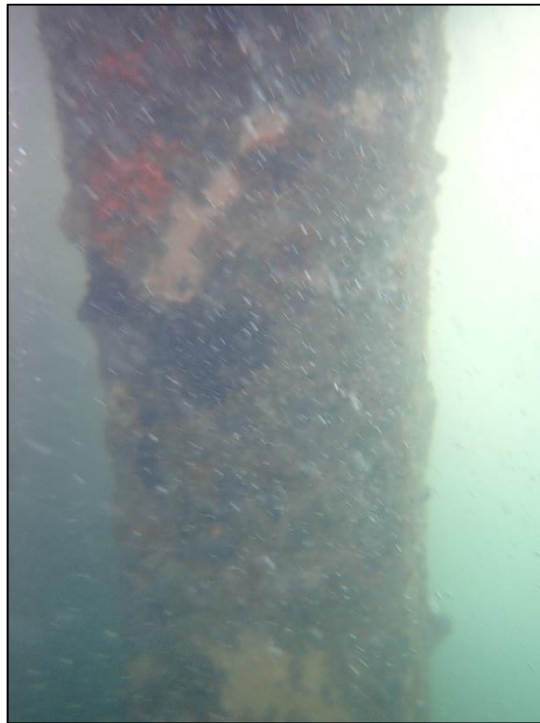
A.65: View of jacketed hoist dolphin piles within the tidal and submerged zone. Note pile observed in good condition with pile jackets.

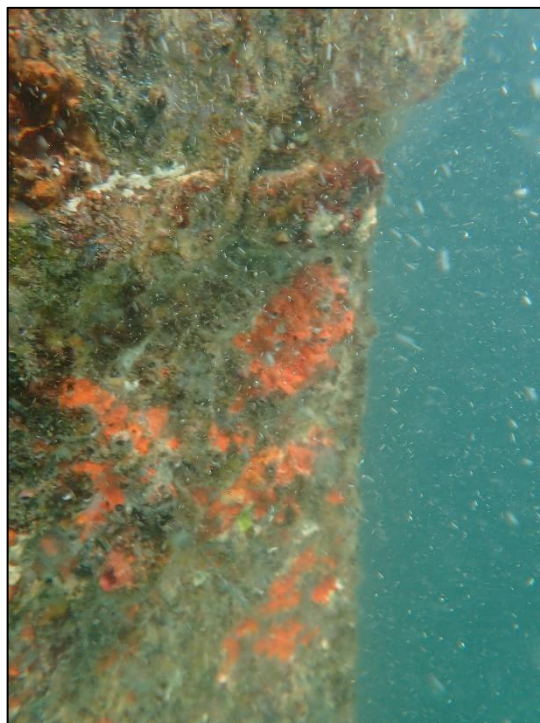
A.66: View of jacketed section of hoist dolphin pile end within the submerged zone. Note pile observed to be satisfactory below the pile jackets.

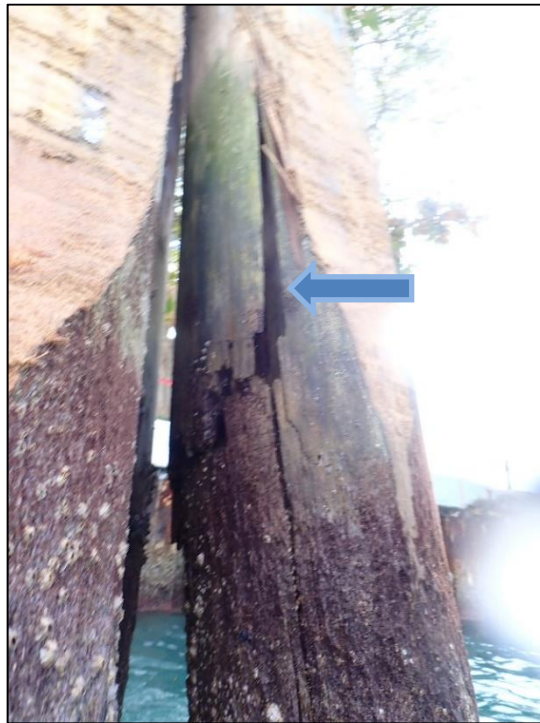
A.67: View of typically observed flexural failure of the timber piles in the timber dolphin. Note northern face damage of piles within the impact zone of the dolphin.

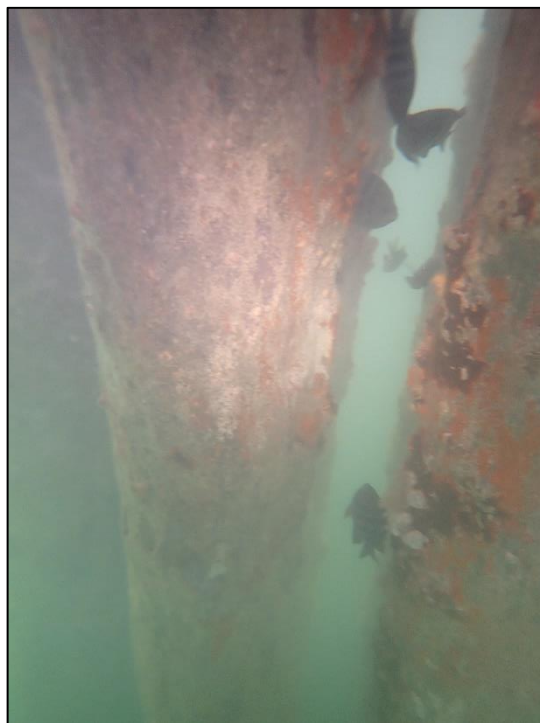
A.68: View of timber dolphin piles within the submerged zone. Minimal section loss of timber piles was observed.
