**Fisher Island Community Association, Inc**

***Fisher Island, FL***

Report #: 24275-9

**RESERVE STUDY**  
**Update "With-Site-Visit"**

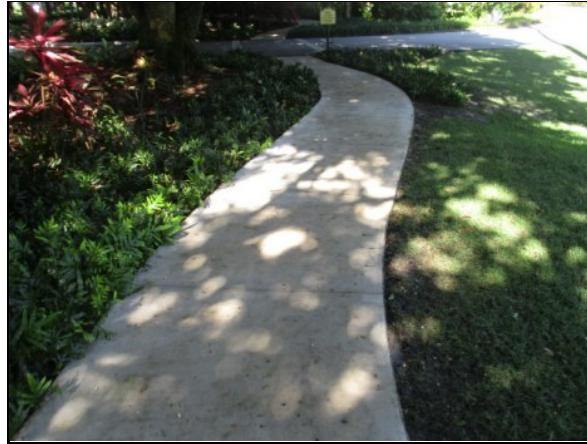
Comments: According to information provided, the Association is anticipating more concrete repairs than normal in 2023. This is shown here as a one-time project, with allowances for future years at a lesser amount as shown in the following component.

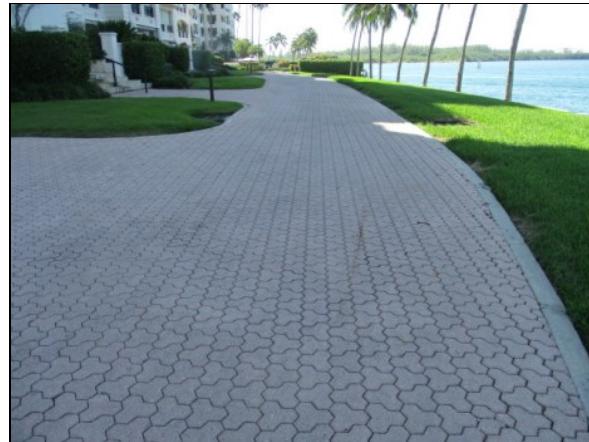
**Quantity: Approx 186,200 GSF**Useful Life:  
50 years

Comments: Quantity shown here does not include driveway areas that are within boundaries of individual condominium associations. Most pavers are in fair condition. Some surface wear and deterioration, but generally consistent. Management reports that individual pavers and sections have been repaired and re-set as needed to address lifting/cracking section. Useful life should be very long under normal circumstances, but plan on long-term replacement at the approximate interval shown here. Inspect regularly and pressure wash periodically for appearance. Inspection and preventive maintenance is typically included within the Operating budget.

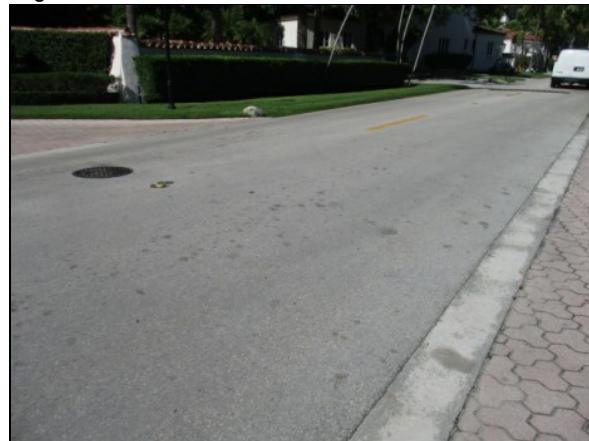
Comments: Asphalt was sealed in 2007 but management reports that this would not be considered in the future due to impracticality of taking roads out of service. Plan to resurface as shown in component #2125 and make patch repairs as needed. No recommendation for seal-coating at this time.

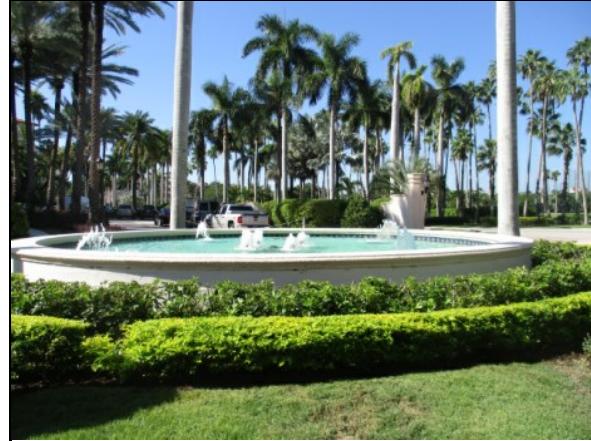
Comments: All four fountains are approximately the same with minor aesthetic differences: circular, roughly 25'-27' in diameter. Concrete structure with tile accents/trim. Some fountains have central tiered structures. Minor cracking and leaking noted around perimeters. Fountains noted to be functional. Typical equipment enclosure includes a small controller and filter, and circulation/fountain pumps. Management reports that all maintenance and refurbishing costs are considered an Operating expense. Complete replacement for aesthetic reasons is unpredictable and not likely to be required. If a complete replacement project is anticipated at some point in the future, the Reserve Study should be re-evaluated to include funding recommendations as needed.

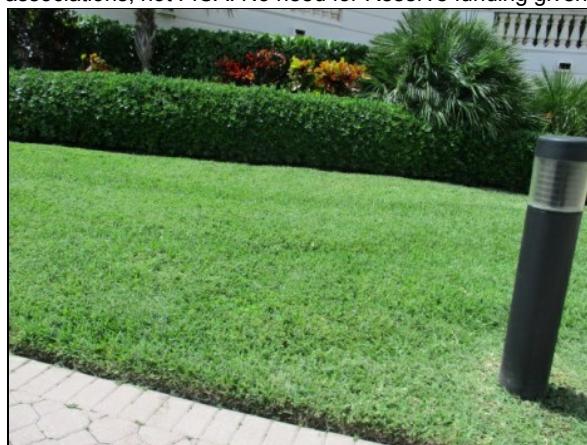
Comments: Inspected during daylight hours; assumed to be in functional operating condition. All bollard light posts are reported to be the property of condominium associations, not FICA. No need for Reserve funding given this assumption.

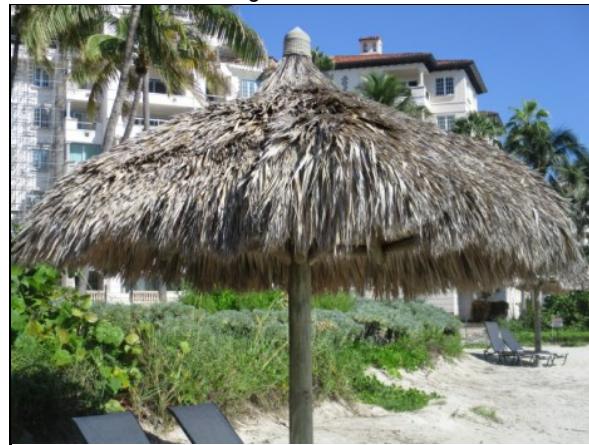
**Quantity: (32) Shades**Useful Life:  
8 years

Comments: Reportedly to be replaced in 2022. Remaining useful life has been extended accordingly.

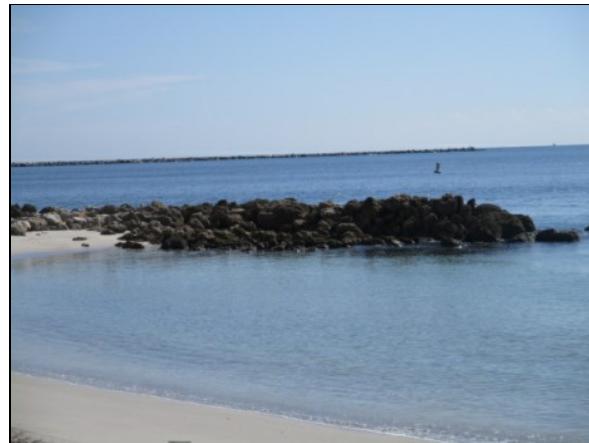
**Quantity: Approx 2,400 LF Beach**

The association is responsible for a section of beach at the East side of the island. The beach also features six rock/rip-rap groin structures which help prevent or minimize erosion by interrupting water flow. Analysis beyond visual inspection is outside the scope of this engagement, but the association may wish to consult with a coastal engineering firm to investigate this area in greater detail. In our experience, these types of structures should have an indefinite useful life with no predictable need for complete replacement. At this time, management reports that any major expenses related to this area will be addressed through the Operating budget or by a special assessment.

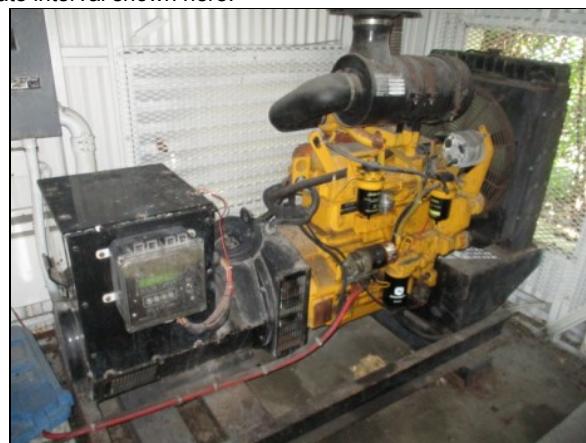
Comments: John Deere diesel generator, protected inside enclosed housing. Purchased in 2004 according to records provided. Plan to replace at the approximate interval shown here.

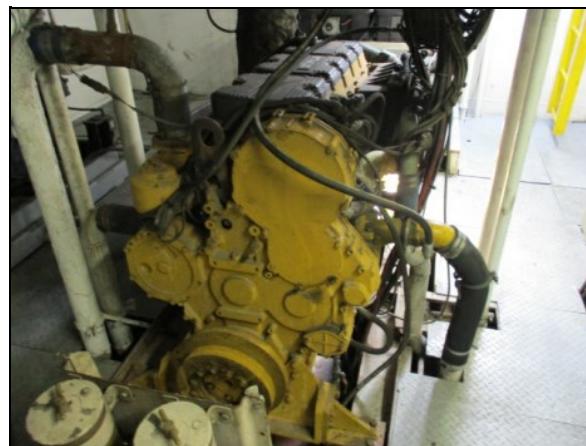
Two engines per vessel according to VP of Transportation. Both engines are in use while underway (one forward, one aft), and generators serve as backup power. Labor and installation is done by FICA staff. Useful life will vary greatly depending on level of maintenance and service. Transmissions are serviced by FICA staff as well, but should have roughly the same life expectancy as the engines according to management. Useful lives are expected to vary slightly, and there should be no need to replace all at one time.
