# Shoreline Inspection Report

## FICA Shoreline Assessment

*Fisher Island,  
Miami-Dade County, Florida*

August 2023

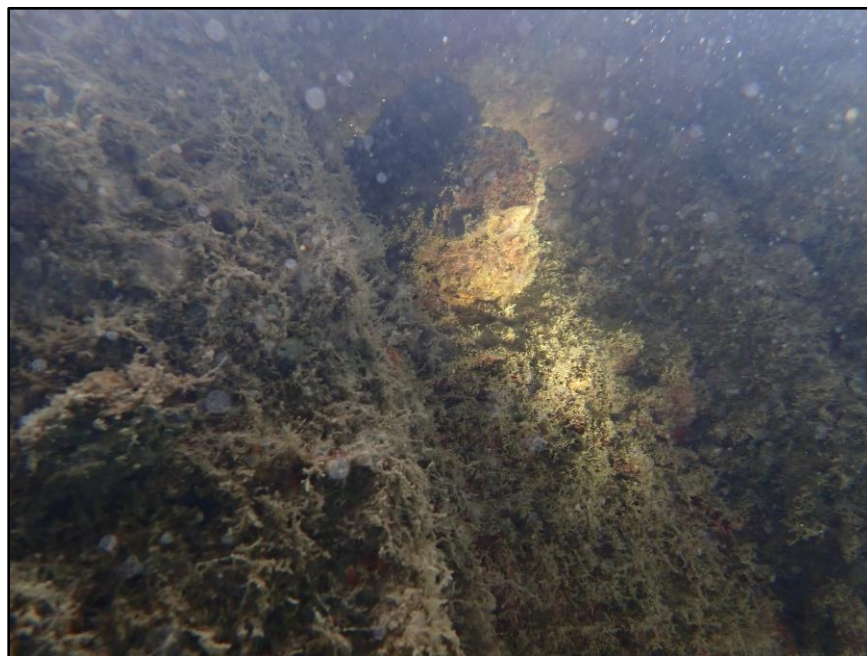
The bulkhead is constructed of steel sheet piles with a concrete cap and an upland tie-back system. Hex bolts were installed on the inner flanges and are assumed to connect the upland tie rod system. Original construction documents were not found during the historical records search, but the bulkhead was shown to exist in a 1988 construction set detailing marina construction efforts. This puts the minimum age of the bulkhead at the time of inspection at 35 years, but it could be significantly older.

**Photo 5: Typical view of anchor head on steel sheet pile at Section 3**

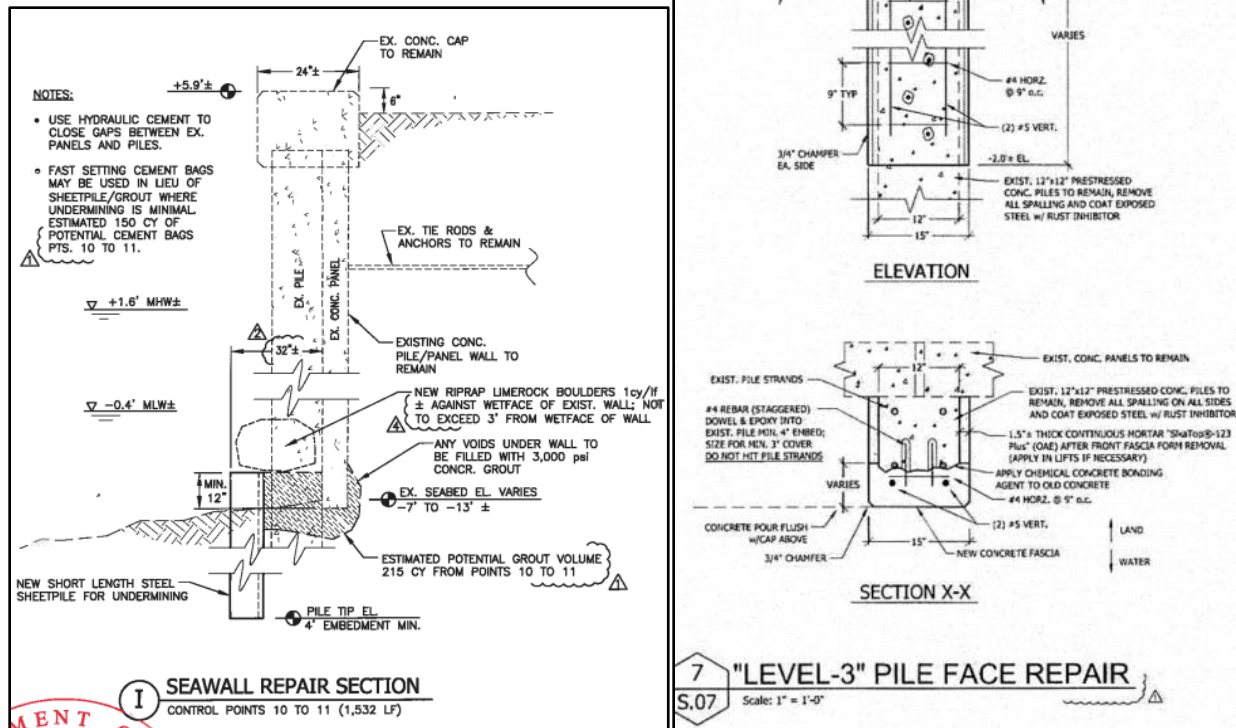
The king piles are originally 12-in. square concrete piles but were encased in the 2012 bulkhead rehabilitation effort. The encasements provided 4 in. of additional concrete on each face and were measured at 16-in. deep and 20-in. across. The encasements typically extended from the cap down approximately 4-5 ft. The rehabilitation effort also included a steel sheet pile toe wall at the base of the bulkhead, riprap and grout bags at the toe of the panels, concrete patching of the king pile-panel interface, and crack repairs on the concrete cap. The rehabilitation section and pile jacket detail can be seen in Figure 11.

**Figure 11: Section 6 bulkhead repair drawings, including pile encasement detail**

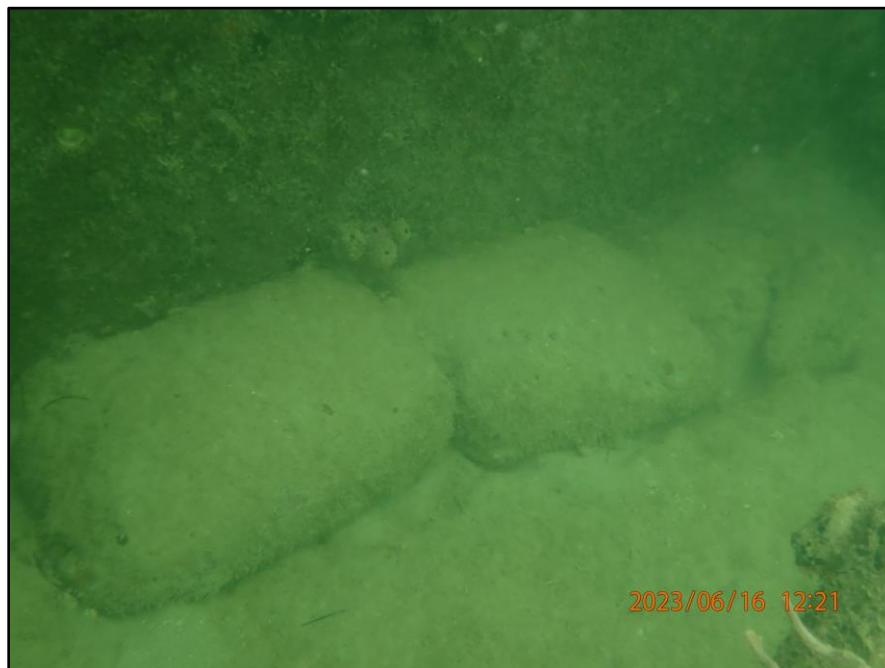
**Photo 17: Intermittent grout bag installation along the toe of Section 6**

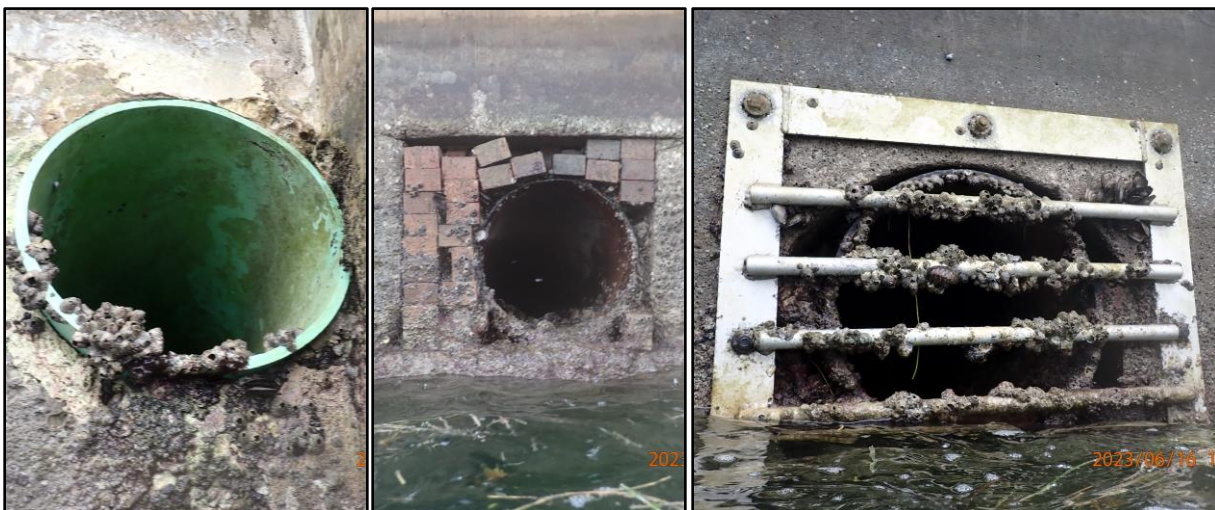
- a 16-in. diameter steel pipe at STA 14+75, with an installed manatee grate,
- a 16-in. diameter steel pipe at STA 18+80 protruding through a 20-in. high by 24-in. wide panel opening, with bricks infill, and
- a 15-in. diameter PVC pipe at STA 26+55.

**Photo 19: Section 6 outfalls**

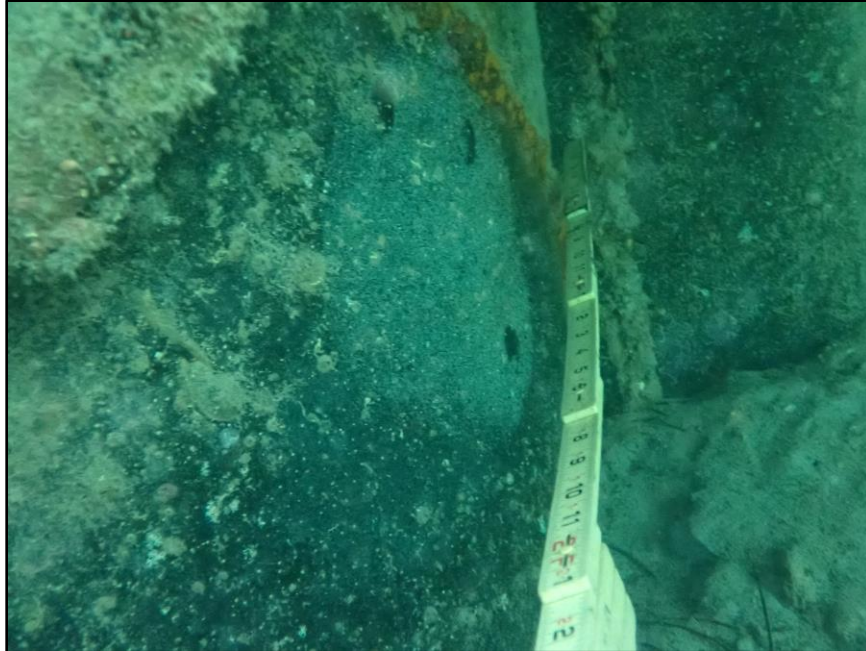
**Photo 36: Section 12 View of new pipe pile portion of combi-wall through deterioration in original outer sheet**

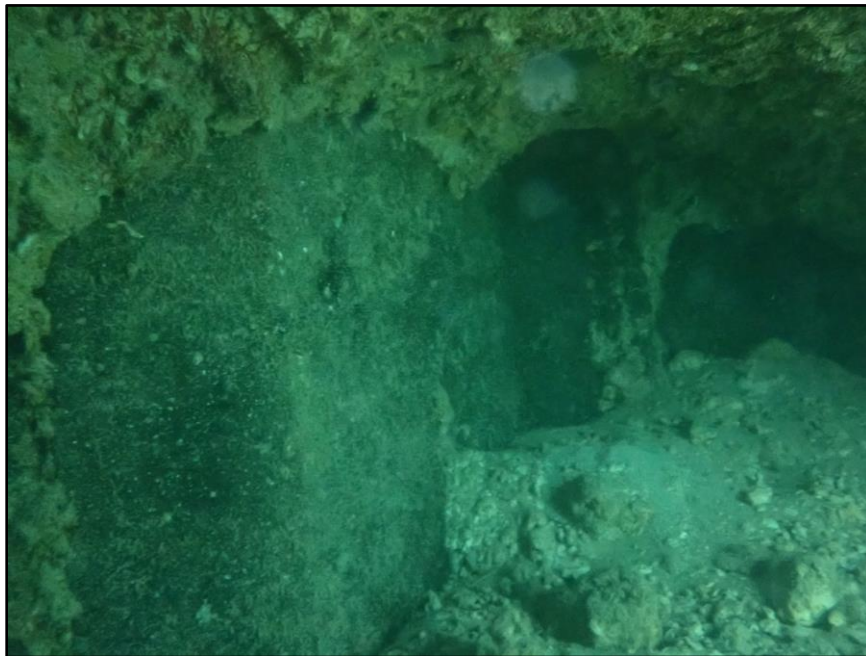
**Photo 37: Section 12 View of new steel sheet pile portion of combi-wall through deterioration in original outer sheet**

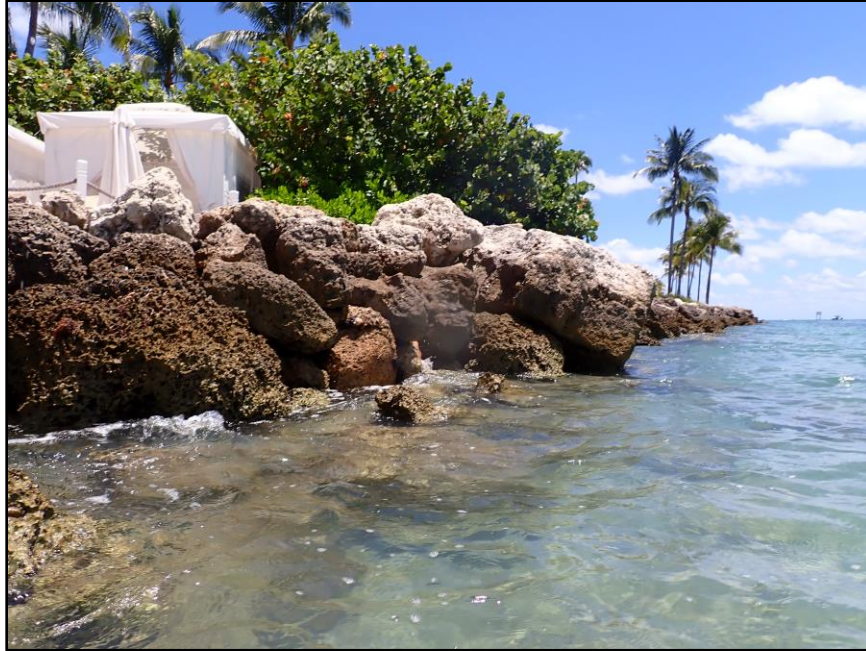
The riprap within this section consists of stacked stable stones at an approximate 2:1 grade. Localized slopes up to 1:1 were observed at the western extent. No significant displacement, scour, or erosion was observed within the scope. The upland soil is well anchored with significant coverage of vegetation.

**Photo 45: Localized 1:1 riprap slope at the western extent**

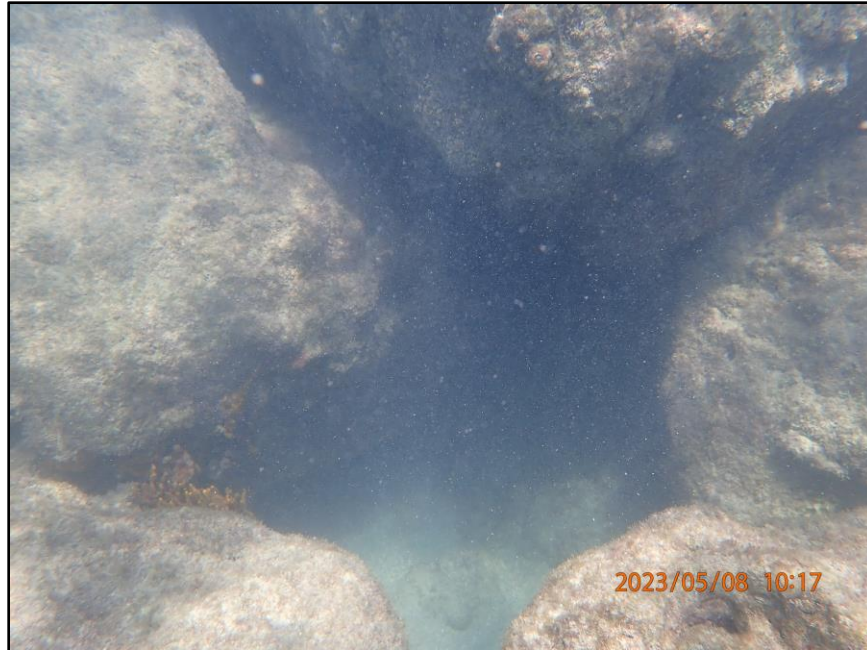
The inspection performed by Cummins Cederberg found the Section 2 riprap displayed localized moderate voids in some locations due to unevenly stacked stones. Localized minor scour pockets were observed at the base of the riprap slope on the inshore face, assumed to be a byproduct of vessel traffic adjacent to the dock.

**Photo 46: Section 2 localized moderate voids in the rip rap**

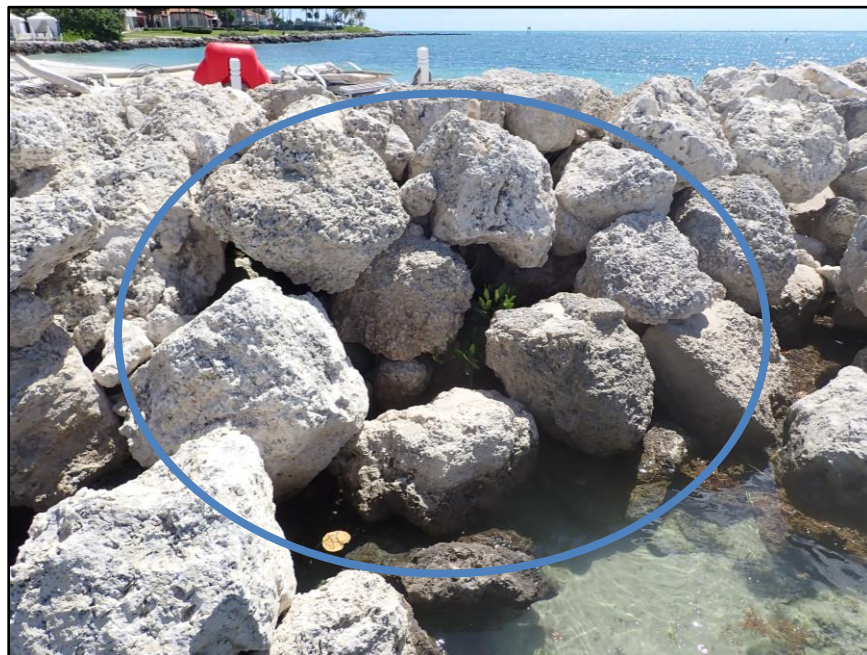
Localized areas of uneven slope were observed where the stones had shifted from their original position leaving steeper slopes and loose stones at the base.

**Photo 47: Section 2 localized riprap slope steeper than 1:1**

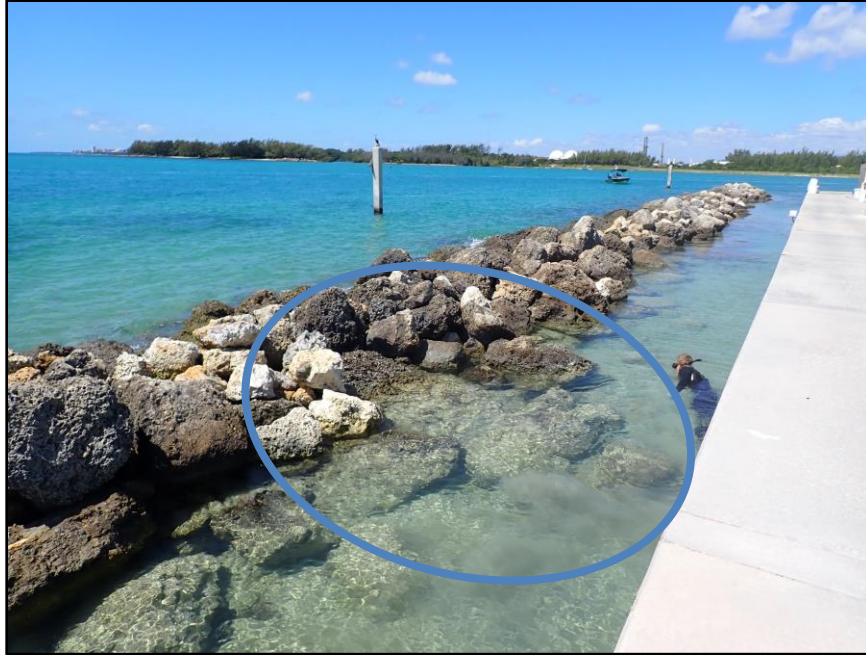
**Photo 48: Section 2 riprap shifted downward STA 0+55, facing northeast**

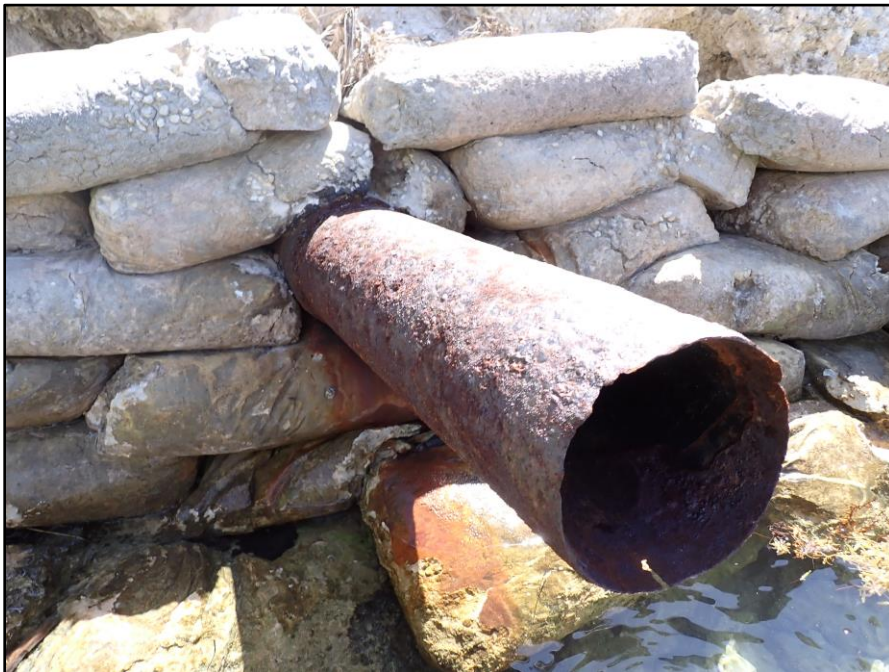
At the beginning of the riprap adjacent to the dock the 6-in diameter steel outfall exhibits severe corrosion, see **Photo 49**.

**Photo 49: Section 2 severe corrosion of steel outfall**

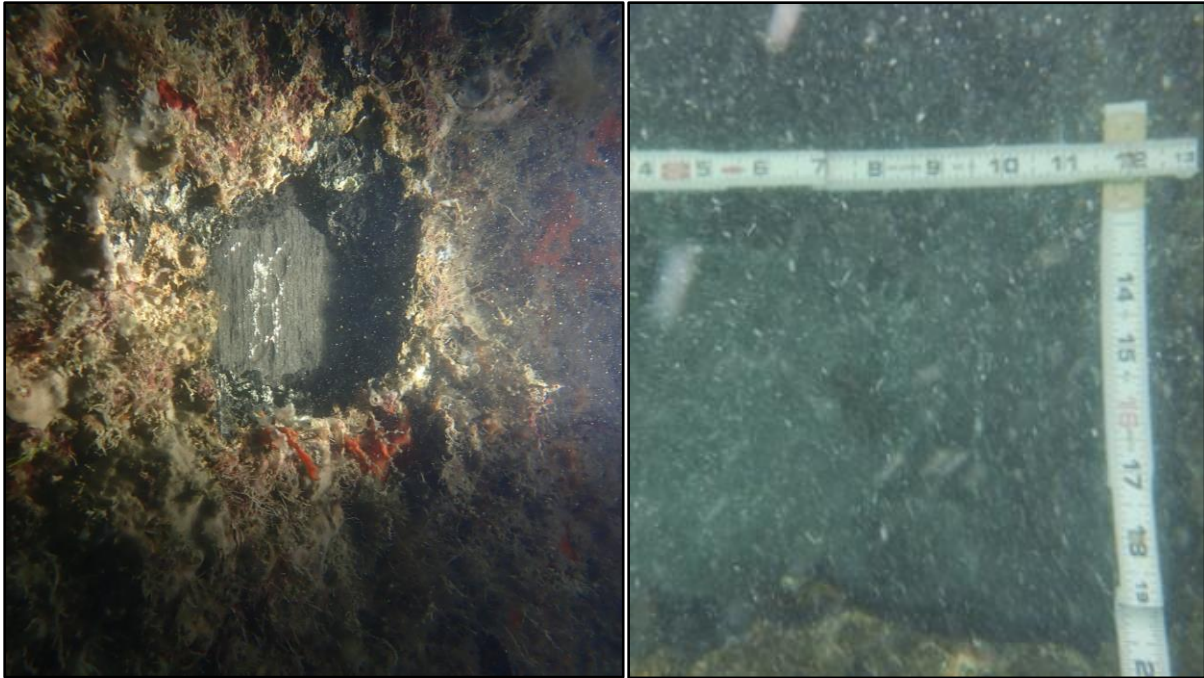
Penetration into the upland fill measured up to 5 in. A significant tilt to the wall was observed at STA 0+00, which was not noted in the 2019 Edgewater report. An excavation was performed adjacent to this location to inspect the tie rod, which was found to be below the ground water level; therefore, only a tactile inspection was able to be performed. The tie rod appeared to be intact with moderate surface corrosion but no significant section loss.

**Photo 50: Typical view of cleaned steel sheet pile in Section 3, 2023 (left) and 2019 report (right)**

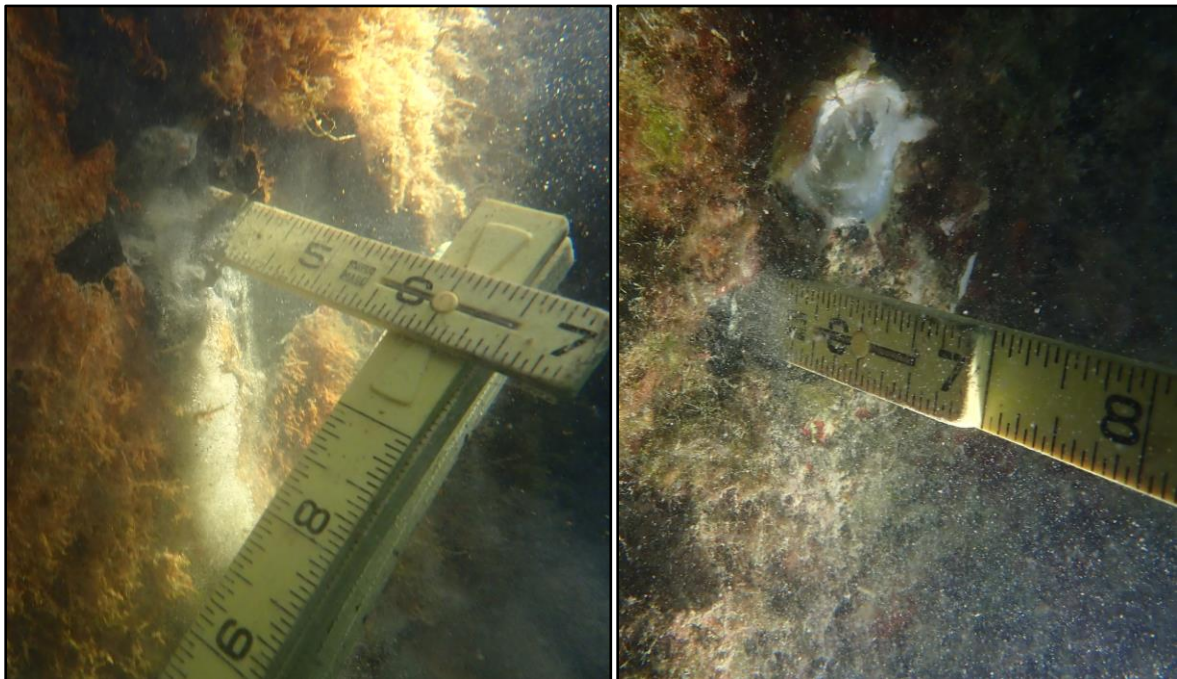
**Photo 51: Multiple locations of 100% section loss in Section 3 steel sheet pile**

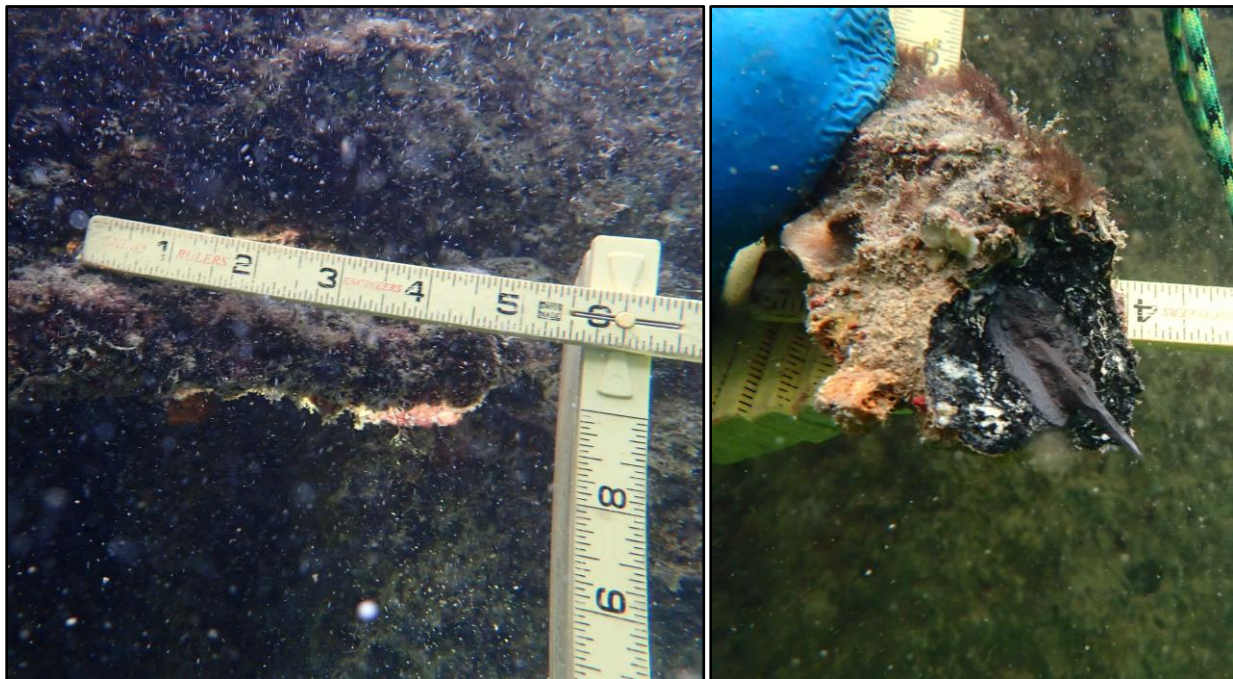
The severe spall on the deck soffit near the east end of Section 3 as noted in the 2019 Edgewater report was observed and the reinforcement within the spall displayed up to full section loss indicating the deterioration has progressed. The above water portions of the cap exhibit localized areas of cracking up to 1/8-in. wide throughout. The paver settlement matched the description given in the 2019 report and the deterioration was not observed to have advanced significantly.

**Photo 52: Major spalling of the bottom edge of the Section 3 concrete cap with full section loss of the reinforcement**

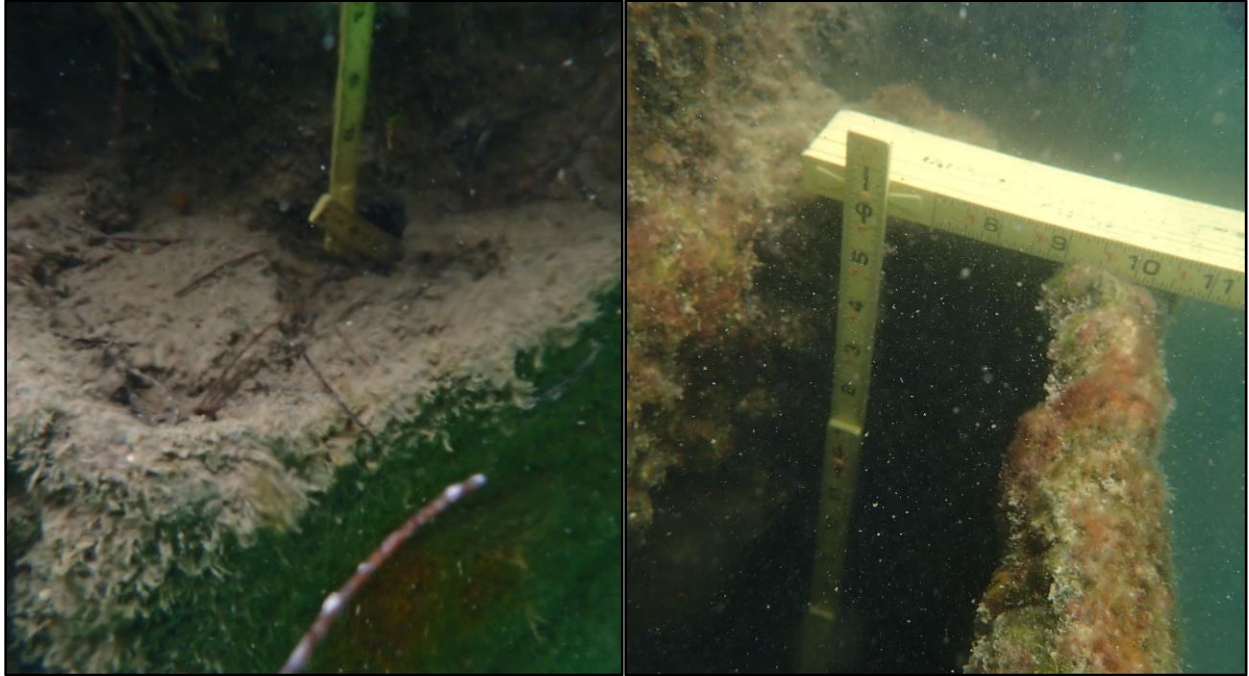
**Photo 53: Voids in between the offshore edge of the Section 3 cap and the bulkhead**

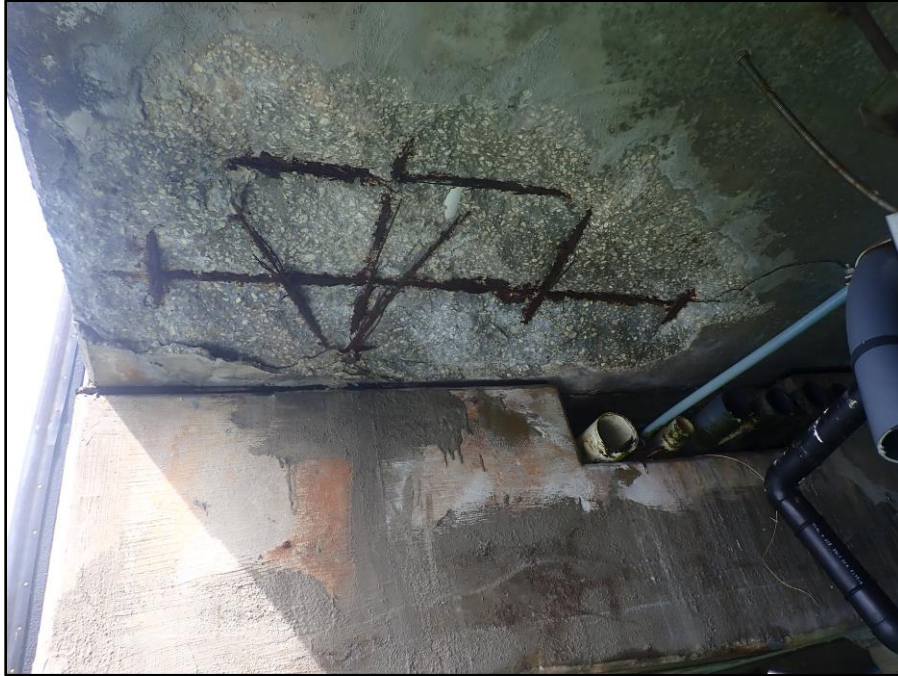
**Photo 55: Severe spall in soffit slab adjacent to the Section 3 bulkhead termination**

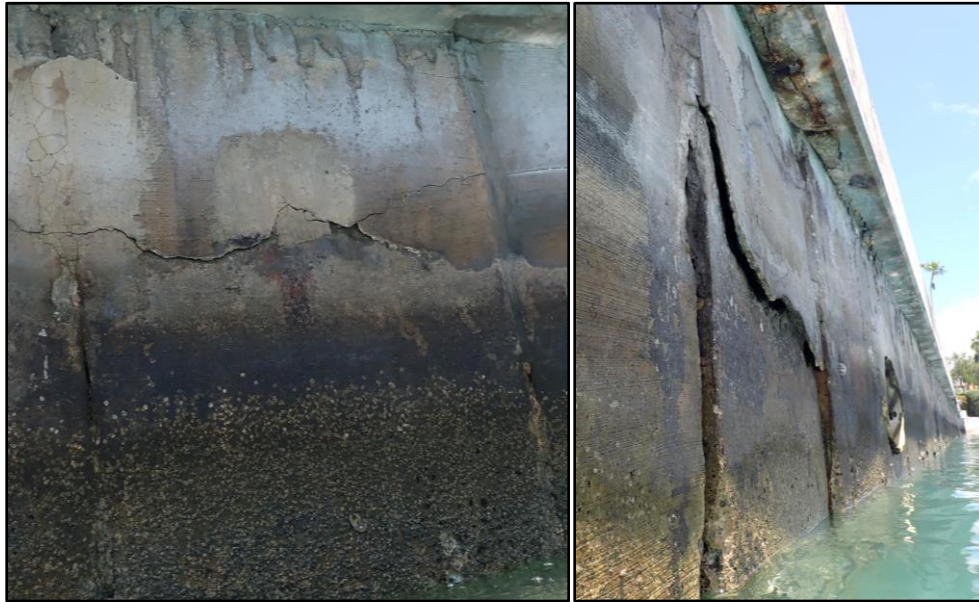
joints exhibit intermittent horizontal and lateral separation up to 2 in. Intermittent sinkholes were observed upland, in line with the sheet pile joints. Similarly, intermittent sediment accumulation was observed at the seabed adjacent to the joints. From STA 5+70 to STA 6+35, the wall deflected visibly outwards. A tie rod was inspected adjacent to this area, at approximately STA 6+65. The rod was found to exhibit moderate corrosion of the outer layer, with a uniform circumferential surface of the solid remaining steel. In general, the concrete sheet pile deterioration has progressed since the 2019 Edgewater inspection.

**Photo 56: Widespread spalling and cracking of the Section 4 concrete sheet pile**

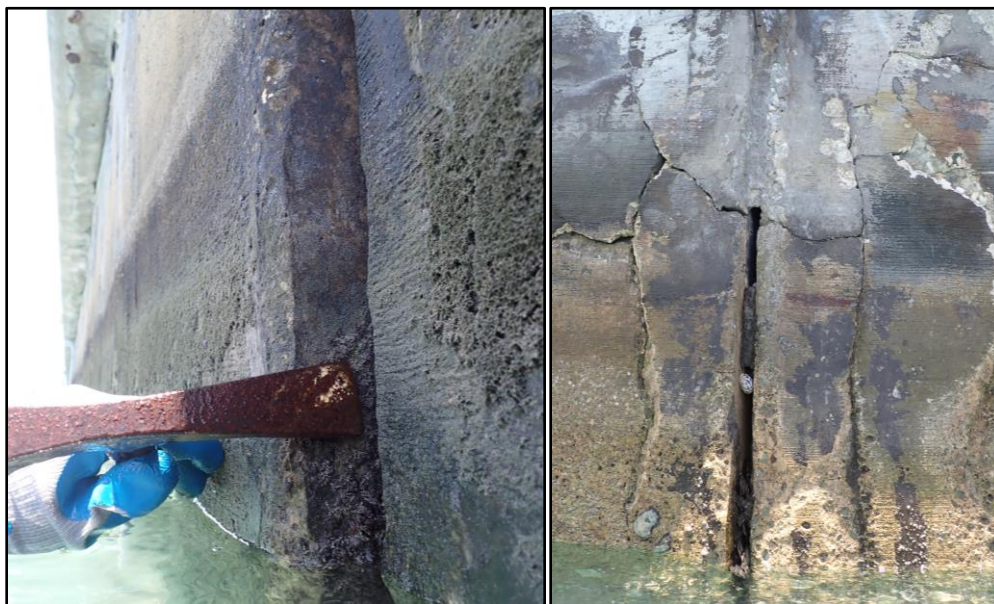
**Photo 57: Section 4 STA. 5+72 Typical view of lateral separation (left) and horizontal separation (right) at sheet pile joints**

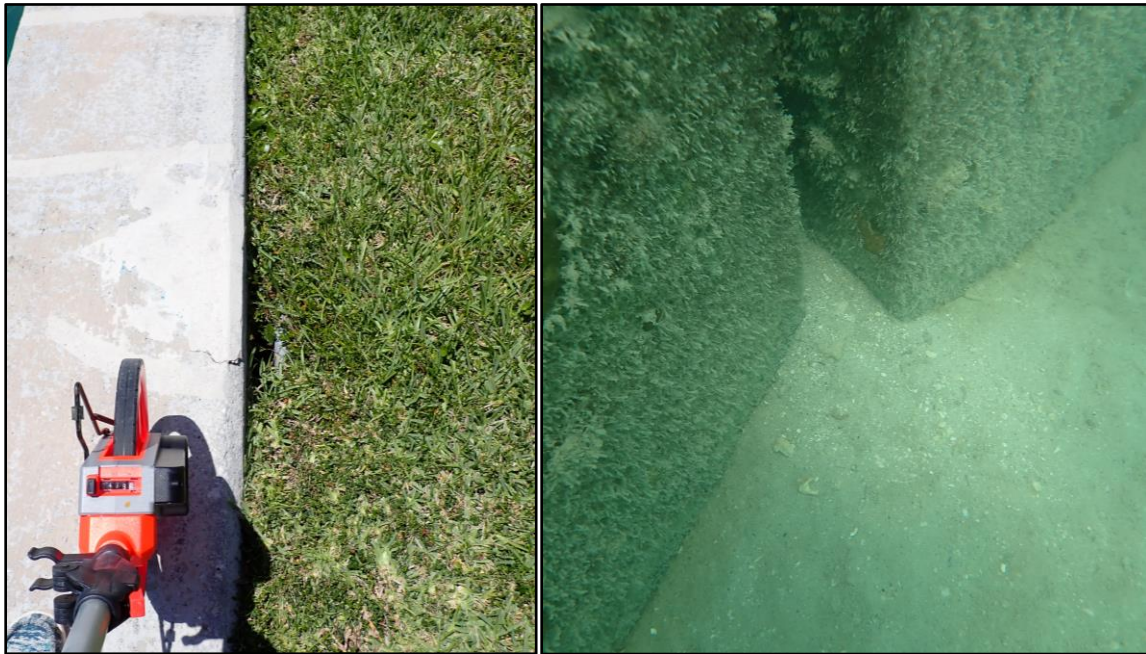
**Photo 58: Section 4 Typical view of upland sinkhole in line with sediment accumulation at mudline**

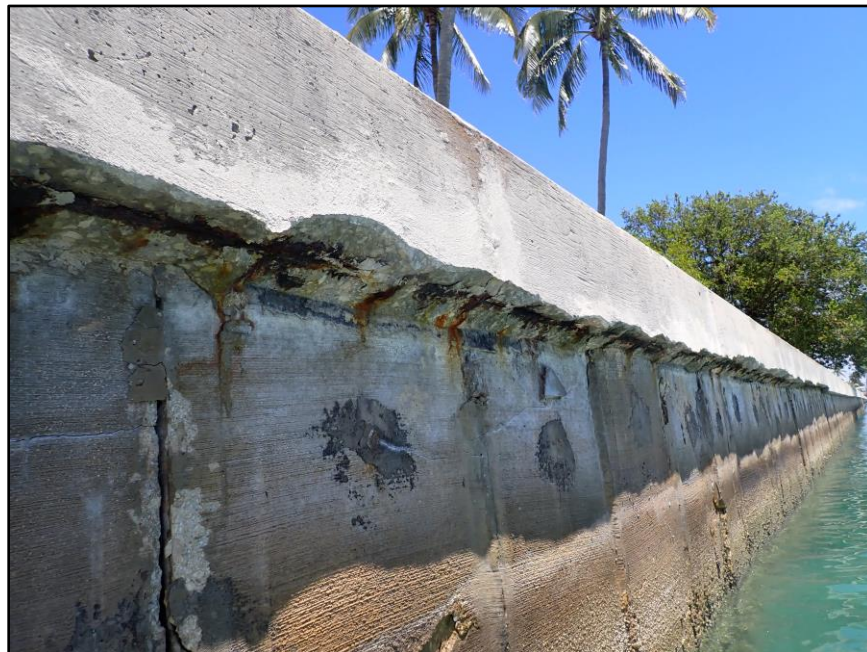
At two locations the bottom face of the concrete cap has spalled, exposing severely corroded reinforcement. The top of the cap exhibits localized cracking, less than 1/8-in. wide, with widespread crack repairs throughout.

**Photo 59: Severe spalling of Section 4 concrete cap with severe corrosion of the exposed reinforcement around STA 8+90.**

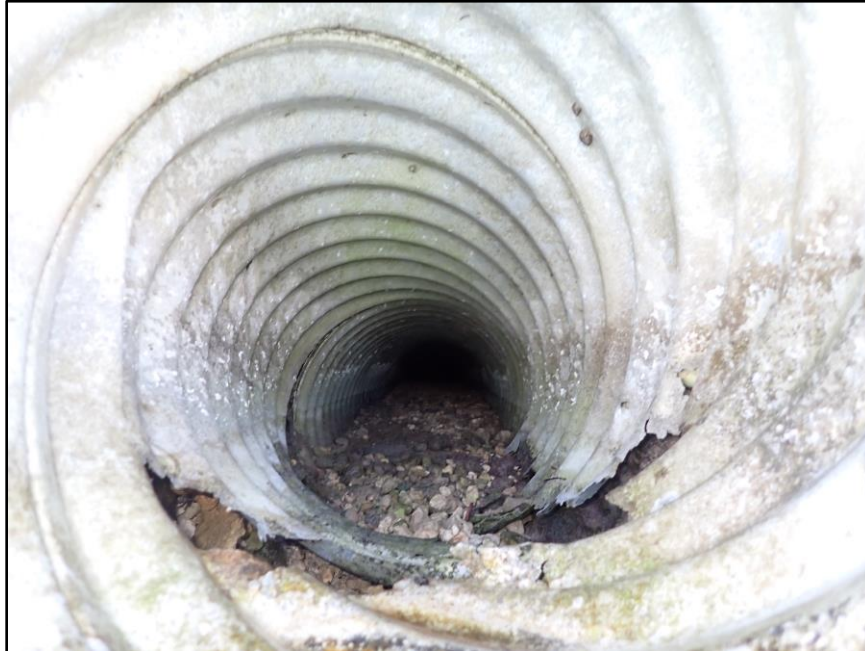
Each of the 14-in. diameter corrugated steel outfalls exhibits partial blockage of the outfall from sediment accumulation. Severe corrosion of the corrugation was also observed.

**Photo 60: Section 4 STA. 0+30 Typical partial blockage of corrugated steel outfall with severe corrosion in the tidal zone**

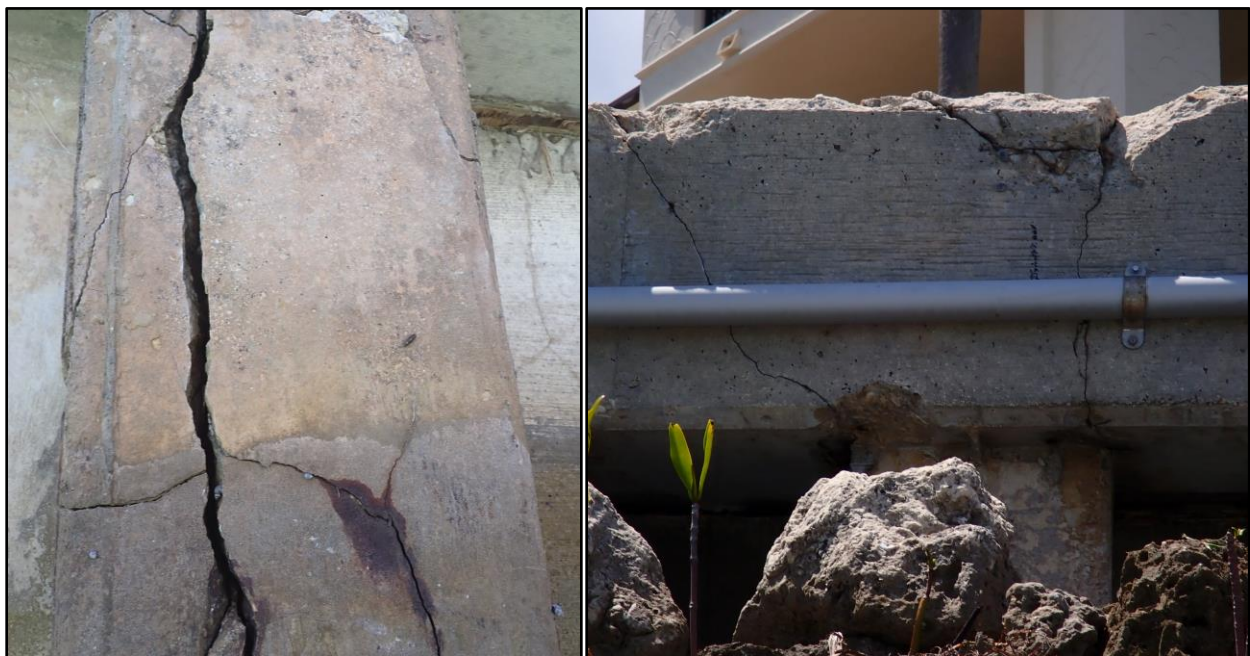
The concrete pile cap exhibits intermittent moderate to major deterioration in the form of 1/8 to 1/2 in. cracking and localized spalling. Concrete cap deterioration appears to have progressed since the 2019 Edgewater report.

**Photo 61: Section 5 Typical severe deterioration of concrete king piles with typical major deterioration of the concrete pile cap**

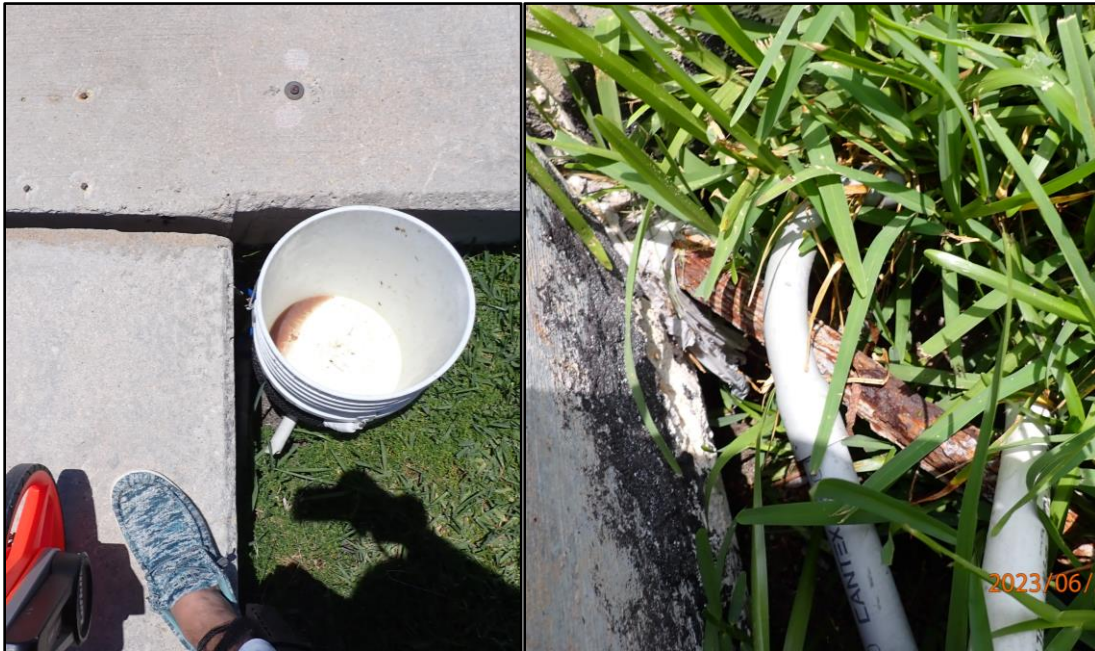
At STA 0+00 on the east wall a 1 ft deep sinkhole was present at the Section 4 termination. A tie rod attached to the Section 4 wall was exposed and exhibits severe corrosion and significant loss of section. At the mudline large scale voids are present between the Section 4 termination pile and the first king pile at Section 5. It is unclear what prevents the remaining upland soil from evacuating through the voids at the base, but fill loss is assumed to continue.

**Photo 62: 1 ft deep sinkhole at Section 5 STA. 0+00 E (left) with exposed tie rod attached to Section 4 bulkhead (right)**

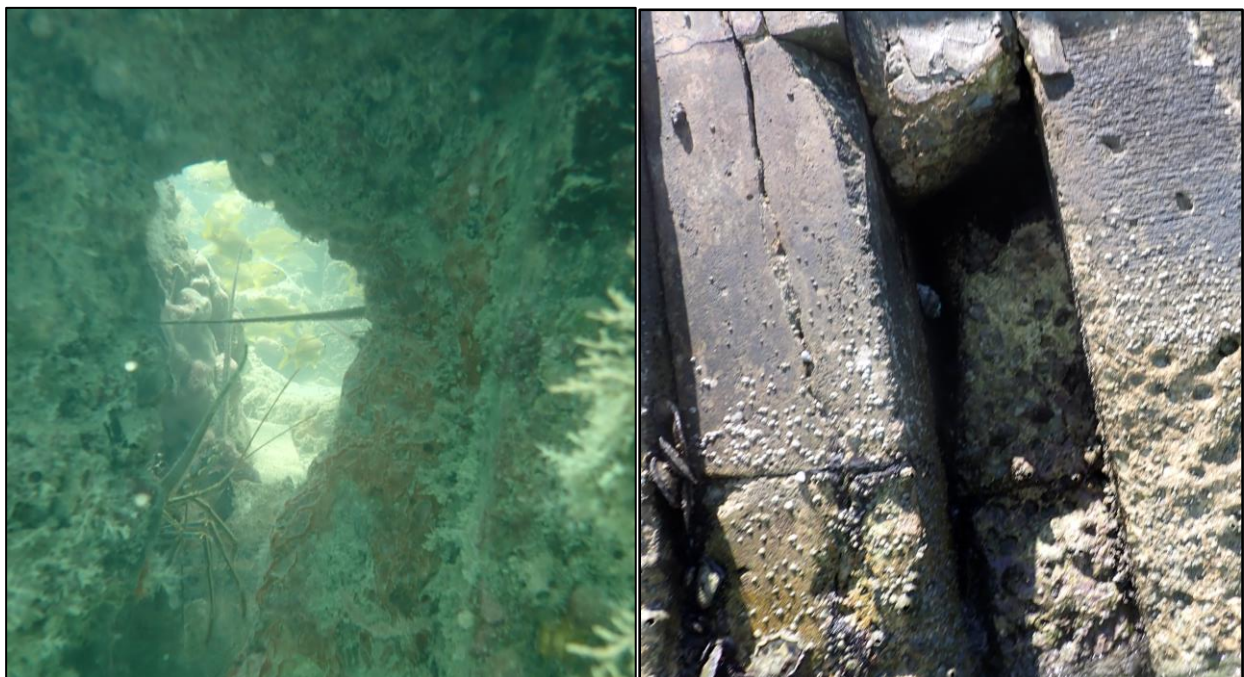
**Photo 63: Large scale voiding adjacent to mudline at interface between Section 4 and Section 5 bulkheads**

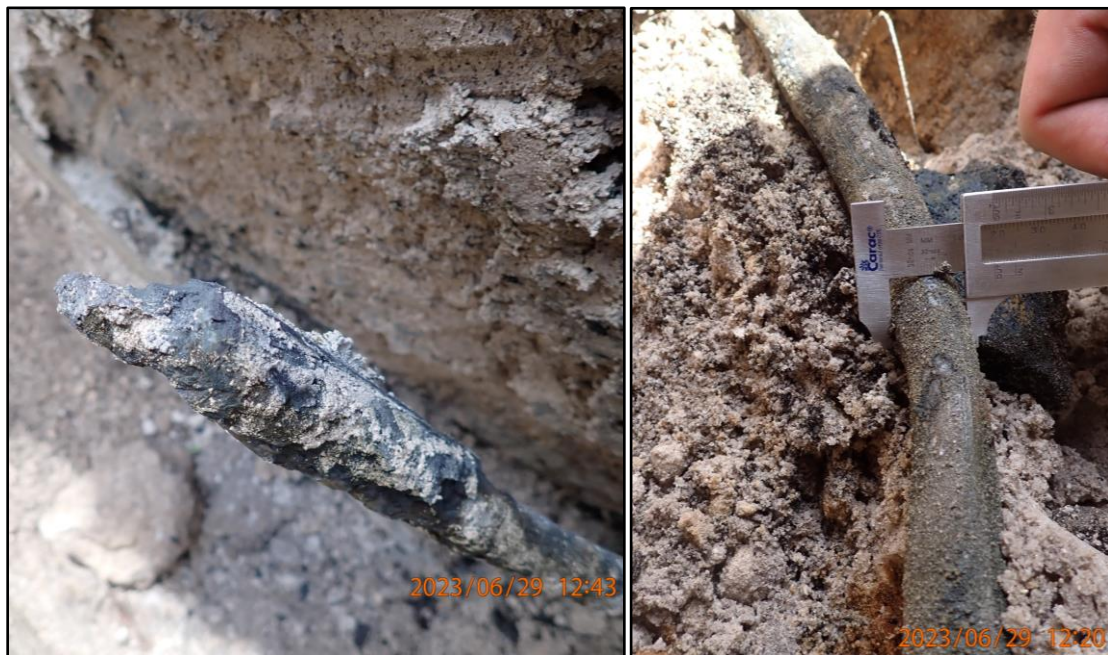
**Photo 64: Section 5 Failed tie rod at STA. 2+75 E (left) and bent tie rod at STA. 0+05 E (right)**

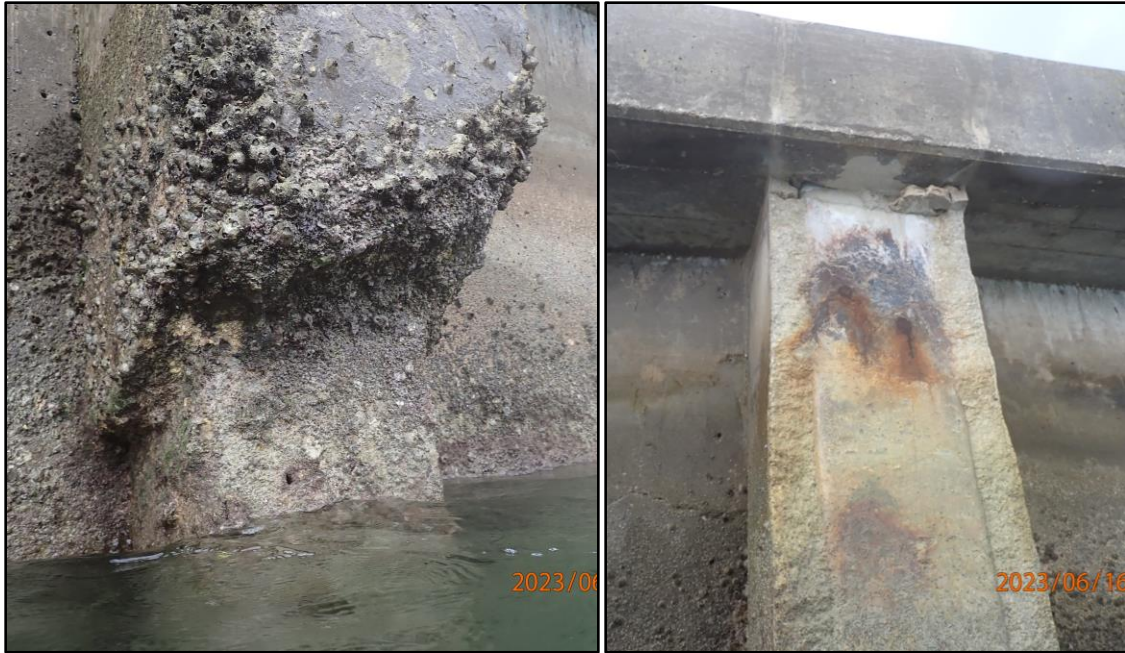
The Section 6 inspection performed by Cummins Cederberg found the concrete pile encasements exhibit widespread failures within the tidal zone and below and localized full height delamination of the offshore face. From previous involvement with Fisher Island projects, we understand this to be a construction defect caused by washout of the concrete while it set. The exposed pile within the tidal zone and below was heavily obscured by residual grout and marine growth and no significant deficiencies were observed. The pile conditions were in line with those observed in the 2019 report. The concrete panels exhibit widespread 1/8 in. wide horizontal or diagonal cracking. Significantly more panels displayed observed deterioration than listed in the 2019 report. Widespread crack repairs were present throughout the concrete cap in line with the description of the cap in the 2019 report. One tie rod was excavated within Section 6 at approximately STA 8+40. The tie rod was below the existing water line at the time of inspection so a visual inspection could not be performed, and the rod was inspected tactilely instead. The tie rod felt smooth with no significant corrosion.

**Photo 65: Typical washout of concrete pile encasement (left) and localized delamination of offshore extent of pile encasement**

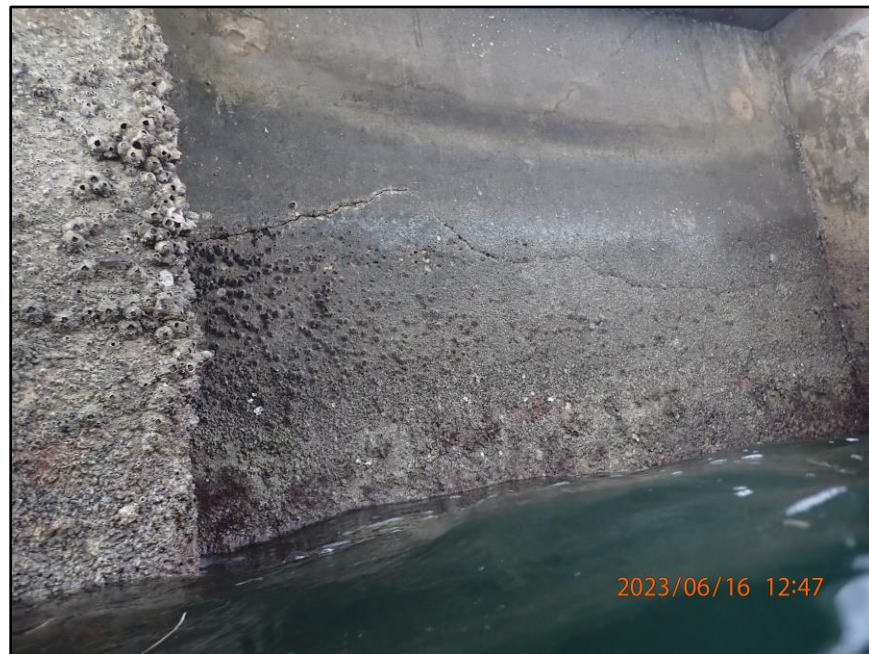
**Photo 66: Typical 1/8 in. cracking of the concrete panels**

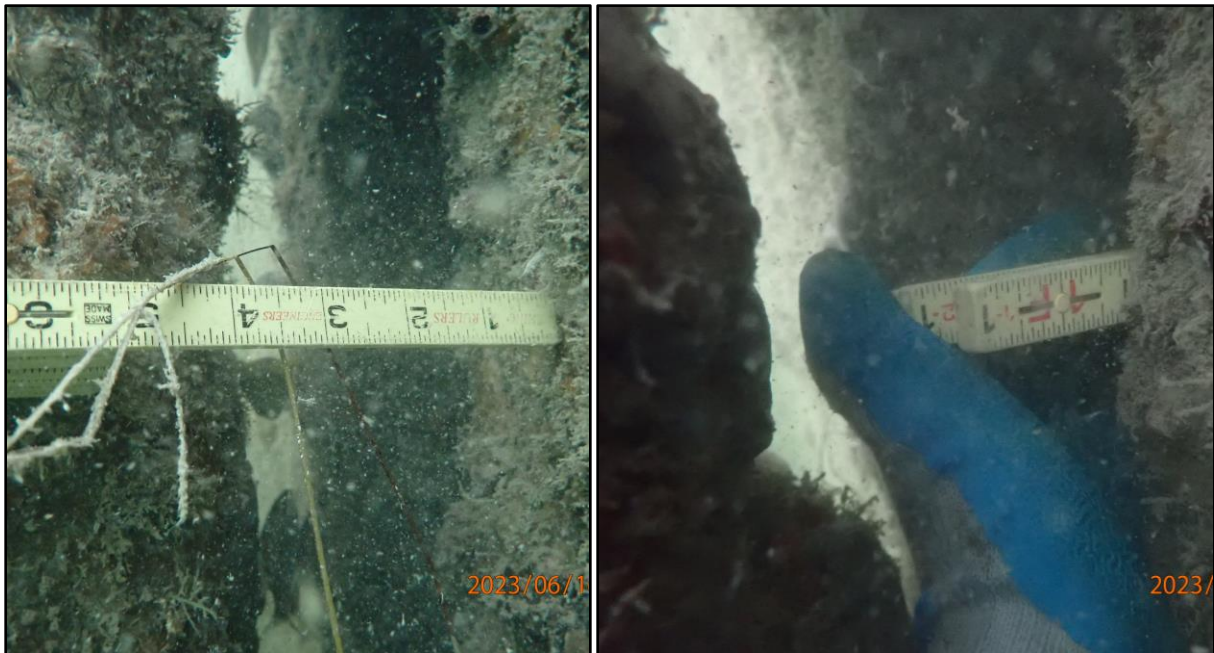
intrusion were present at the pile panel interface. Intermittent upland sinkholes were observed in line with the panel joints.

**Photo 67: Typical pile panel gap with significant penetration into the panel joint**

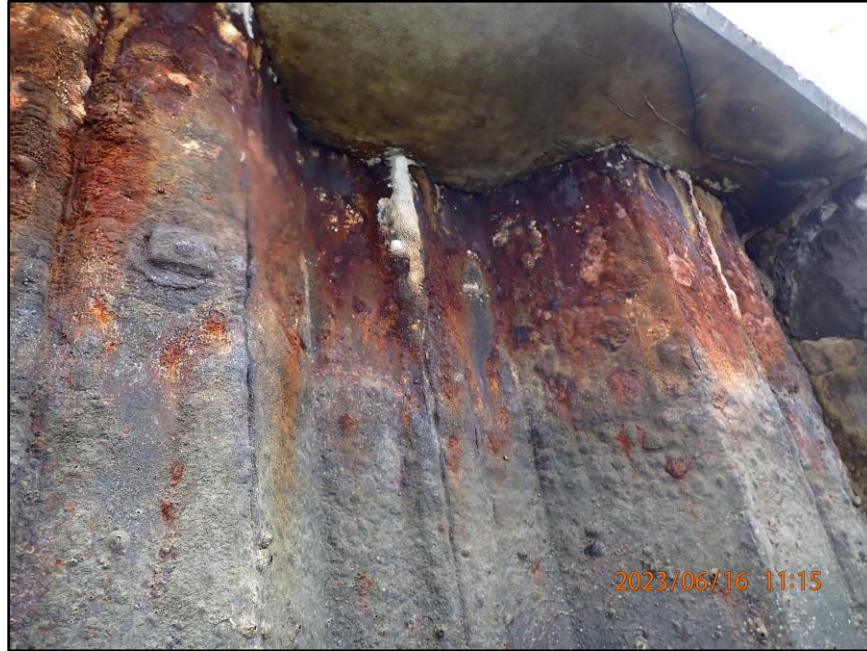
flange. The flanges were typically thinner in the tidal zone than the mudline indicating typical accelerated corrosion rates in the tidal zone. Since the original section and date of construction is unknown the rate of corrosion is also unknown. If UTM readings are taken in a future inspection it can be compared to the current readings to estimate corrosion rates. The underside of the cap exhibits intermittent 1/8 in. cracking adjacent to the steel sheet pile, likely due to the expansion of the sheets caused by severe corrosion. The topside of the cap exhibits intermittent grouted crack repairs. The cap appears to be of a more recent construction than the existing sheet pile.

**Photo 70: Typical condition of steel sheet pile and concrete cap**

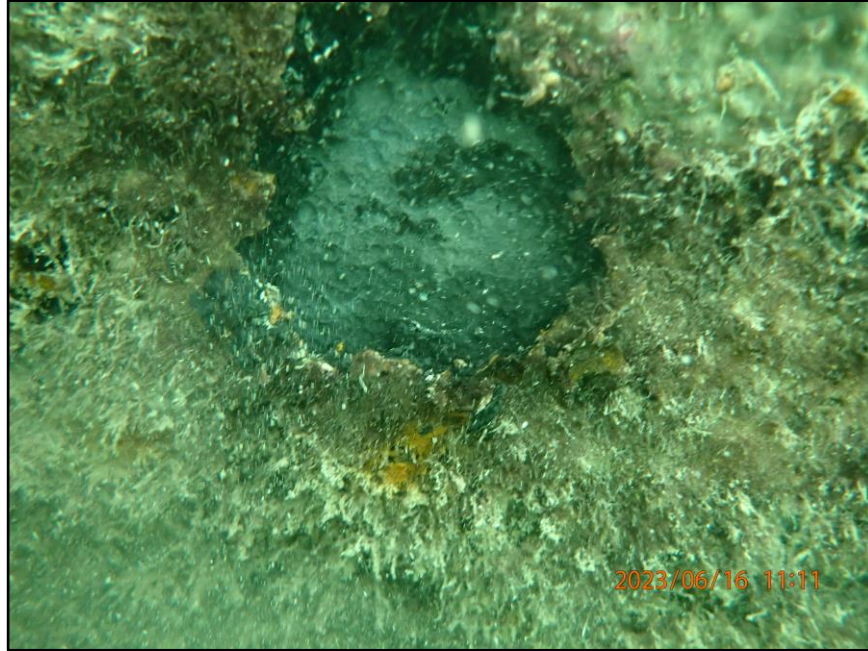
**Photo 71: STA 12+18 Cleaned section of steel sheet pile for UTM reading with major to severe pitting**
