# Shoreline Inspection Report

## FICA Shoreline Assessment

*Fisher Island,  
Miami-Dade County, Florida*

August 2023

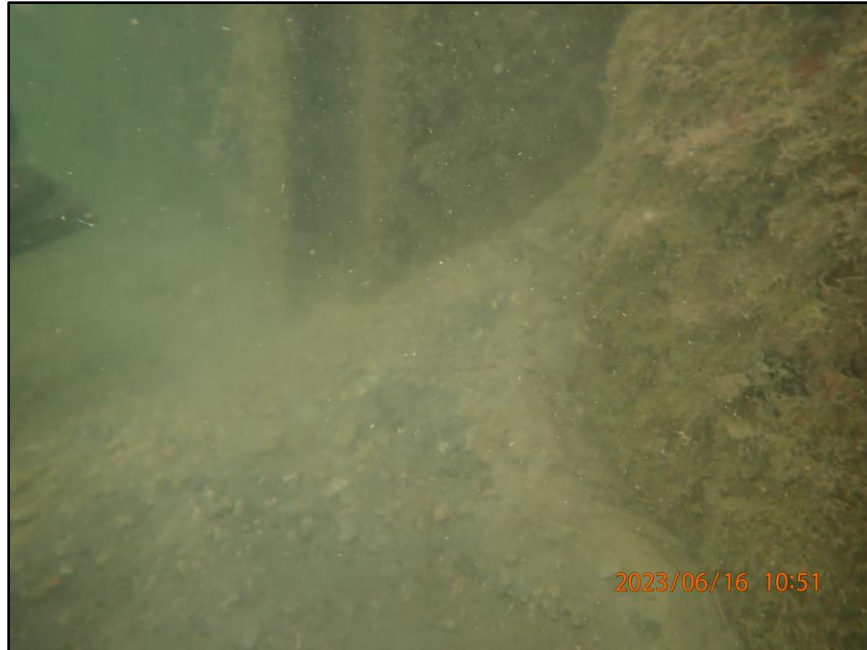
At STA 0+00 the Section 8 transition exhibits 6-12 in. of sediment accumulation at the mudline. At approximately STA 0+50 a sinkhole is present at the bend in the bulkhead measured 32 in. long by 16 in. wide by 21 in. deep. One tie rod was investigated at approximately STA 0+70. The tie rod was encased in a painted outer coating that appeared to be in like new condition. It is assumed that the tie rods have been replaced since the original construction.

**Photo 72: Sediment accumulation at Section 8 termination**

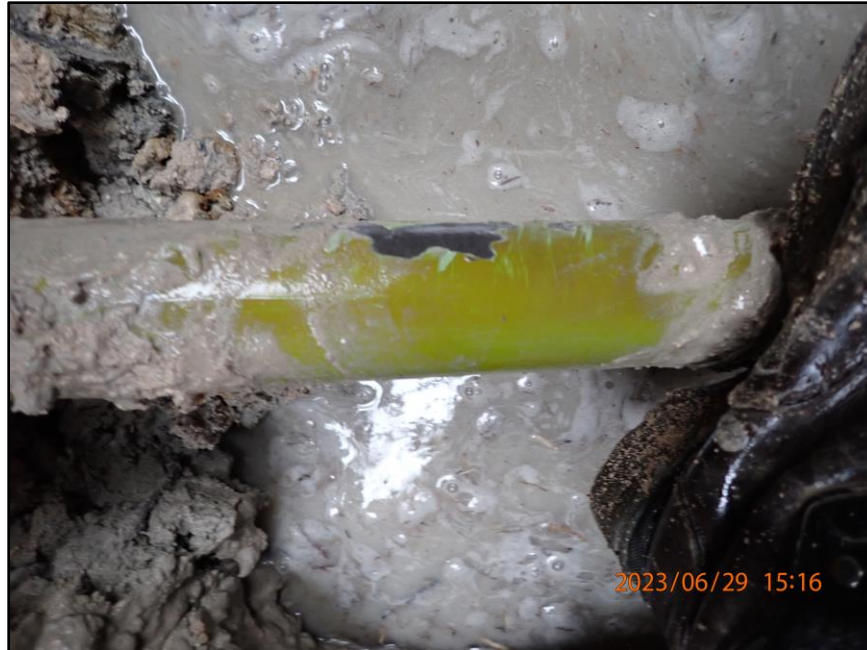
**Photo 74: Tie rod inspected at STA 0+70 in like new condition**

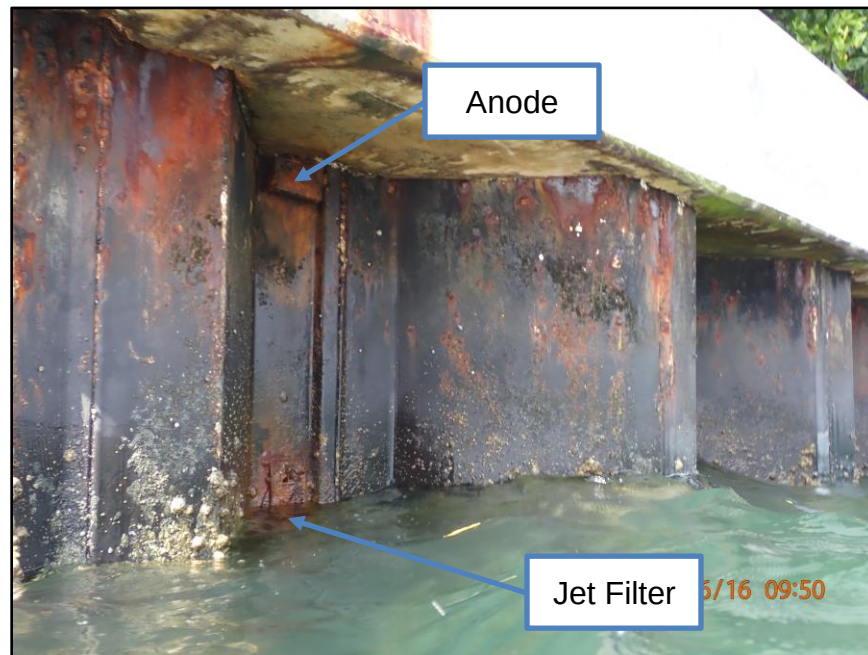
**Photo 75: Moderate corrosion of the steel sheet pile within the tidal zone with localized major corrosion of the jet filter**

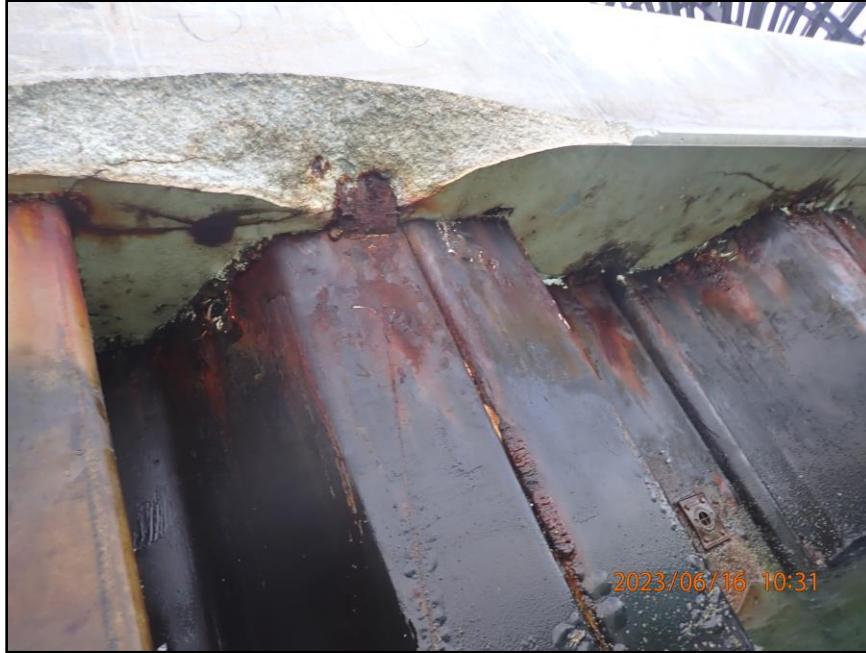
**Photo 76: Localized major spalling with widespread cracking of the concrete cap**

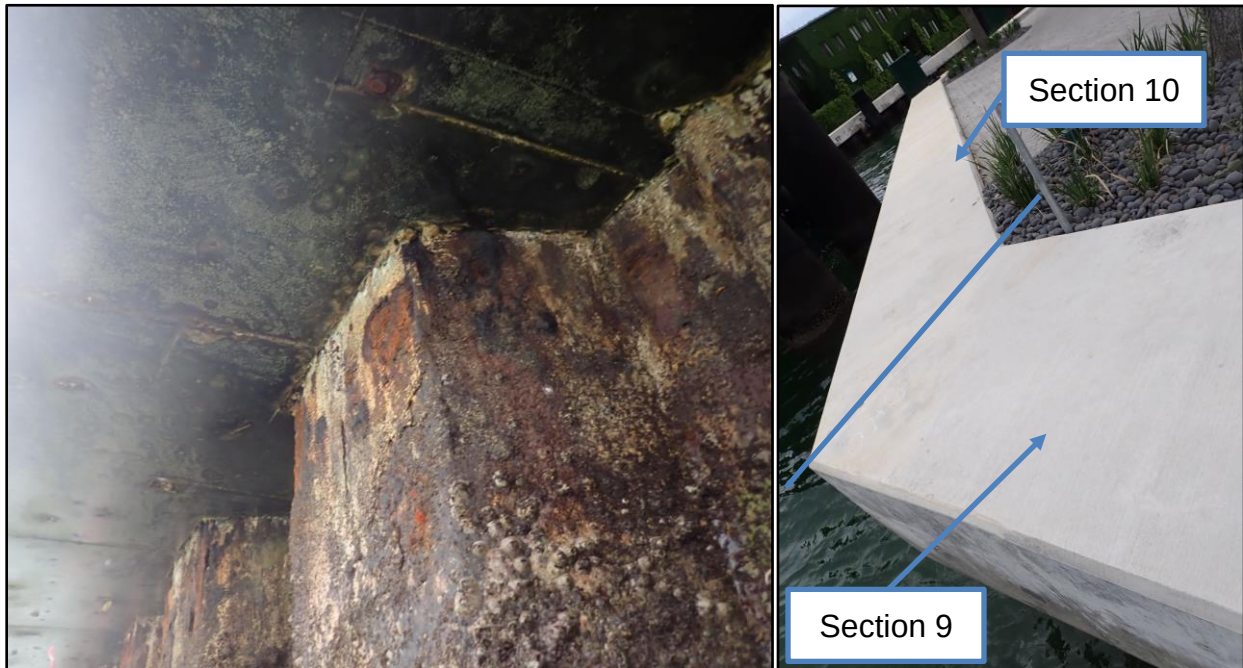
**Photo 78: Typical condition of steel sheet pile (left) and concrete cap (right) STA 0+00 – STA 0+30**

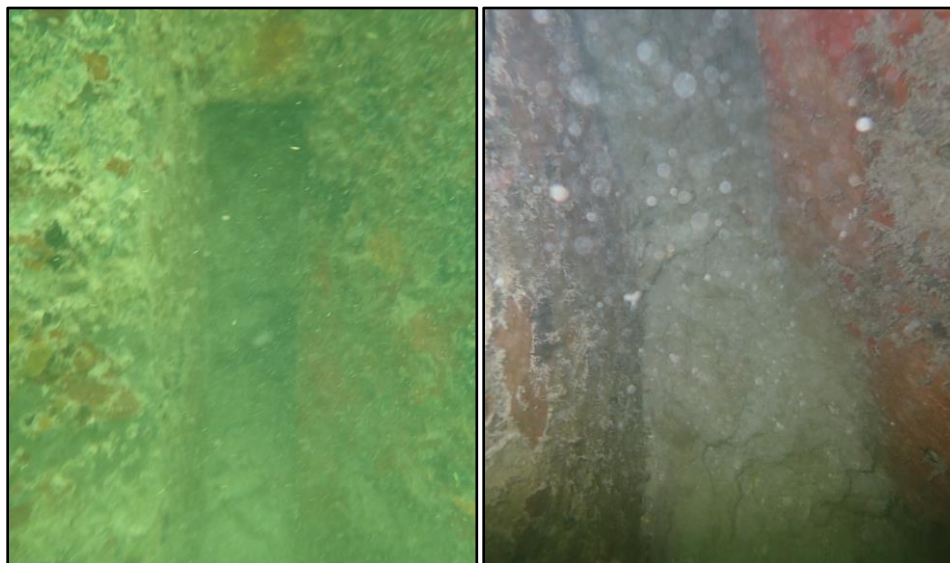
**Photo 79: Voiding at mudline at STA 0+00 (Section 10 interface)**

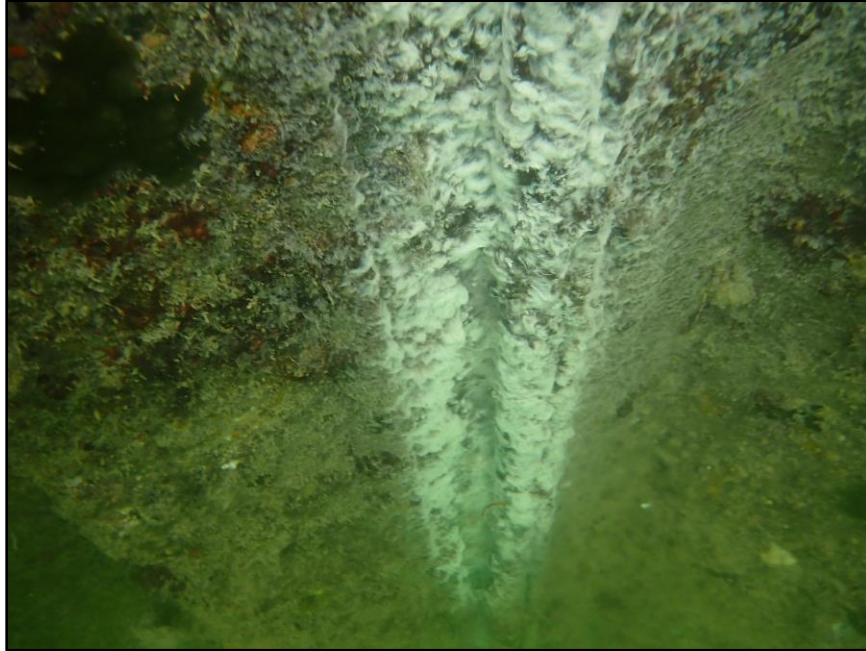
**Photo 80: Freshwater intrusion at STA 0+30 sheet pile interface**

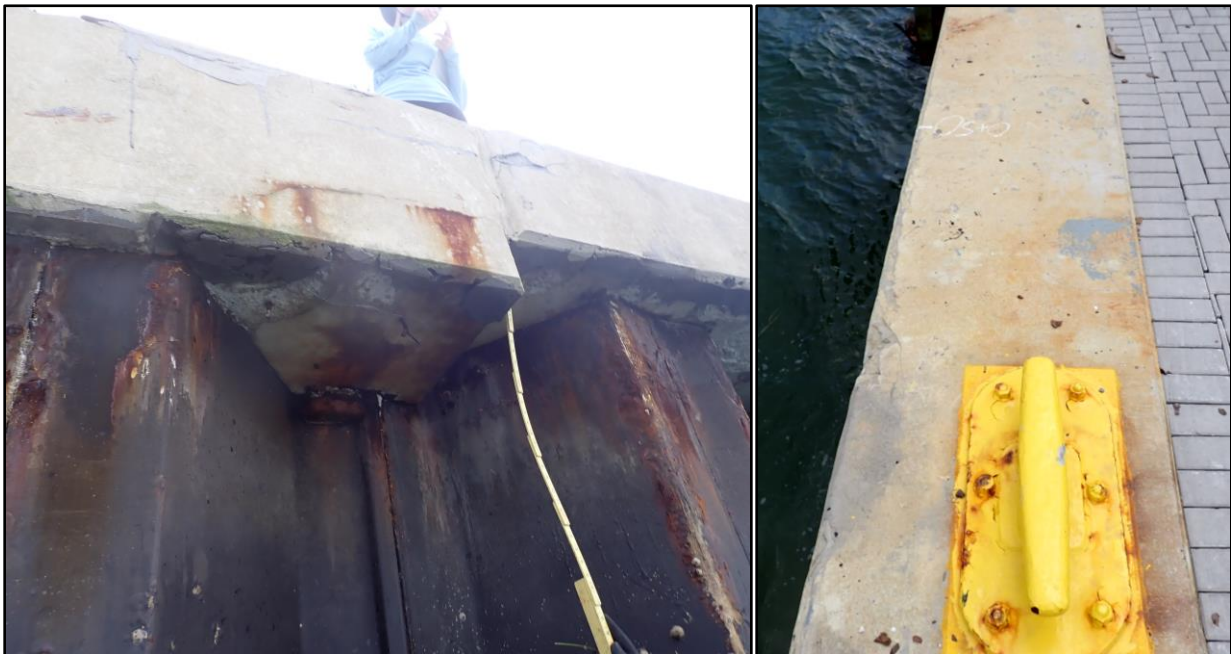
**Photo 81: Typical condition of steel sheet pile and concrete cap STA 0+30 – STA 0+85**

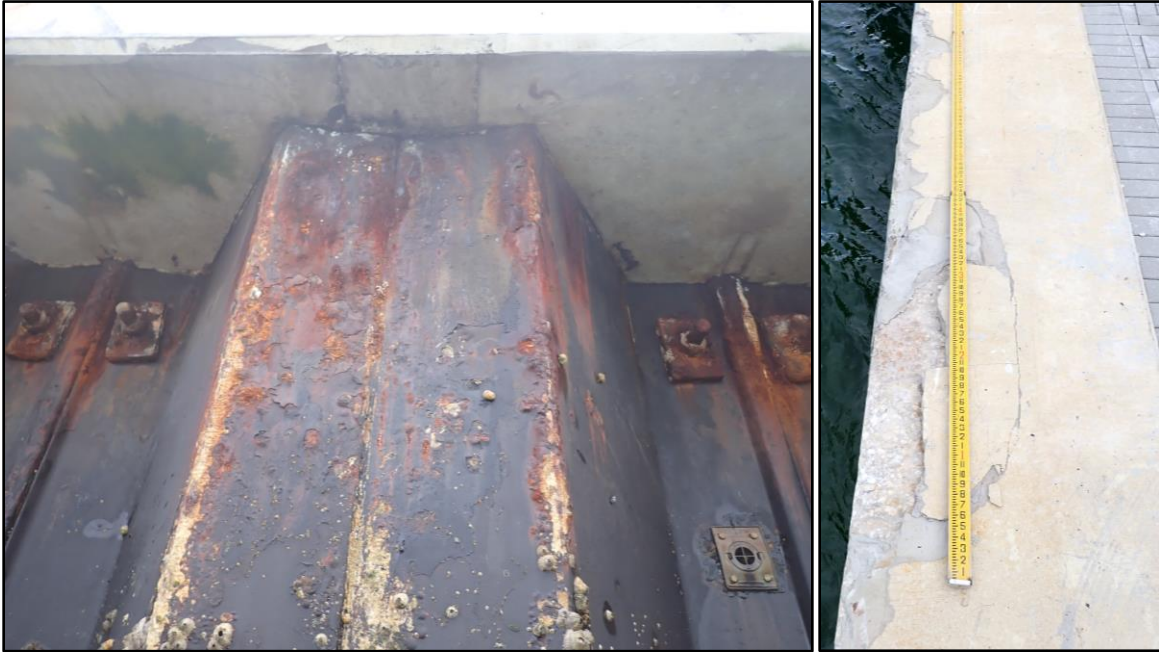
**Photo 82: Typical condition of steel sheet pile and concrete cap STA 0+85 – STA 4+64**

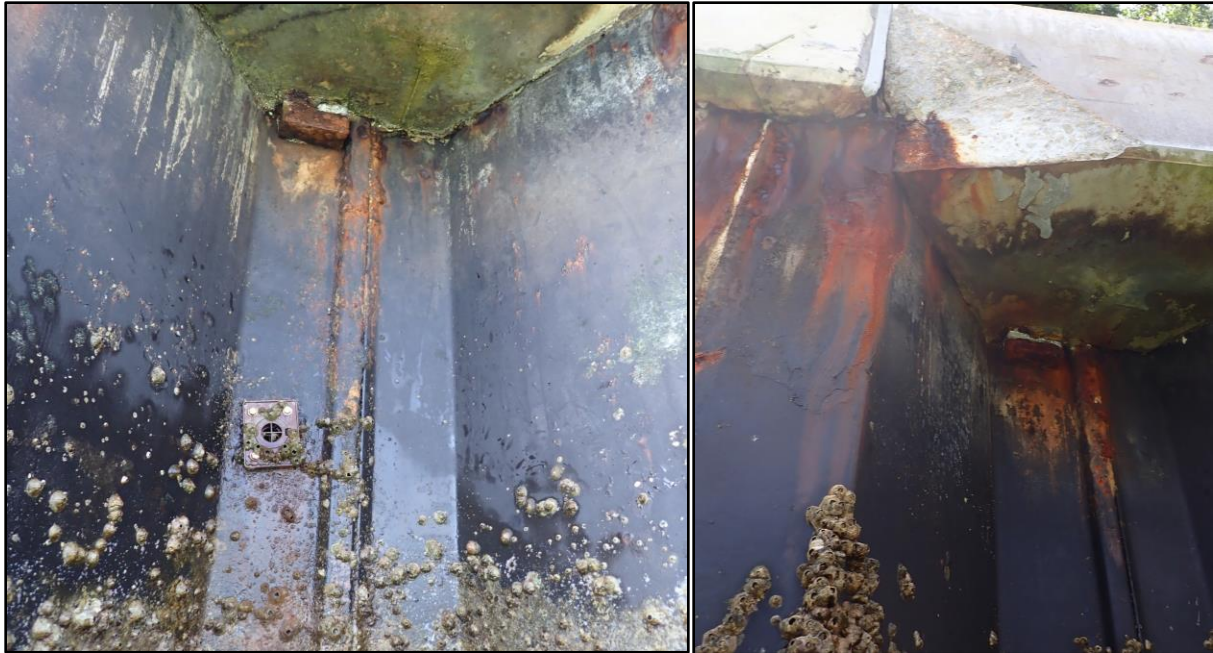
**Photo 83: Typical condition of steel sheet pile STA 4+64 – STA 9+39 and major cap spill at STA 4+64**

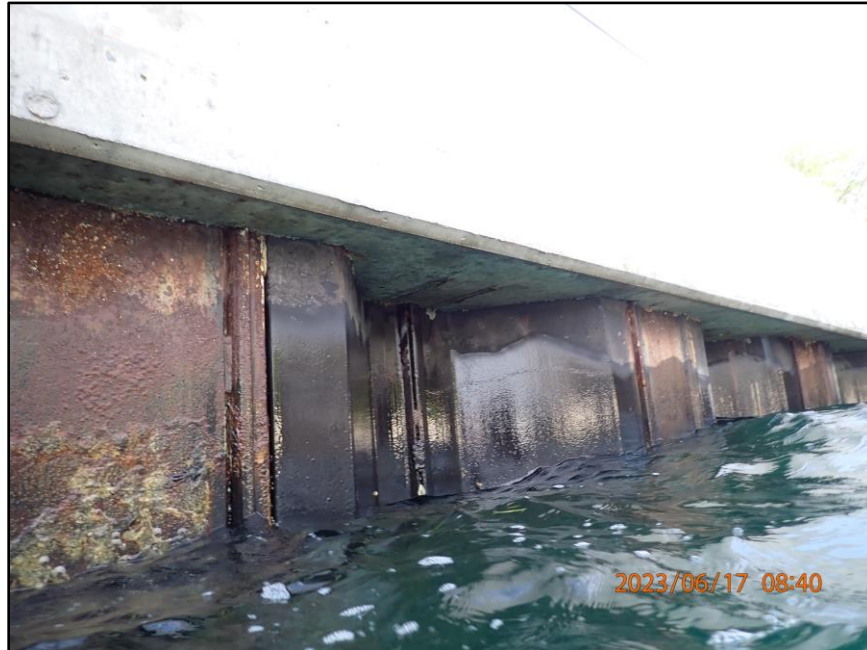
**Photo 85: Minor corrosion of HZ piles and minor rust staining of AZ sheet pile**

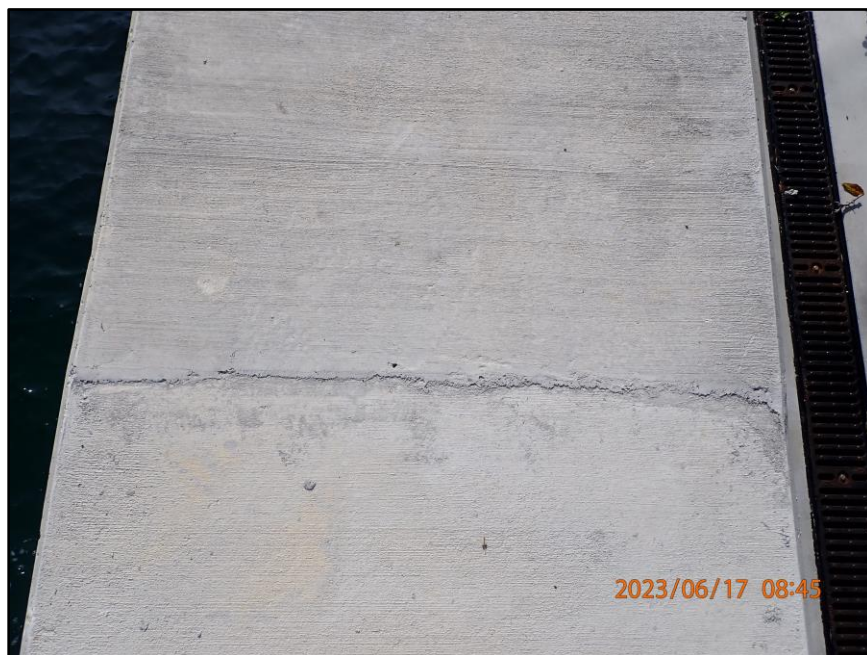
**Photo 86: Localized shrinkage cracks**

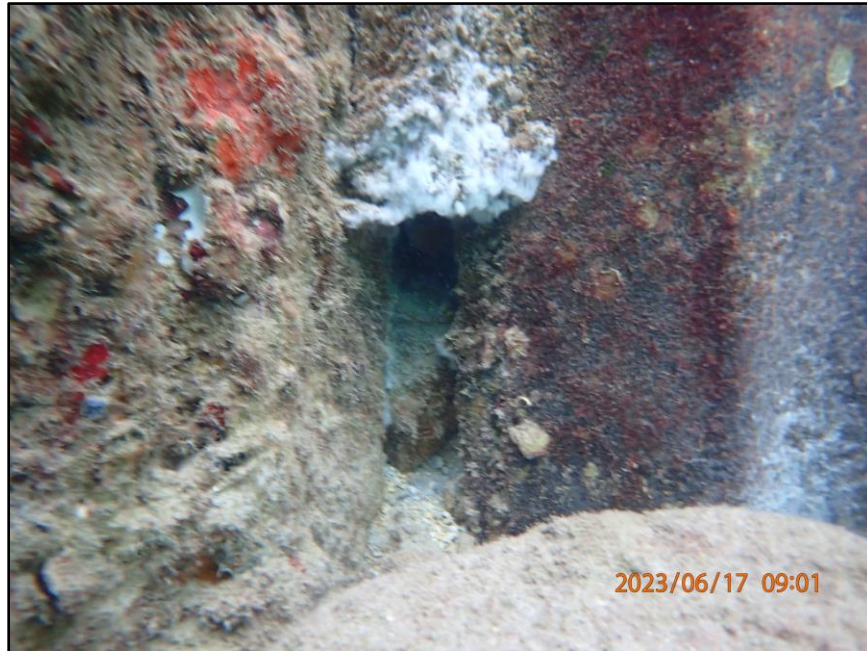
**Photo 87: Void at bulkhead connection at mudline STA 4+70**

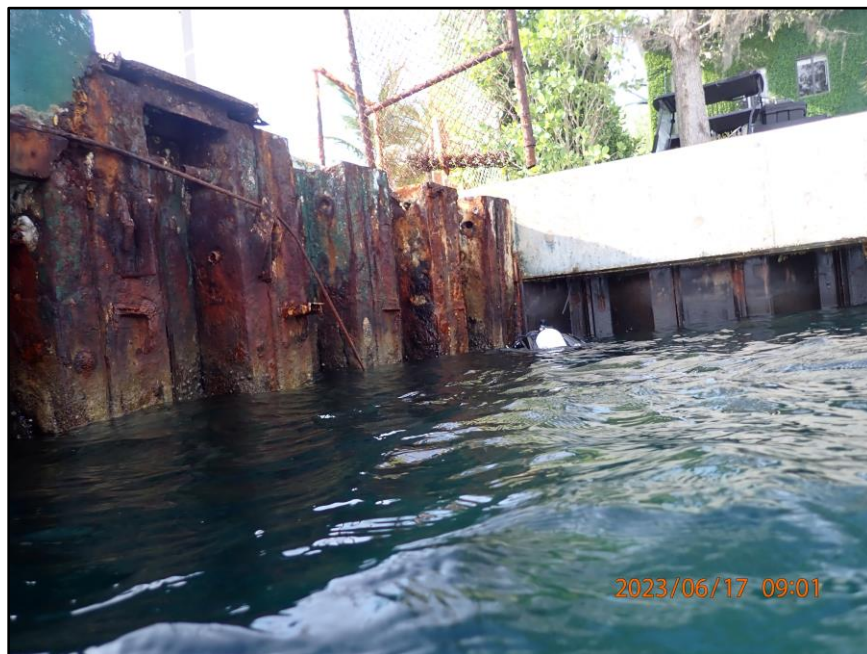
**Photo 88: Failed cap from STA 4+70 to 4+90, severe corrosion of the steel sheet pile**

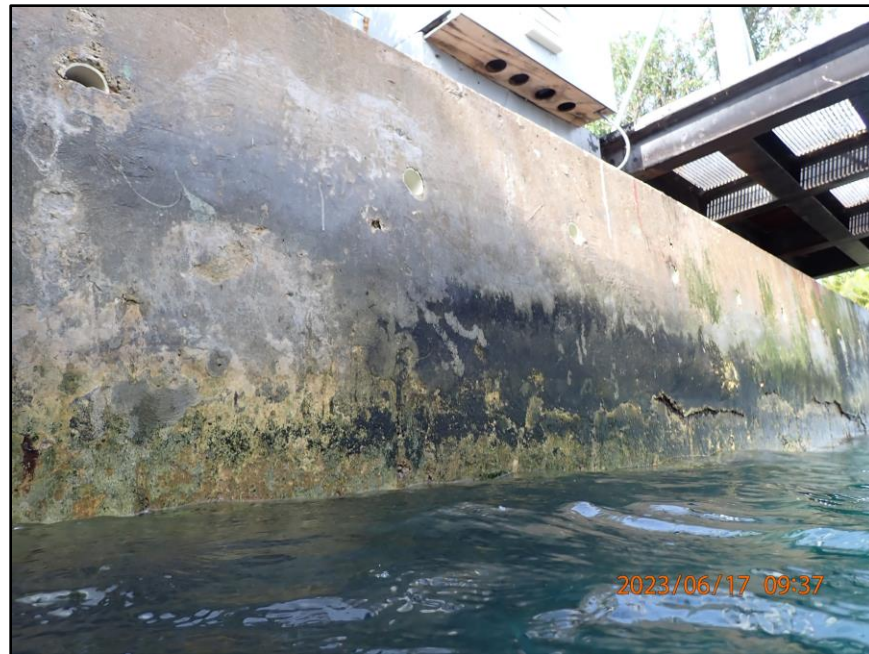
**Photo 89: Intermittent delamination of the concrete cap STA 0+00 to STA 0+84**

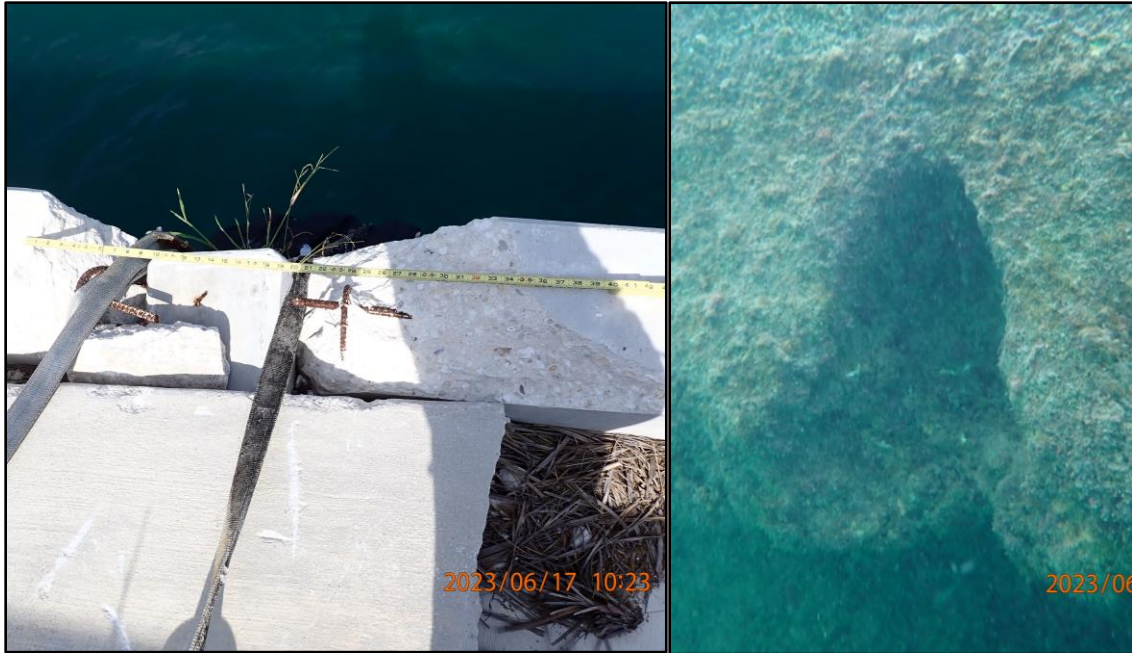
**Photo 90: Widespread major to severe spalling of the concrete cap, STA 0+84 to STA 5+80**

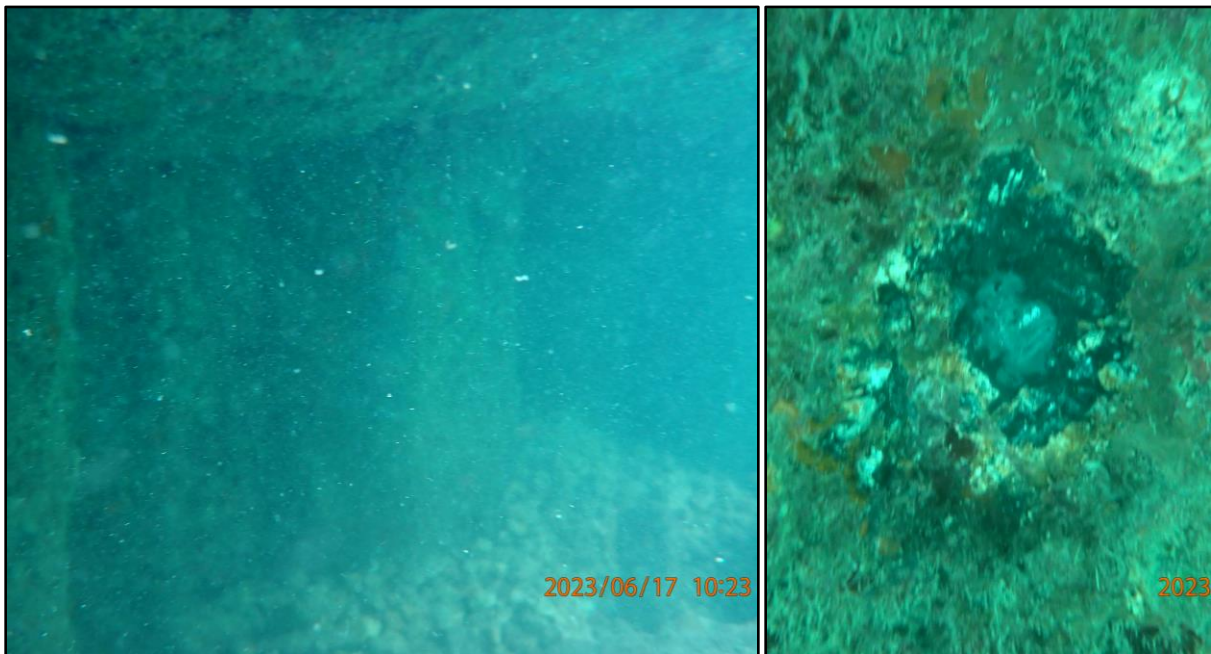
**Photo 91: View of inner layer of sheet pile visible through large void in outer layer of sheet pile at STA 3+60 (left); cleaned area of sheet pile for UTM (right)**

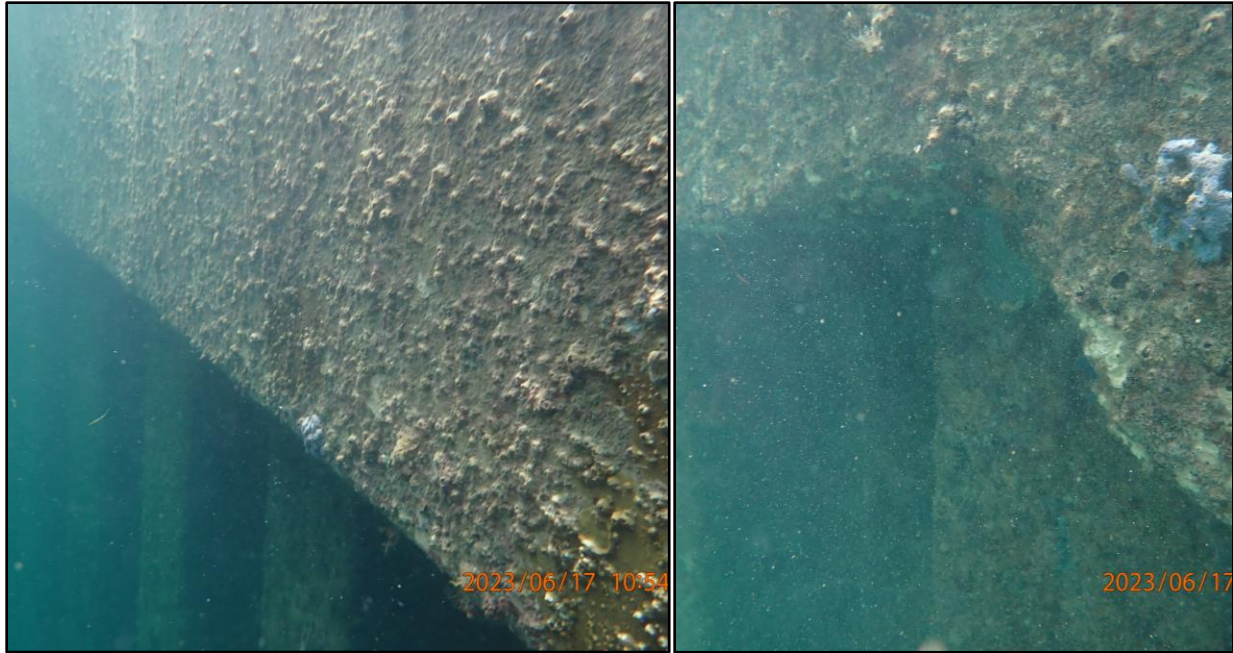
**Photo 92: Typical condition of steel sheet pile and concrete cap (left) and localized moderate spall of concrete cap (right), STA 5+80 to STA 9+60**

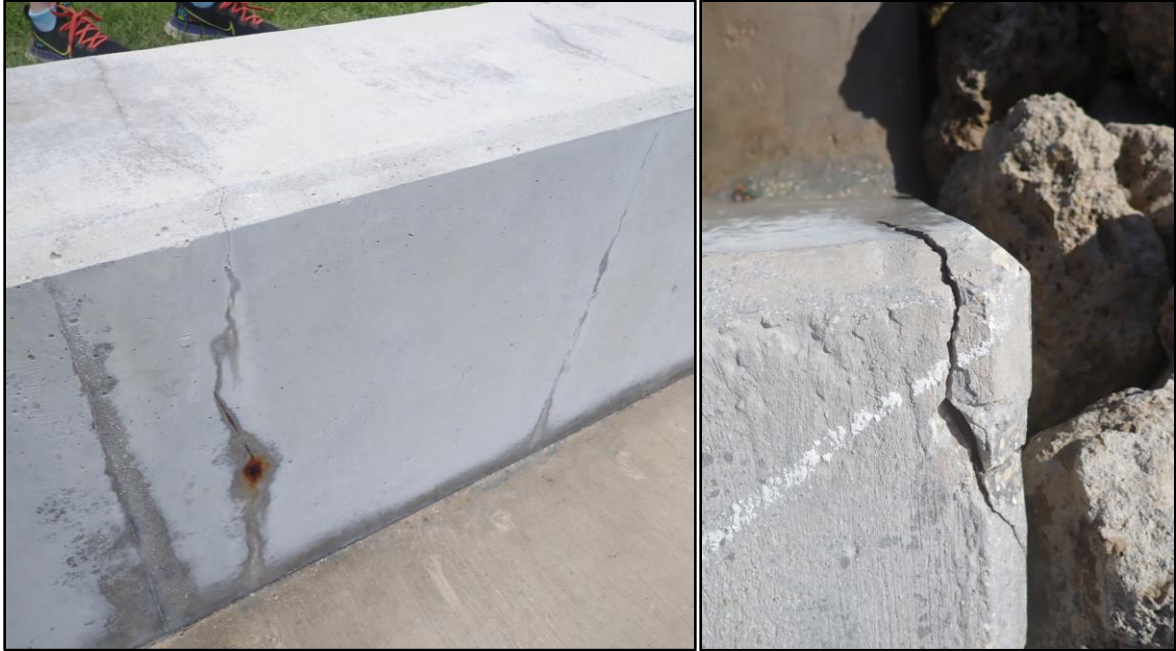
**Photo 93: Intermittent cracking of the concrete cap up to 1/8 in. with localized cracking up to 1/4 in. forming a closed spall**

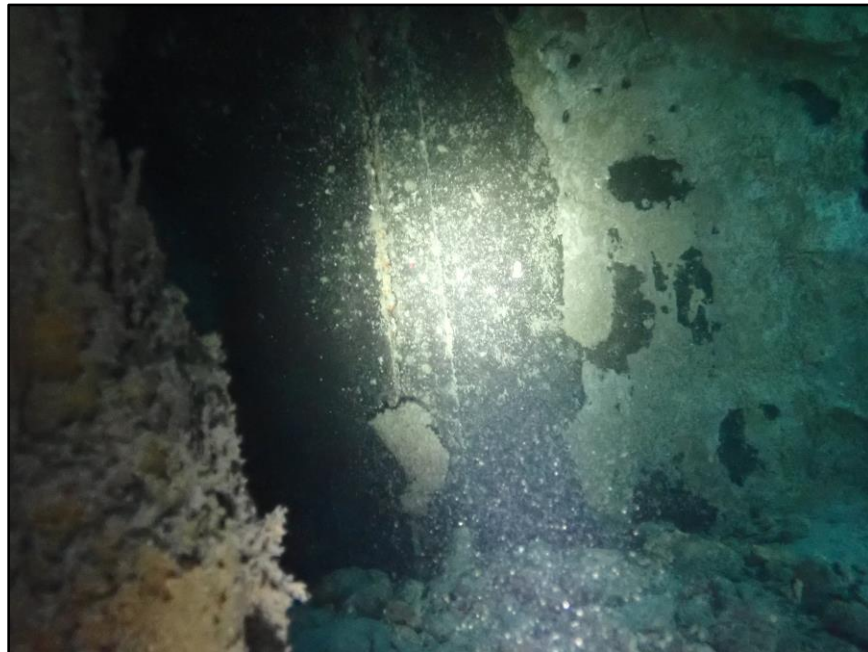
**Photo 94: Typical steel surface of combi-wall with clean and intact coating**

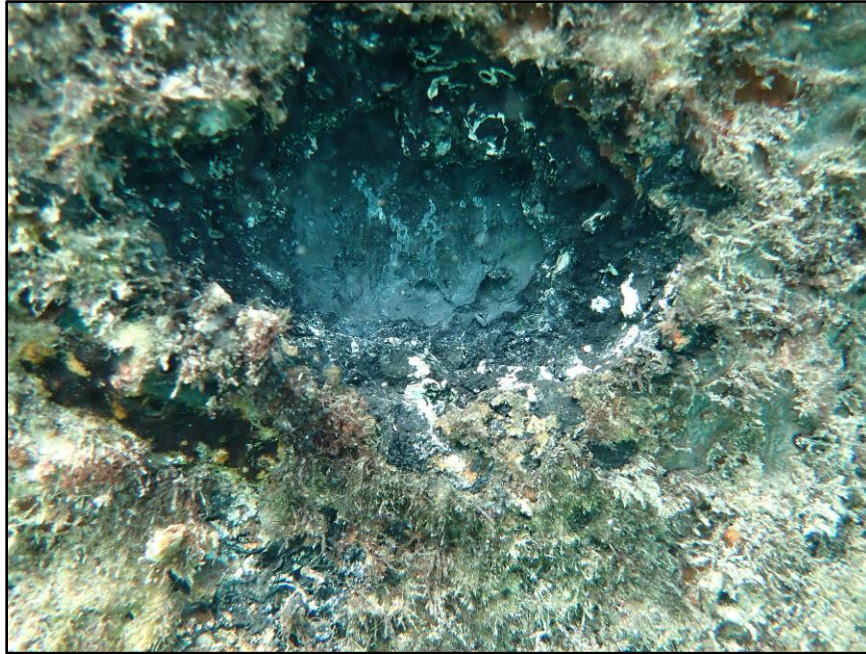
**Photo 96: Severe pitting of the Parcel 15 steel sheet pile observed when cleaned**

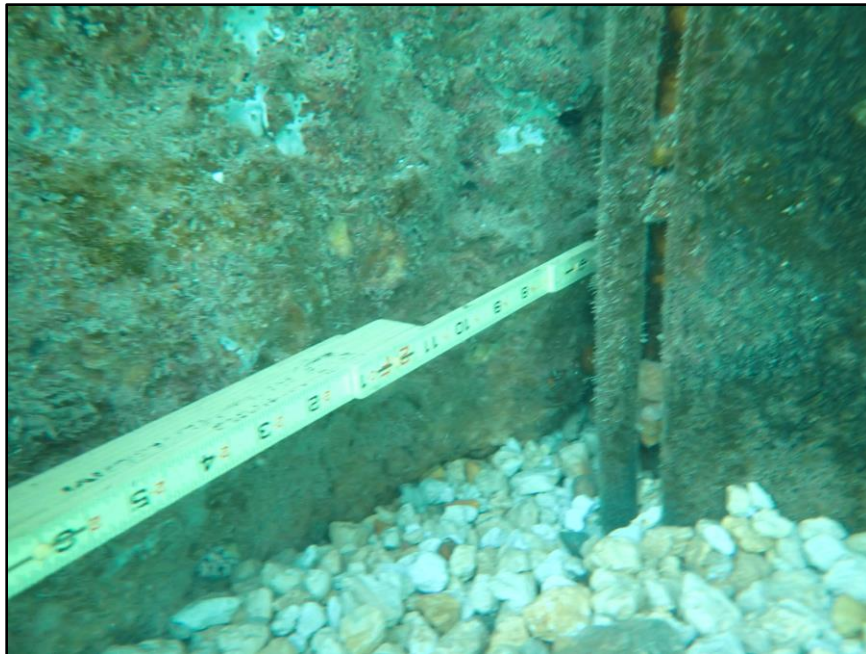
**Photo 97: 1.5 ft of penetration into voiding at STA 0+84 sheet pile termination**

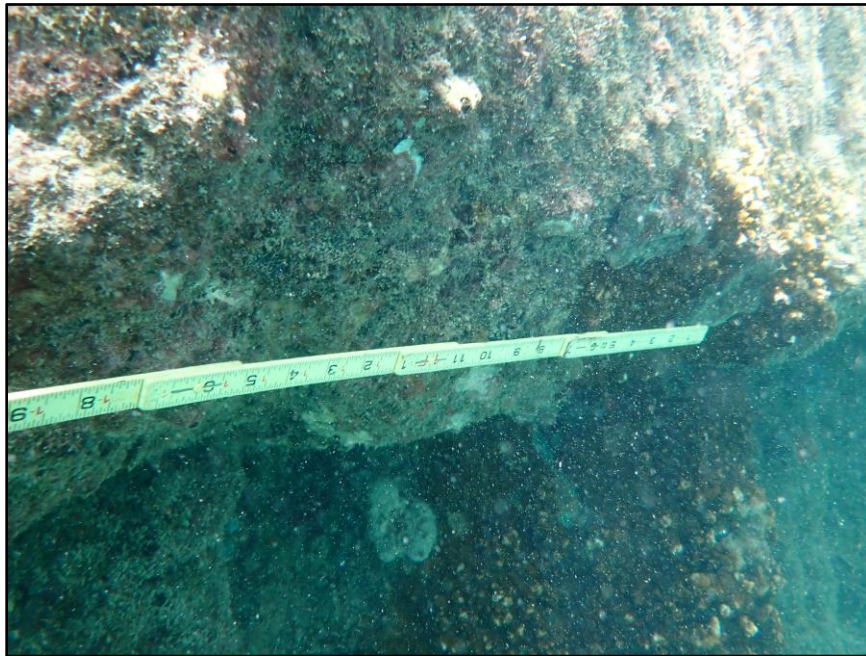
**Photo 98: Widespread severe spalling of the bottom edge of the concrete cap**

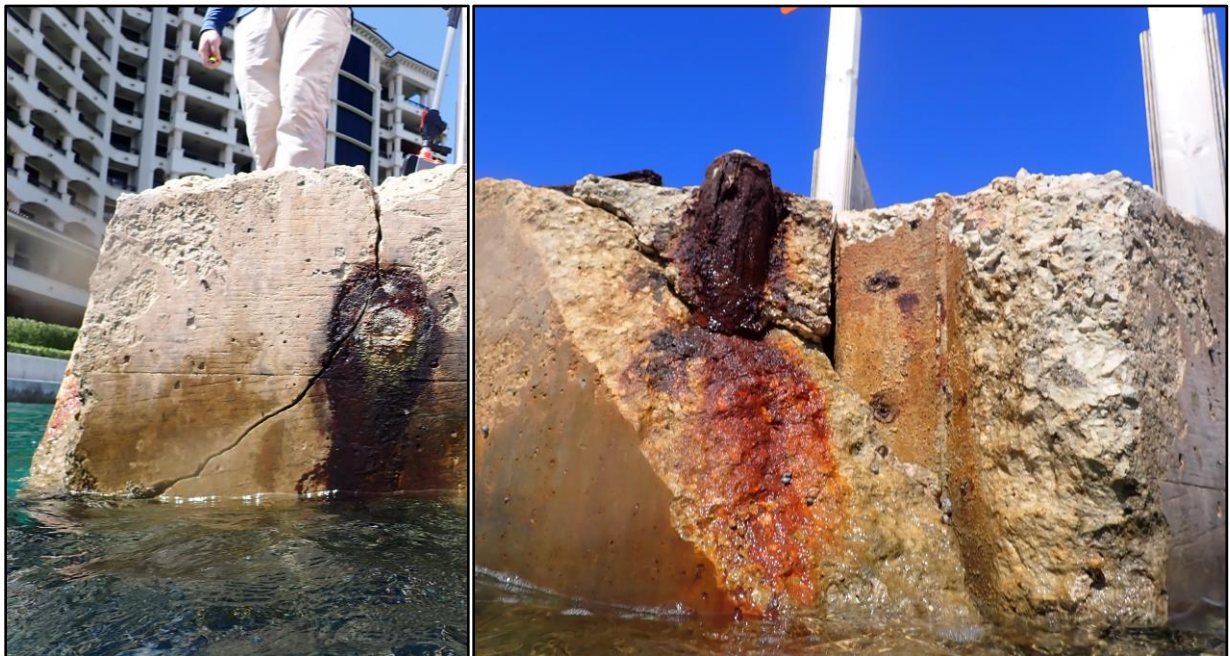
**Photo 99: Intermittent severe cracking and spalling on offshore face due to severely corroded embedded cleats**

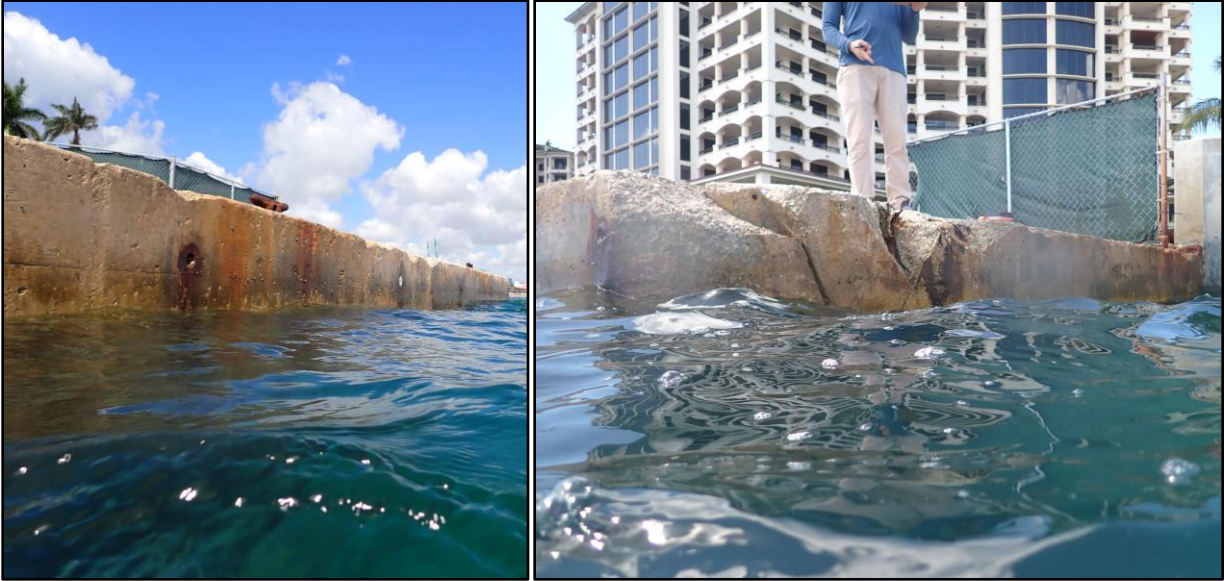
**Photo 100: Typical widespread moderate erosion and spalling of the offshore face of the cap on the north face (left) and severe spalling of the cap on the west face (right)**

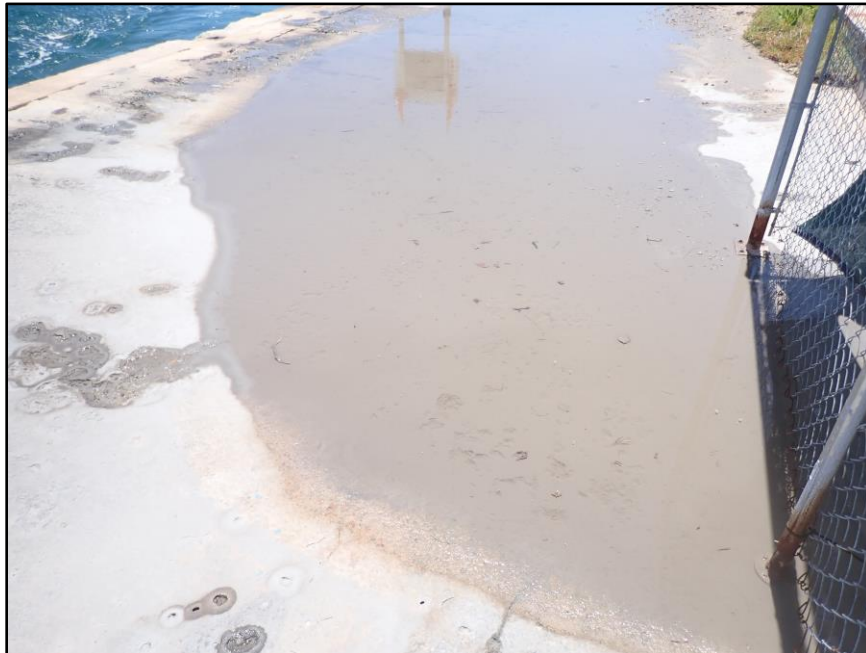
**Photo 101: Widespread upland pooling throughout Parcel 15**

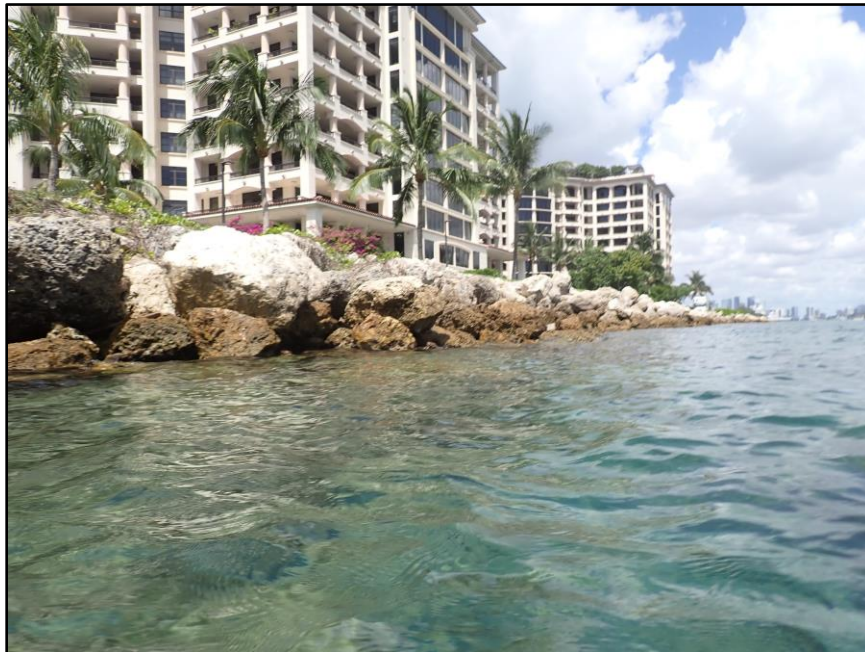
**Photo 102: Intermittent grades of smaller diameter riprap at steeper than 1:1 slope**
