Marine Engineering Inspection Report

**Fisher Island
Mainland Terminal
and Residential
Ferry Landing**
Fisher Island, Florida

March 2021

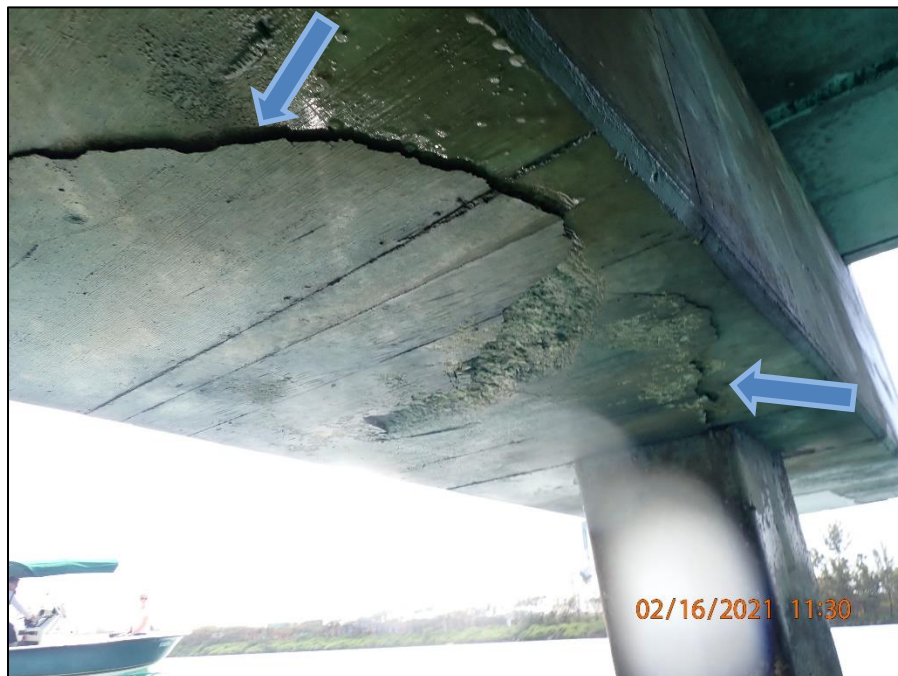
A.6: Concrete delamination along pile cap soffit between piles 7 and 8 at pile bent 1.

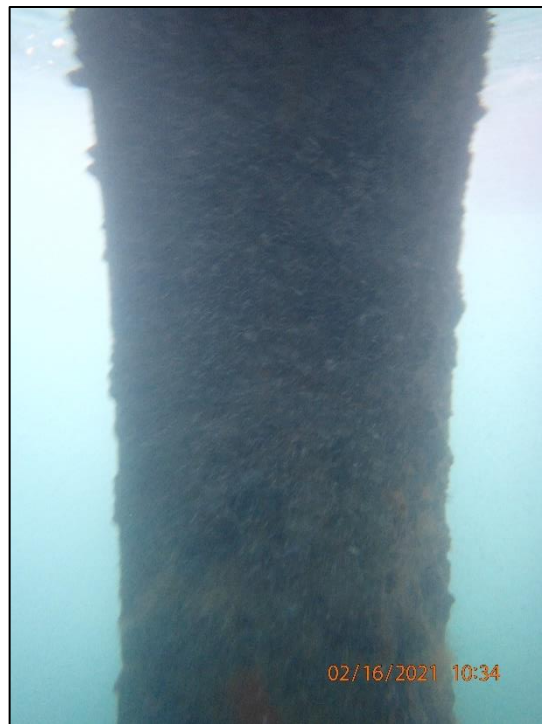
A.18: Typical hoist dolphin concrete pile in the tidal zone. Note minimal section loss of piles.

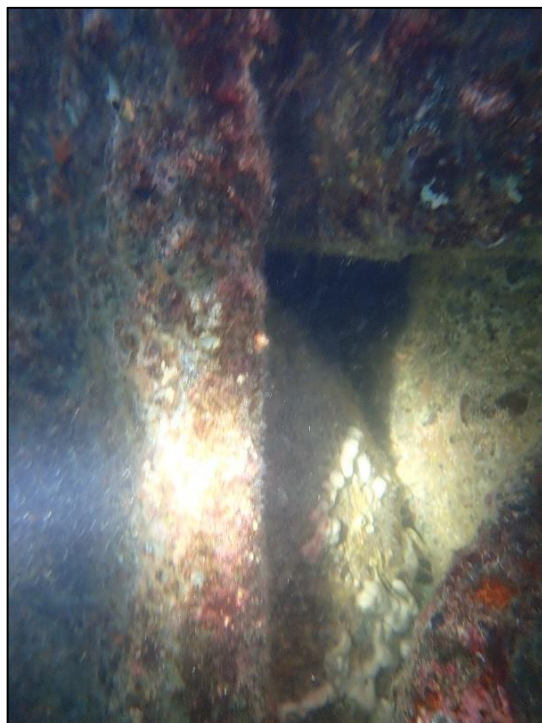
A.46: View of cavity through steel sheet pile at the connection between the sheet pile wall at northern start of the ferry ramp wall.

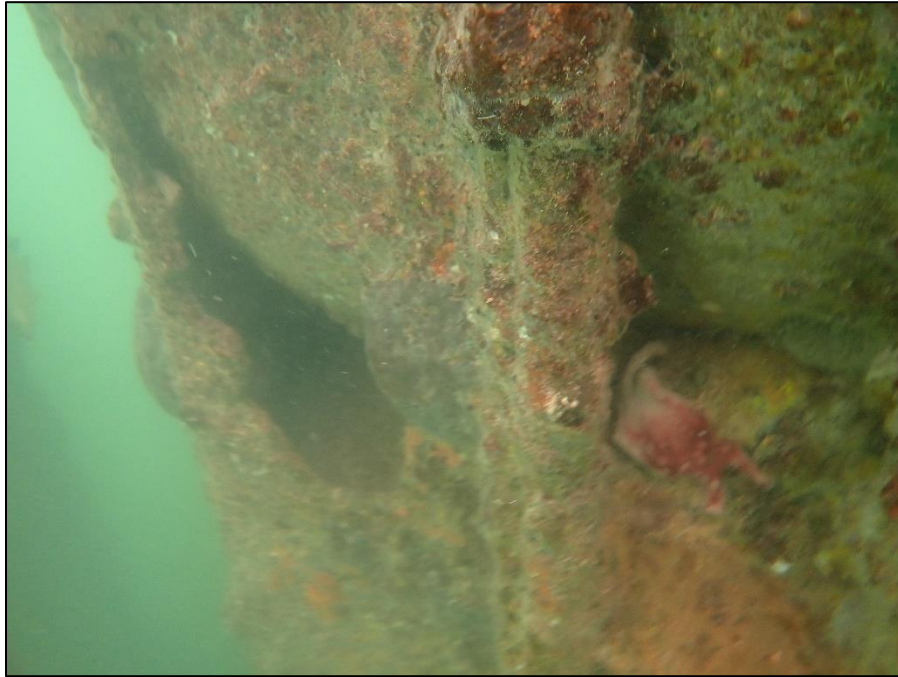
A.47: View of cavity through steel sheet pile located where the northern hoist dolphin and ferry ramp meet.

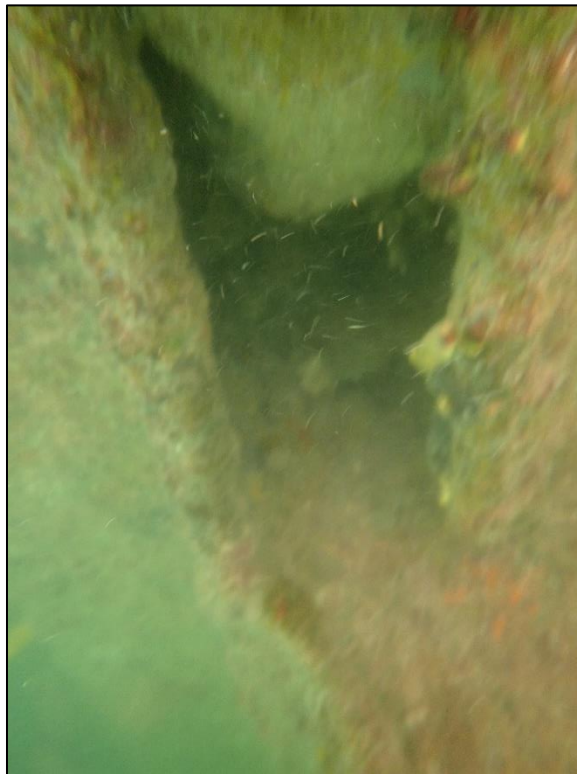
A.48: Cavity through steel sheet pile located at northern hoist dolphin and ferry ramp connection.
