**Fisher Island Community Association, Inc**

***Fisher Island, FL***

Report #: 24275-9

**RESERVE STUDY**  
**Update "With-Site-Visit"**

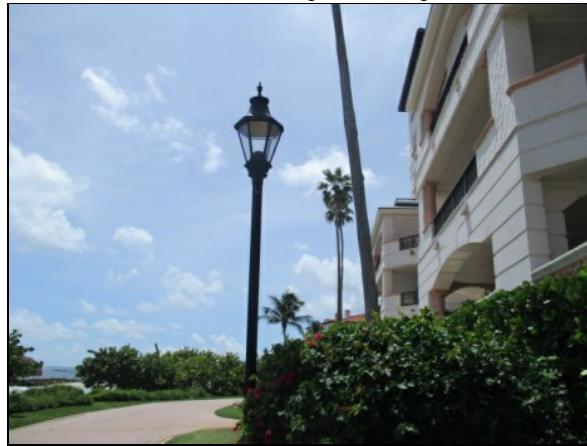
As of 2014, Management suggests inclusion of the lights for full replacement within the Reserve schedule. Lights could also theoretically be retrofitted to more modern LED technology, but costs shown here are based on replacement of entire post and fixture. Timeline for replacement has not been discussed, but lights are original and showing wear and age in many areas.

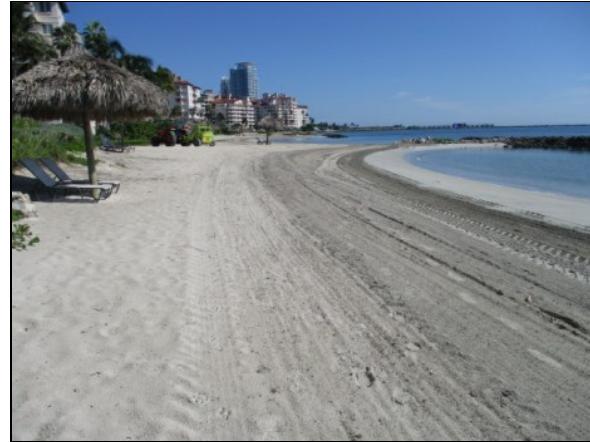
As of 2022, FICA management reports that the next restoration/renourishment project is anticipated in 2024 for a budgeted cost of approximately \$1.5 million.

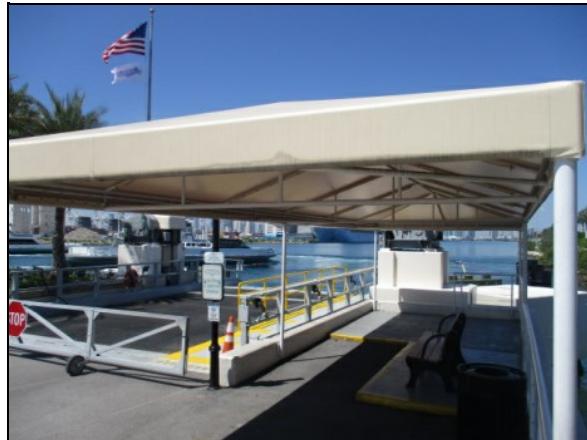
Comments: Fair condition, aging normally. Fabric/canopy should be washed periodically to maintain appearance. Framing should be repaired and painted to prolong life expectancy. In most cases, existing framing can be re-used when new canopy is installed. Inspect regularly to identify any rips, tears, burns, etc. Ensure that anchor points and hardware are intact and take note of any recommendations for removal during high winds or storms to prevent damage.

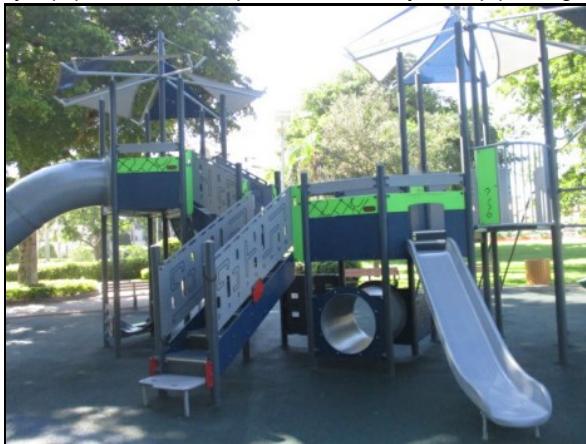
Certain pieces/components of play equipment can be replaced individually to help prolong remaining useful life.

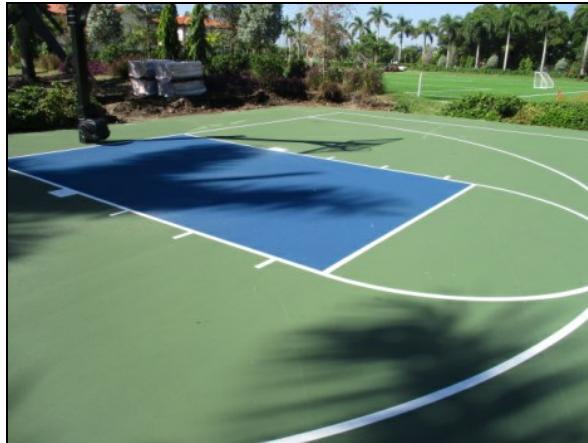
Comments: Court remained in generally fair condition at time of inspection. Sport courts should be inspected and repaired routinely as an Operating expense in order to preserve an attractive, playable court surface. Plan to repair (as-needed) and re-coat at the approximate interval shown here in order to protect the court from sunlight and weather.

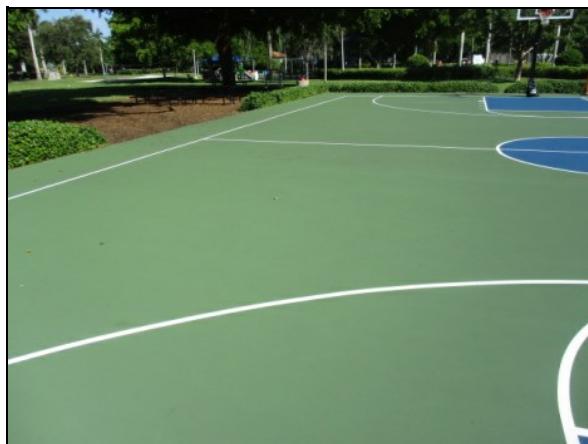
Sport courts should be inspected and repaired routinely as an Operating expense in order to preserve an attractive, playable court surface. Plan to repair (as-needed) and re-coat at the approximate interval shown here in order to protect the court from sunlight and weather.

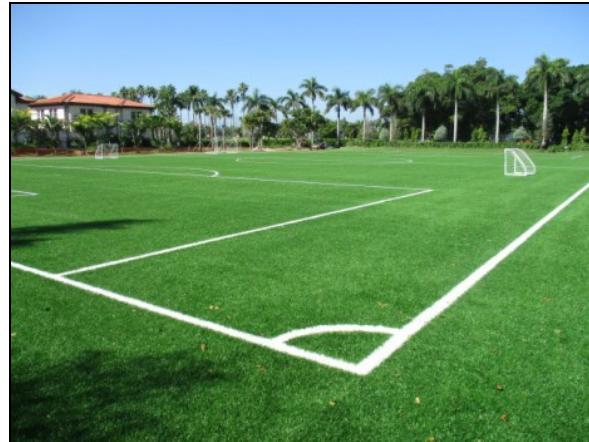
Comments: Artificial turf field was newly installed in 2022 and remained in very good condition at time of inspection. Plan for periodic replacement at the approximate interval shown here. Should be inspected periodically for drainage issues or other physical concerns. Useful life can depend on level of use/play and aesthetic preferences.

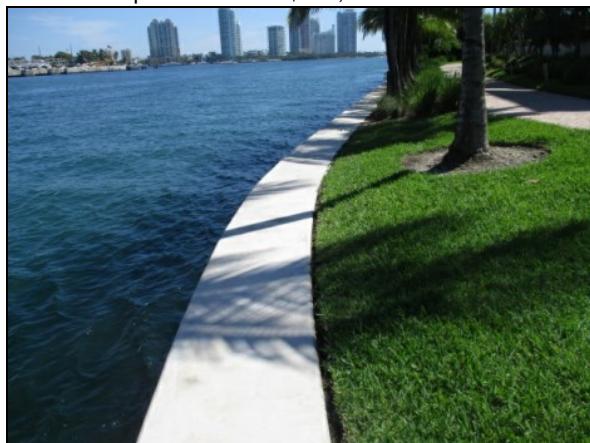
S. Bulkhead Station 39+81 to 49+89 Seal Gaps in Bulkhead \$100,800.00

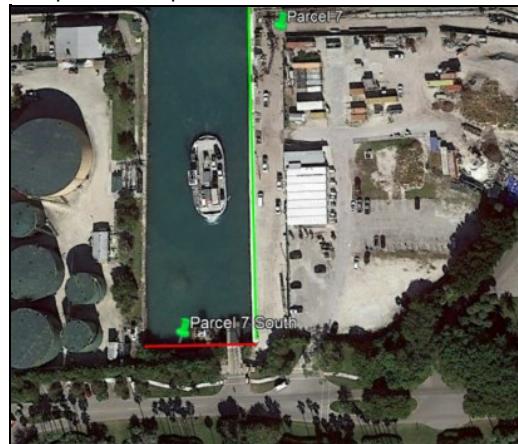
Comments: As of 2022, FICA management reports that this section of bulkhead was not replaced along with the other Parcel 7 areas, and should be shown as anticipated for replacement in 2025.

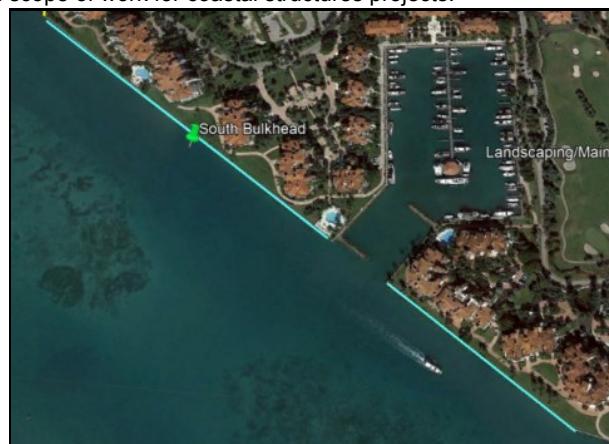
Comments: Scope of work: (Sta. 39+81 to 49+89). Repair spalls in cracks in bulkhead (Assume 20% every 10 years)

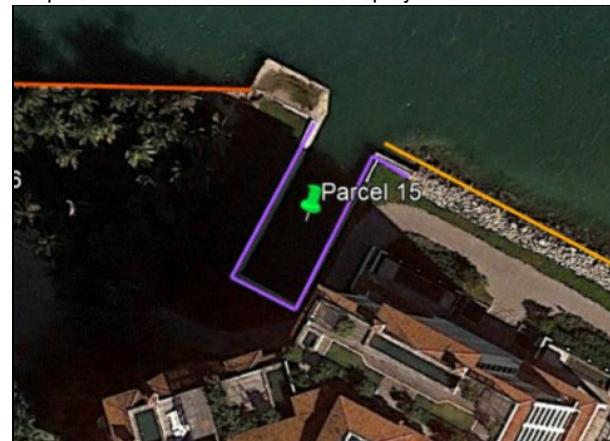
Comments: Scope of work: Repair spalls in cracks in cap (Assume 15% every 10 years)

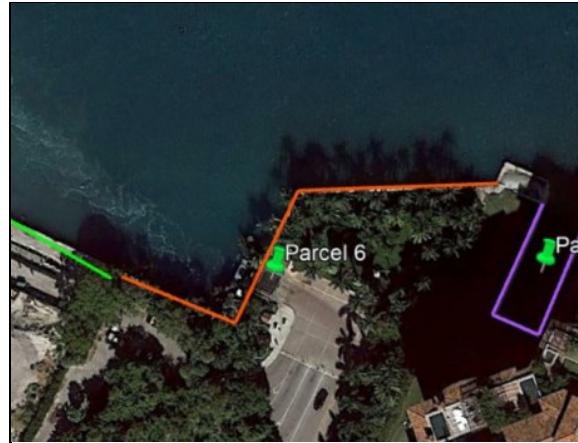
History: To be replaced in 2022-2023 per information provided. Remaining useful life has been adjusted accordingly below, assuming like-new condition in 2023.

Comments: Scope of work: Repair spalls in cracks in cap (assume 10% every 10 years)

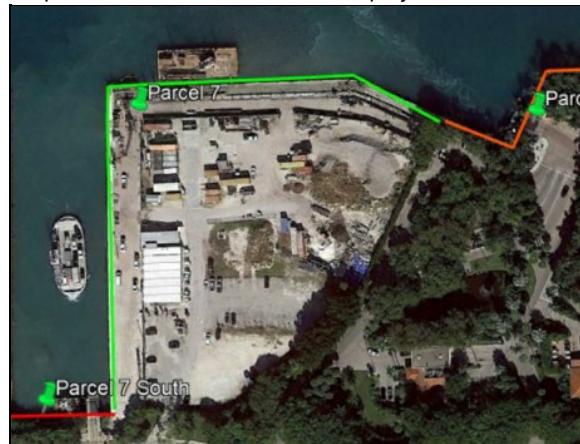
History: Replaced as of 2020-2021

Comments: Scope of work: Repair spalls in cracks in cap (assume 10% every 10 years)

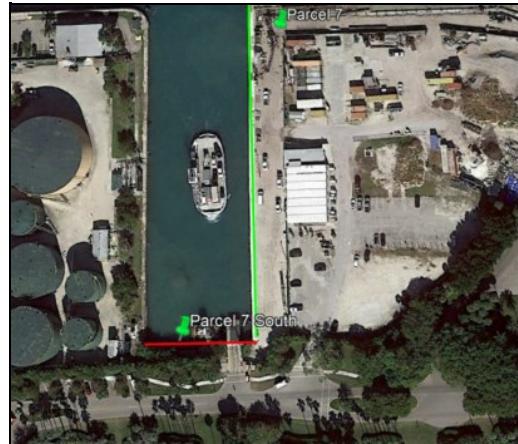
History: To be replaced in 2025

Comments: Scope of work: Repair spalls in cracks in cap (assume 10% every 10 years)

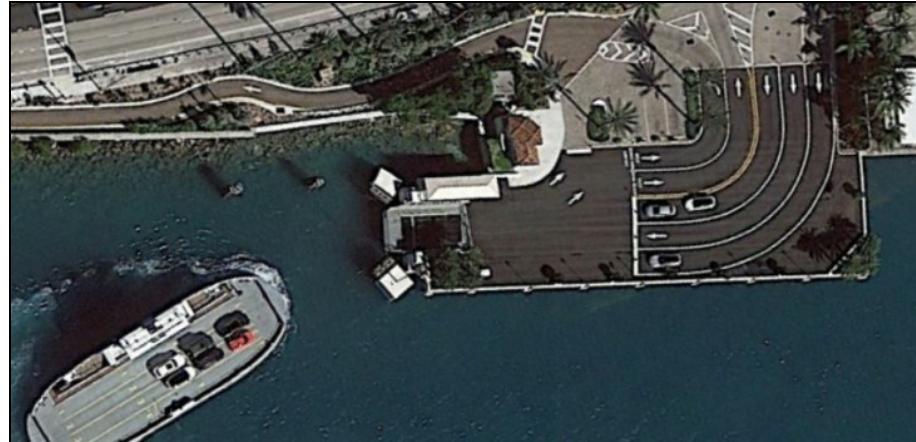
Comments: Major repairs/replacement anticipated for 2025-2026 according to Management. This component represents an allowance for future repair/refurbishment cycles. Remaining useful life has been extended to reflect like-new conditions as of 2026.

Scope of work: Repair spalls and cracks in caps (Assume 15% every 10 years)

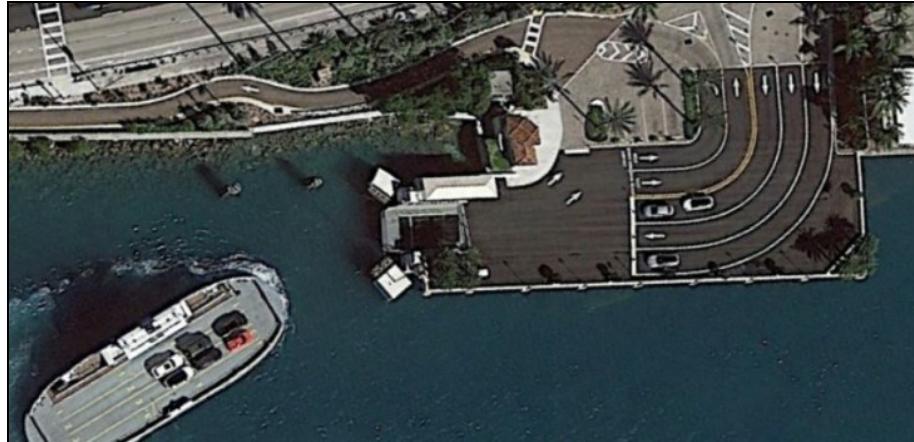
Comments: Major repairs/replacement anticipated for 2025-2026 according to Management. This component represents an allowance for future repair/refurbishment cycles. Remaining useful life has been extended to reflect like-new conditions as of 2026.

Scope of work: Repair spalls in deck planks (assume 5% every 10 years)

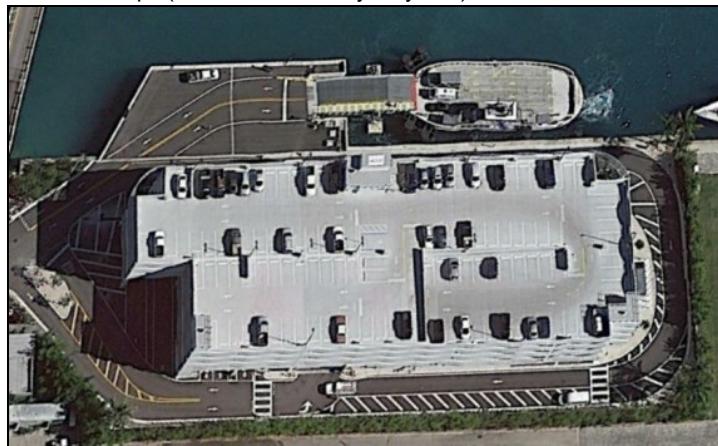
History: Terminal East bulkhead was completely replaced in 2017 per information provided. Wharf constructed in 2020.

Scope of work: Repair spalls and cracks in caps (Assume 15% every 10 years)

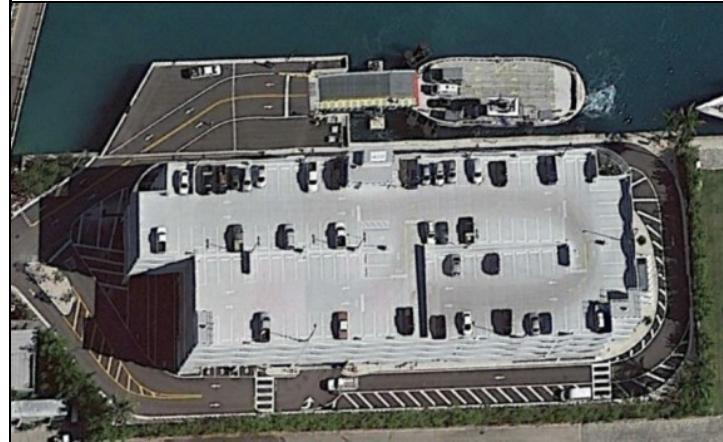
History: Terminal East bulkhead was completely replaced in 2017 per information provided. Wharf constructed in 2020.

Scope of work: Repair spalls in deck planks (assume 5% every 10 years)

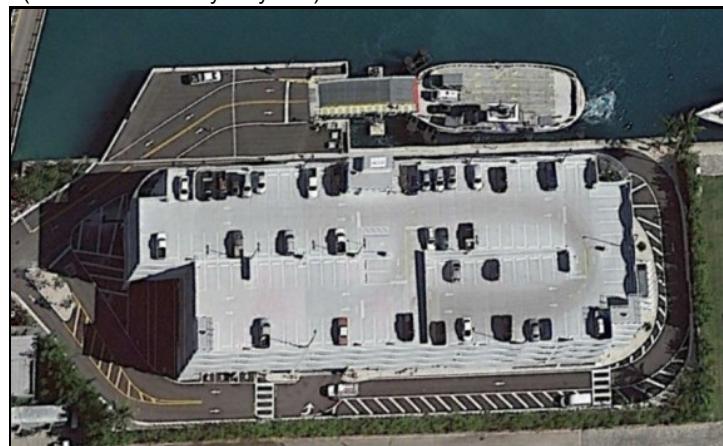
History: Terminal East bulkhead was completely replaced in 2017 per information provided. Wharf constructed in 2020.

Scope of work: Install pile jackets (assume 25% every 10 years)

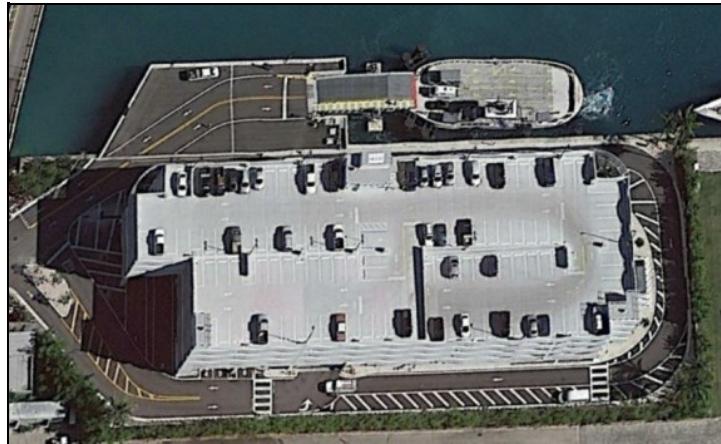
History: Terminal East bulkhead was completely replaced in 2017 per information provided. Wharf constructed in 2020.

Scope of work: Seal bituminous topping (assume every 5 years)

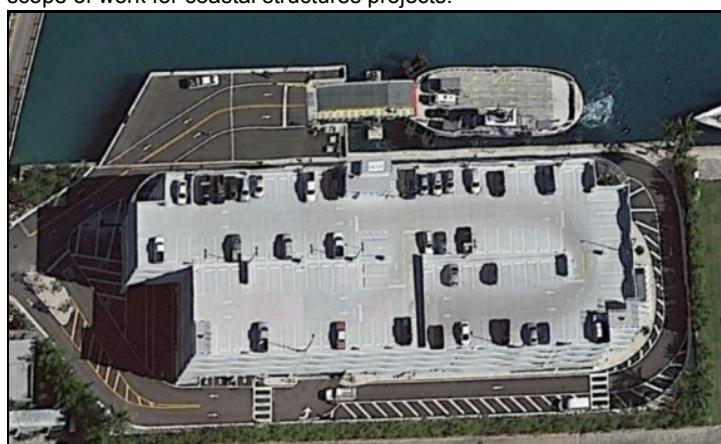
Comments: Scope of work: Repair spalls and cracks in caps (Assume 15% every 10 years).

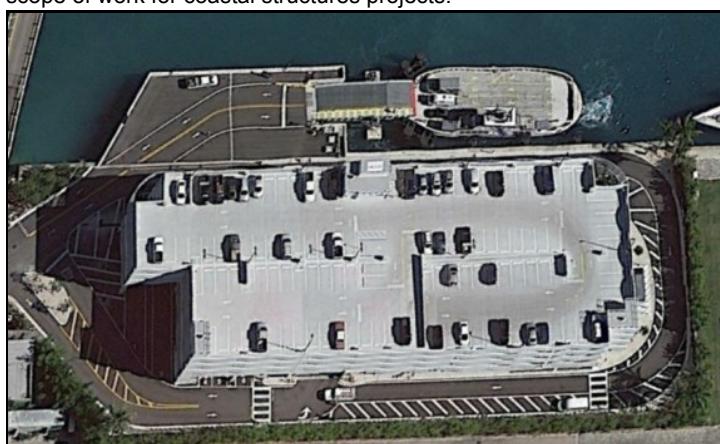
Comments: Scope of work: Replace anodes. (Assume every 12 years).

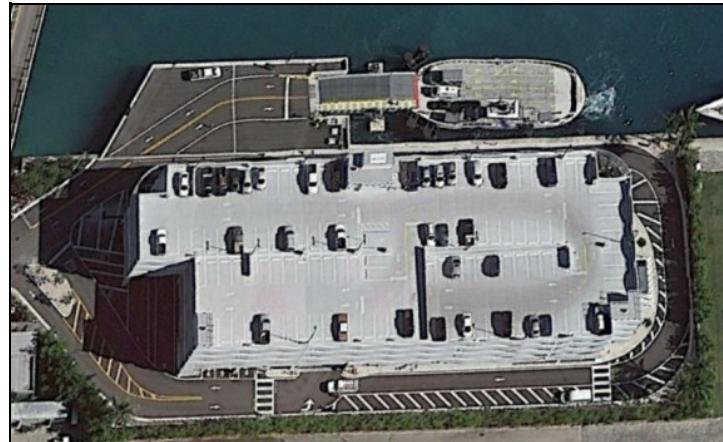
Comments: Scope of work: Repair spalls and cracks in caps (Assume 10% every 15 years)

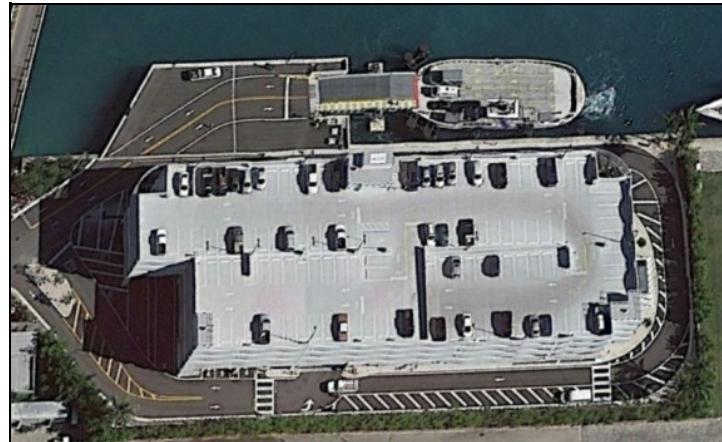
Comments: Scope of work: Replace anodes. (Assume every 12 years)

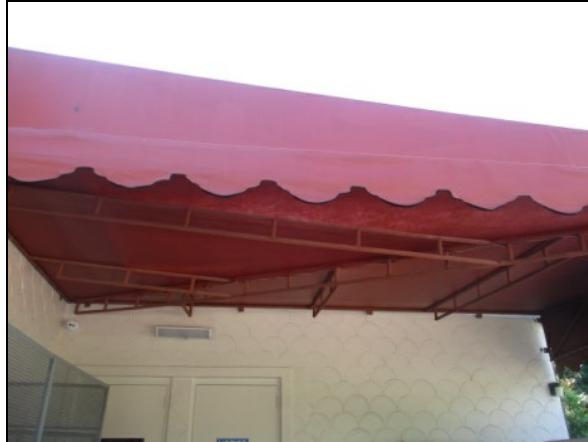
### Comp #: 2306 Awnings/Canopies - Replace

Fair condition: Awnings determined to be in fair condition typically exhibit more moderate signs of age, including noticeable color fading, loose/sagging material or other aesthetic problems. Attachments and hardware remain in serviceable condition.

Fabric/canopy should be washed periodically to maintain appearance and inspected regularly to identify any potential maintenance needs. Ensure that anchor points and hardware are intact and take note of any recommendations for removal during high winds or storms to prevent damage to the awning, framing, and/or building structure. Framing should be repaired and usually painted to prolong life expectancy. Minor repairs should be considered an Operating expense. Remaining useful life below is based on consideration of original installation date, evident conditions, and/or any repair/replacement information provided by the Client during this engagement. Existing framing can be re-used in most cases when a new canopy is installed. As such, cost estimates shown below assume replacement of fabric/canopy only with funding for eventual frame replacement being included in component #2308.

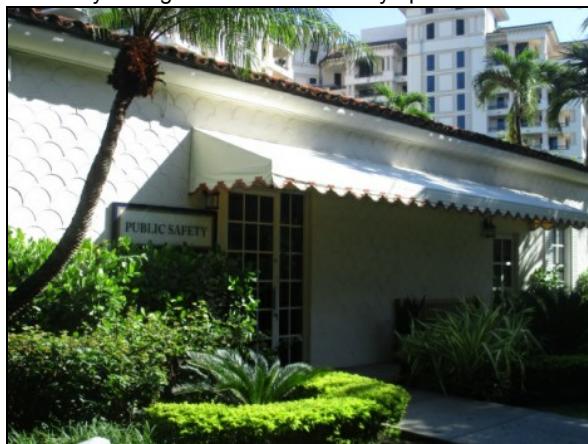
Comments: Fair condition: Painted exterior surfaces determined to be in fair condition typically exhibit some minor to moderate signs of wear and age such as chalking, peeling, blistering, etc. Problems tend to develop in more exposed areas first. Hairline cracks may be present at this stage. Overall appearance is satisfactory.

There are two important reasons for painting and waterproofing a building: to protect the structure from damage caused by exposure to the elements, and to restore or maintain good aesthetic standards for curb appeal. As routine maintenance, we recommend that regular inspections, spot repairs and touch-up painting be included in the operating budget. Typical paint cycles can vary greatly depending upon many factors including; type of material painted, surface preparations, quality of material, application methods, weather conditions during application, moisture beneath paint, and exposure to weather conditions. During our inspection, we attempted to measure/quantify sealant around window and door frames, but additional sealants may be present in the building envelop which should be replaced at time of painting/waterproofing project. Proper sealant/caulking at window and door perimeters and other "gaps" in the building structure are critical to preventing water intrusion and resulting damage. The general rule of thumb is that sealant/caulking should be in place wherever two dissimilar building material surfaces meet, such as window frame to concrete structure junctions. For best results, the Client may want to consult with a paint company representative, building envelope specialist and/or structural engineer to specify the types of materials to be used and define complete scope of work before bidding. In our experience, cost estimates for painting and waterproofing can vary widely, even when based on the same prescribed scope of work. Estimates shown here should be updated and revised as needed based on actual bids obtained or project cost history during future Reserve Study updates.

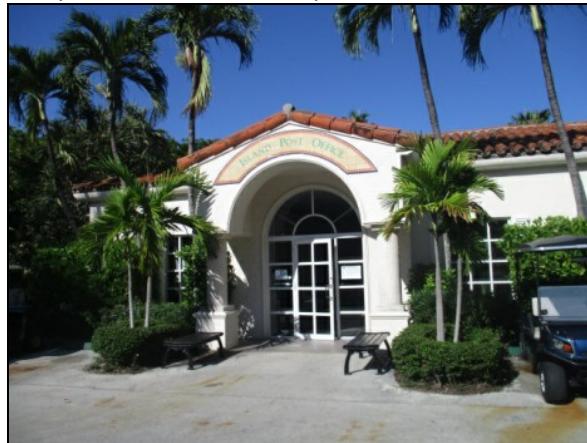
**Comp #: 2367 Windows/Doors - Replace**

Fair condition: Windows and doors determined to be in fair condition typically exhibit normal signs of wear for their age, including more surface wear to framework and hardware, but no advanced corrosion or other concerns. At this stage, windows and doors are believed to be functional and aging normally, but more advanced technology may be available.

Unless otherwise noted, this component refers only to common exterior windows and doors. All are assumed to have been compliant with applicable building codes at time of installation. Inspect regularly for leaks and cracks around frame and repair as needed. Clean tracks and ensure hardware is functional to prevent accidental damage during opening/closing. With ordinary care and maintenance, useful life is typically long but often difficult to predict. Many factors affect useful life including quality of window currently installed, waterproofing details, exposure to wind and rain, etc. Individual windows and doors should be replaced as an Operating expense if damaged or broken. We recommend replacement at the approximate interval shown below based on consideration of installation/replacement dates, evident conditions, and/or our experience with similar Clients. Unless otherwise noted, cost estimates are based on replacement with current impact-resistant models.

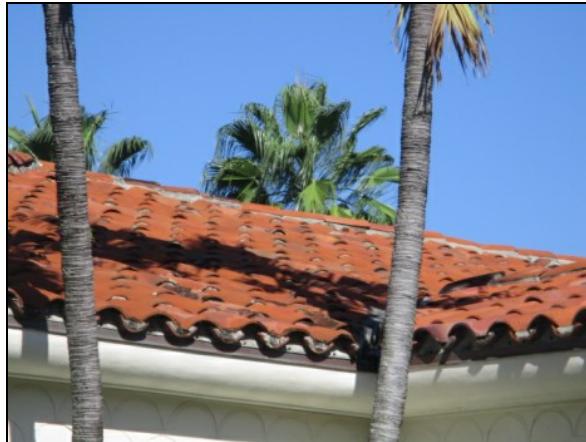
**Comp #: 2383 Tile Roof - Replace**

Tile roofing is typically a long-lived component assuming it was properly installed and is properly maintained. The primary reason to replace tile roofs is not based on the condition of the tiles themselves, whose main purpose is to provide a barrier for the underlayment which is the actual waterproofing layer of the roof system. As such, the timeline for tile roof replacement is generally estimated based on the age of the roof. As routine maintenance, many manufacturers recommend inspections at least twice annually and after large storm events. Promptly replace any damaged/missing sections or conduct any other repair needed to ensure waterproof integrity of roof. We recommend having roof inspected in greater detail (including conditions of sub-surface materials) by an independent roofing consultant prior to replacement. There is a wealth of information available through organizations such as the Roof Consultant Institute <http://www.rci-online.org/> and the National Roofing Contractors Assn. (NRCA) <http://www.nrca.net/>. If the roof has a warranty, be sure to review terms and conduct proper inspections/repairs as needed to keep warranty in force. Remaining useful life is typically based on roof age, but can also be adjusted based on inspection of any accessible areas, looking for any cracked, slipping or missing tiles, as well as consultation with the Client about history of repairs and preventive maintenance. Typical replacement includes removal and replacement of tiles and underlayment, with repairs to any damaged substrate made as needed.

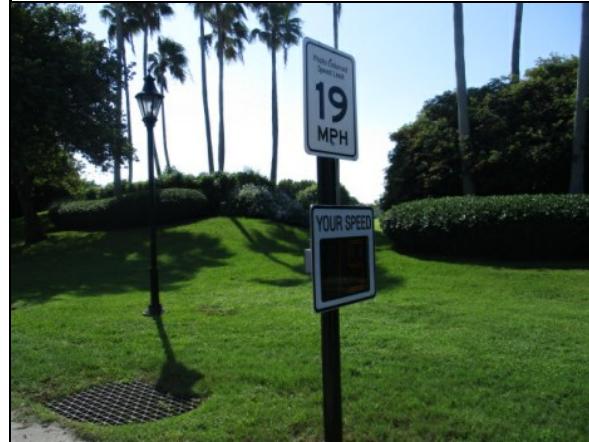
**Comp #: 2507 Radar Signs - Replace**

History: Per information provided, radar signs replaced in 2017 for \$17,500

Comments: Radarsign model TC-500. Plan to inspect/test regularly to ensure proper function, and replace at the approximate interval shown here

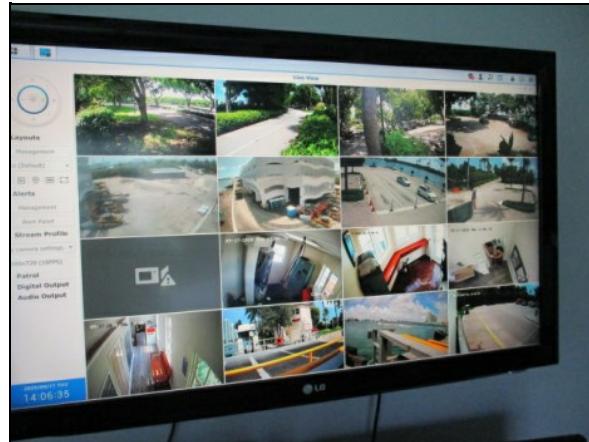
Security/surveillance systems should be monitored closely to ensure proper function. Whenever possible, camera locations should be protected and isolated to prevent tampering and/or theft. Typical modernization projects may include addition and/or replacement of camera fixtures, recording equipment, monitors, software, etc. Costs assume that existing wiring can be re-used and only the actual equipment will be replaced. In many cases, replacement or modernization is warranted due to advancement in technology, not necessarily due to functional failure of the existing system. Keep track of any partial replacements and include cost history during future Reserve Study updates.

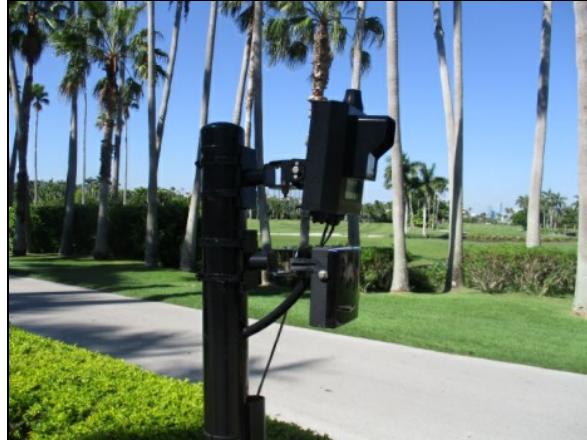
**Comp #: 2544 Traffic Cameras - Replace****Quantity: (5) Cameras**

Note: useful life extended at request of Management in 2022.

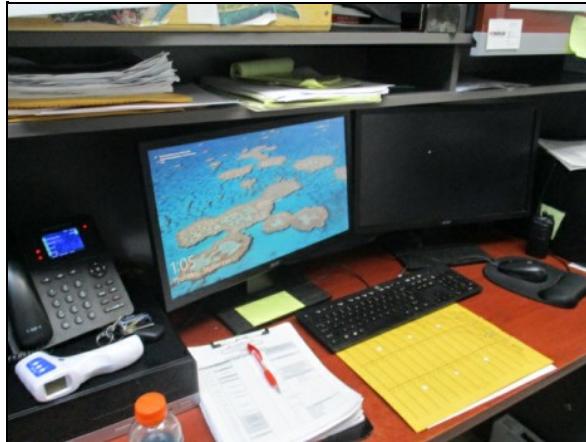
**Comp #: 2545 Computer/IT Equipment - Replace****Quantity: Large Quantity**

History: Per information provided, major upgrade/replacement completed in 2017-2018 for \$10,300

Comments: Scheduled for replacement in 2023 according to information provided:

Computers and other IT equipment have a relatively short useful life (depending on the application and level of use) due to advancements in technology. Plan to replace/upgrade the existing equipment at the approximate interval shown here to ensure proper function and uninterrupted service. Keep track of any partial replacements and include cost history during future Reserve Study updates.

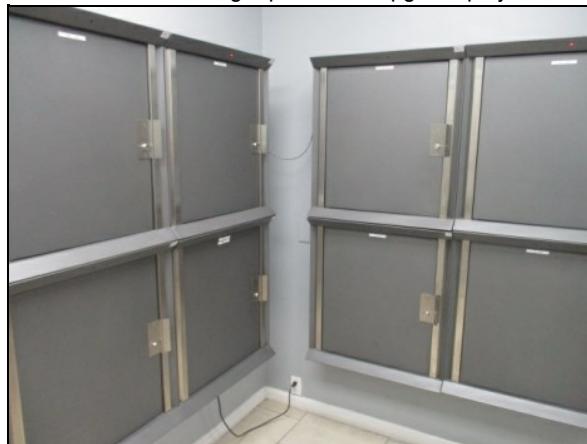
**Comp #: 2547 Key Watcher System - Replace****Quantity: (1) System**

History: Per information provided, key watcher equipment replaced in 2017-2018 for approximately \$64,500

Comments: FICA stores roughly 1,000 keys at any given time to restrict access to units. All equipment is reported to be modern and in good working order at this time. Plan for recurring replacement/upgrade projects at the approximate interval shown here.

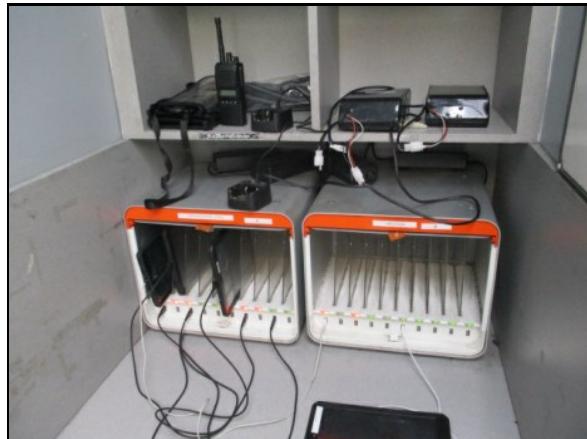
**Comp #: 2548 Radios - Replace****Quantity: Approx (20) Radios**

Comments: Digital radios to be purchased in 2022 for \$55,000 per information provided. Plan for recurring replacements at the approximate interval shown here.

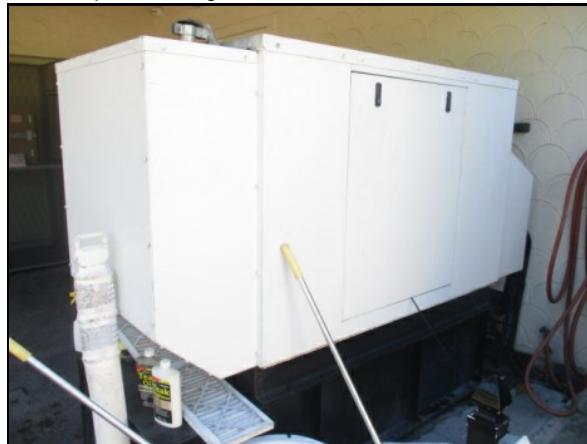
**Comp #: 2549 Generator - Replace**

Semi-protected location should allow for an extended useful life. . Vendors typically report that with ongoing maintenance (e.g. fluids, batteries, tune ups), useful life can be extended for many years. However, funding for complete replacement is often warranted due to lack of available replacement parts rather than failure of the system as a whole. Treat periodic service and inspect as general maintenance expense within Operating budget, not Reserves. Generator is a key building element in this location due to risk of severe storms and power outages, and should be tested evaluated regularly to ensure proper function.

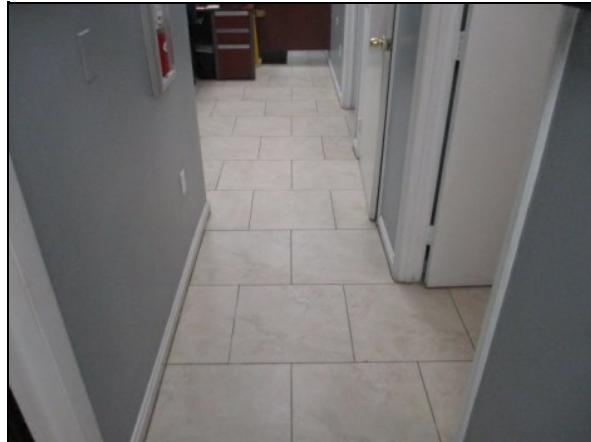
Fair condition: Offices determined to be in fair condition typically exhibit some routine signs of wear and tear, but no unusual or advanced deterioration. FF&E is in serviceable condition with no unusual conditions observed or reported by staff.

Periodic office remodeling is prudent in order to maintain an attractive, functional workspace for personnel. Typical projects often include replacement of room finishes and furnishings, and may also include replacement of IT equipment, phones, office supplies, storage units, etc. Life estimates can vary greatly depending on level of use and preferences of Client. If the office is used as a "public" area for hosting potential buyers and other important visitors, remodeling should be a high priority. Costs can significantly vary based on an anticipated scope of work as well as materials chosen for remodeling/renovation. Unless otherwise noted, cost allowances shown below assume remodeling with both similar quantities and qualities as existing materials. Schedule and cost estimates should be re-evaluated during future Reserve Study updates and adjusted as needed based on any new information obtained and conditions evident at that time.

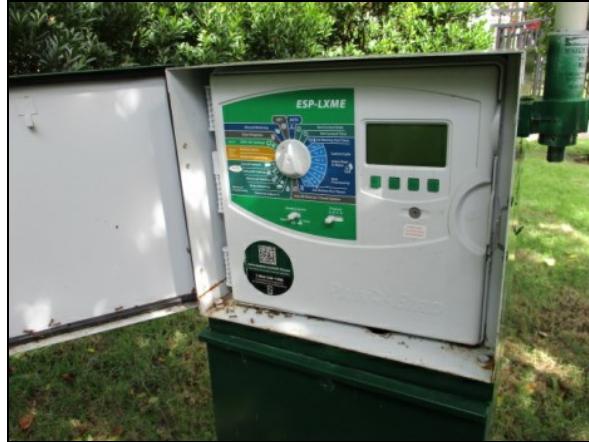
**Comp #: 2587 Irrigation Controllers - Replace**

Comments: According to manager, most of the smaller controllers are routinely replaced as an Operating expense. FICA had completed upgrading about 25 of the larger controllers in 2015 to weather-monitoring models to help save on water costs. These controllers will also entitle the Association to county rebates to help minimize costs. Cost shown here includes credit for rebates based on actual cost history.

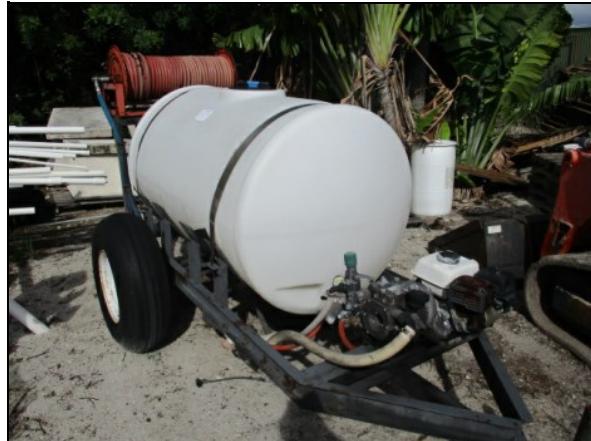
**Comp #: 2603 300 Gal. Sprayer (2014) - Replace**

Comments: A newer sprayer was purchased in 2014 according to management. Cost shown is reportedly for the tank itself, as trailers are refurbished/rebuilt by staff.

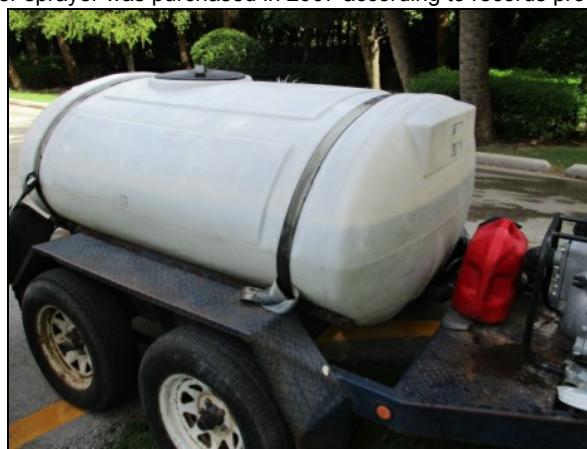
**Comp #: 2603 500 Gallon Sprayer - Replace**

Comments: The Workhorse water sprayer was purchased in 2007 according to records provided by management.

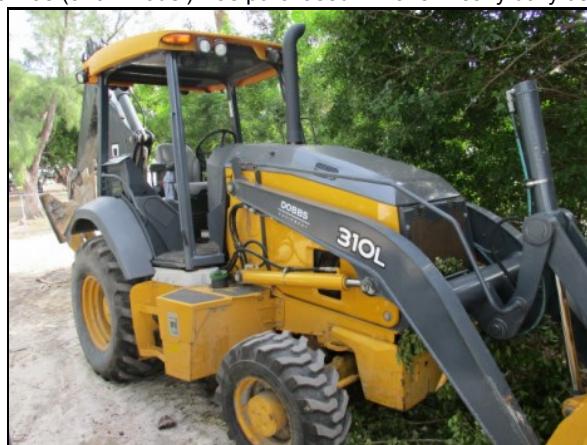
**Comp #: 2603 Backhoe (310L) - Replace**

History: Per information provided, backhoe replaced in 2018

Comments: The John Deere backhoe (310L model) was purchased in 2018. Heavy daily use expected.

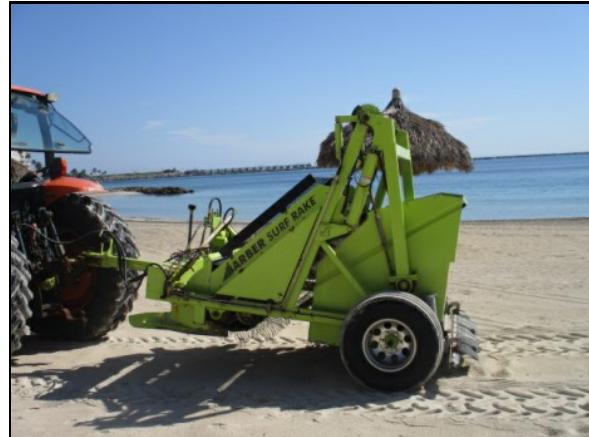
**Comp #: 2603 Beach Rake (2021) - Replace**

History: Replaced in 2021 for \$61,477 per information provided.

Comments: Barber Surf Rake, appeared to be in functional condition at time of inspection. Useful life has been reduced at the request of FICA management.

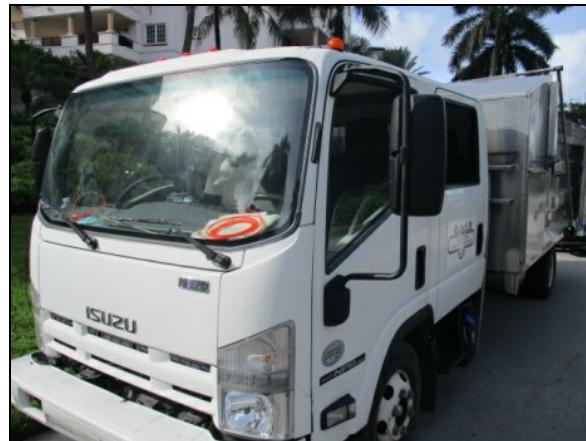
**Comp #: 2603 Dump Trucks - Replace**

Comments: These three dump trucks (Isuzu brand, NPR HD diesel engines) were all purchased new in 2015 and remain in good, serviceable condition according to staff. Useful life and remaining useful life reduced after input from management.

Plan to replace at the approximate interval shown here.

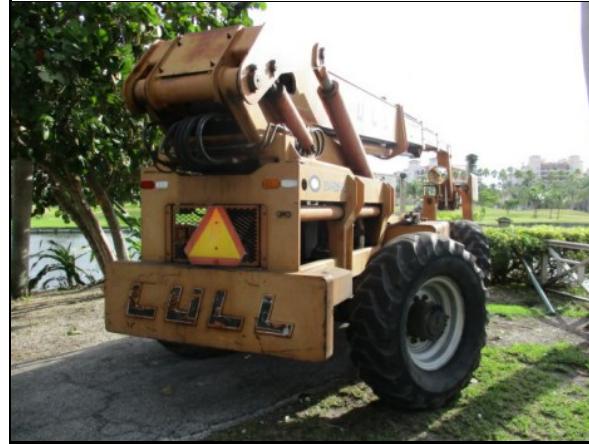
**Comp #: 2603 Forklift - Replace**

Comments: Lull forklift was purchased in 2002 according to management. Many repairs (Approx \$15,000) were made in 2014, which should help extend life. Also rebuilt in 2018.

RUL shown here has been extended.

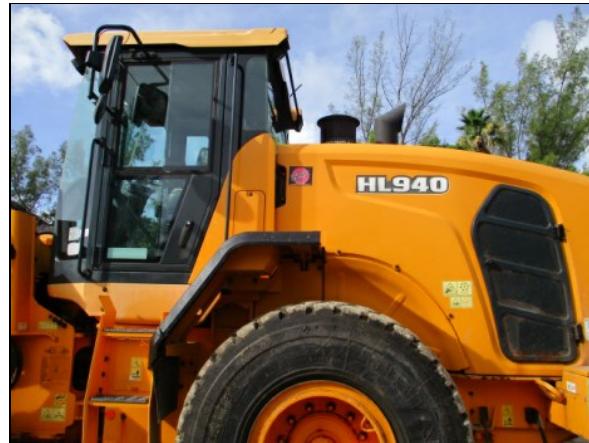
**Comp #: 2603 Hyundai HL940 Loader - Replace**

History: Per information provided, loader replaced in 2018 for approximately \$220,000

Comments: The old John Deere model 624G loader was replaced in 2018 with a new Hyundai model HL940. Reported to be in good condition at time of inspection.

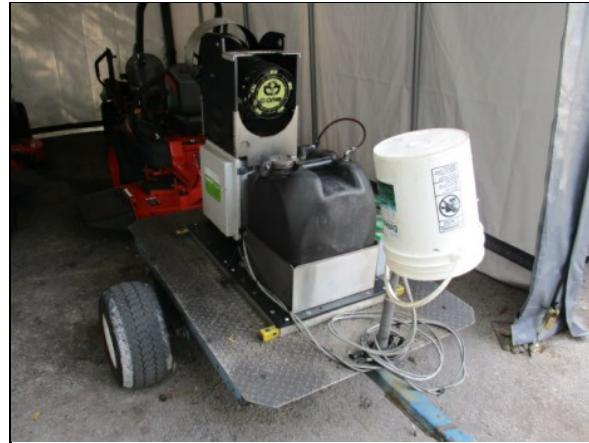
Comments: This sprayer was replaced in 2015 and is reported to be in fair working condition. Clarke SmartFlow II brand.

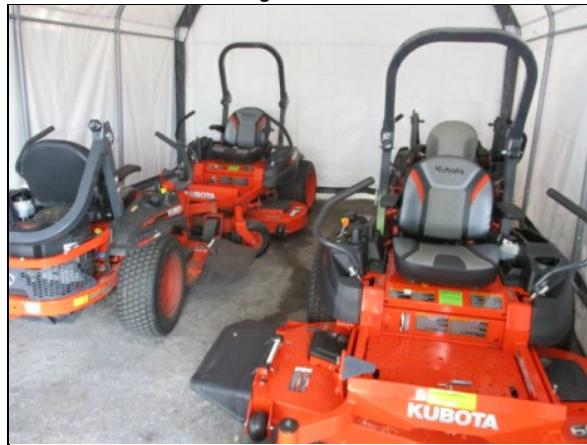
**Comp #: 2603 Mowers (Kubota) - Replace**

Comments: (4) Kubota mowers purchased in 2020. Of the 4 Toro mowers, three mowers were removed, and only one Toro unit (model number 74141) was preserved. This component accounts for the replacement costs of all (4) Kubota mowers. 2 Kubota mowers had model numbers: Z421KW-3-54, and remaining 2 mowers had model numbers Z421KWT-3-60.

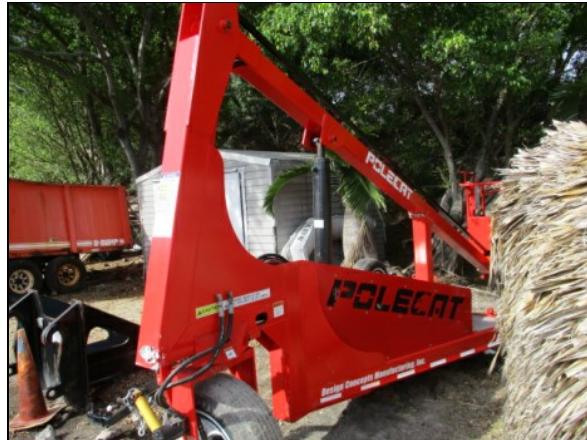
**Comp #: 2603 PoleCat Lift - Replace**

Comments: Expected to be replaced in 2022 according to information provided. Remaining useful life has been extended accordingly as shown below.

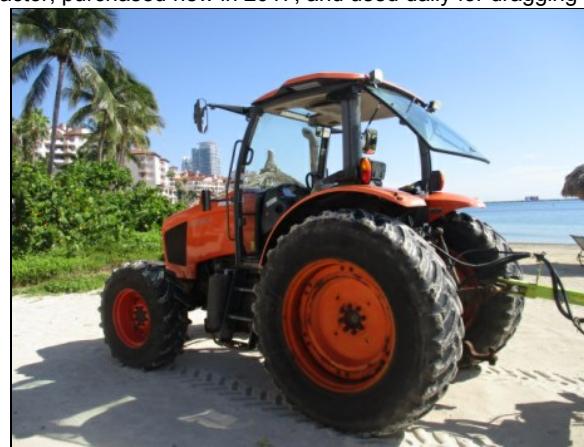
**Comp #: 2603 Tractor (Beach Rake '17) - Replace****Quantity: (1) Tractor**

History: Per information provided, beach rake replaced in 2017 for \$72,292

Comments: Kubota M126-GX tractor, purchased new in 2017, and used daily for dragging the beach rake.

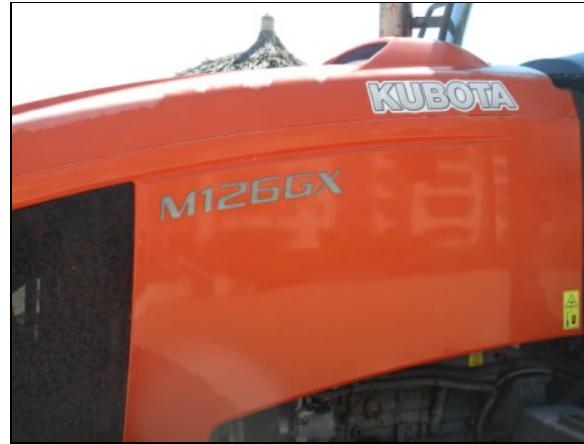
**Comp #: 2603 Tractor (Beach Rake '18) - Replace****Quantity: Kubota Tractor**

Comments: According to Management, another tractor was purchased in 2018 for pulling the new beach rake that was also purchased in 2018.

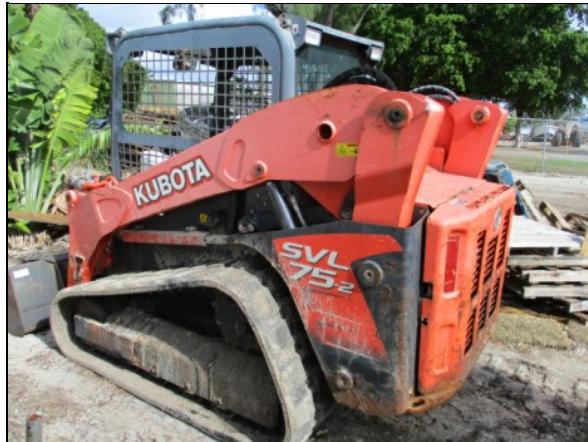
Comments: This Kubota skid-steer tractor was purchased new in 2015. Expected to be replaced in early 2023 for approximately \$60,000 according to information provided.

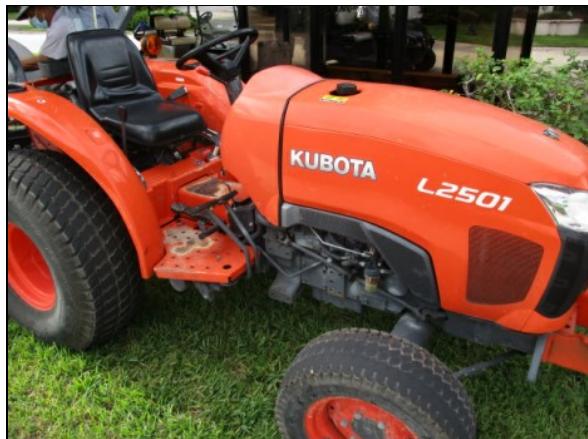
**Comp #: 2603 Tractor (Kubota L2501HST) - Replace**

History: Per information provided, Kubota tractor replaced in 2017 for \$19,821

Comments: The older Ford tractor was replaced in 2017 with new Kubota tractor, model L2501HST according to information provided.

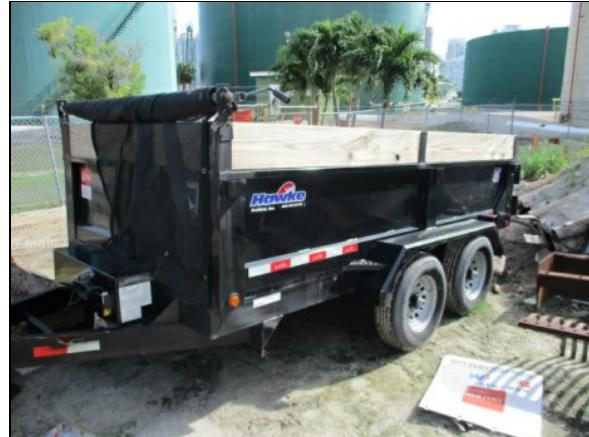
**Comp #: 2603 UDump 6812 Trailer - Replace**

History: Replaced in 2021 for \$10,200 per information provided.

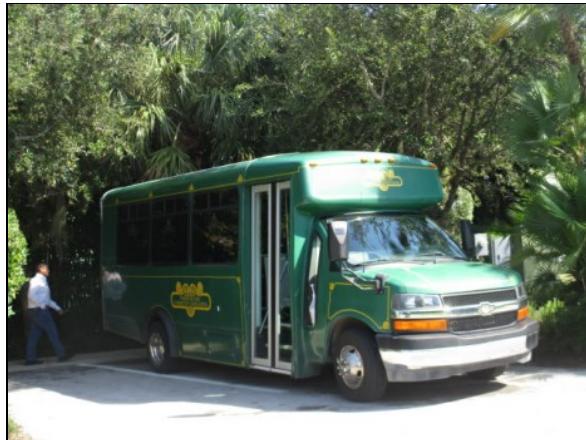
### Comp #: 2187 Passenger Vans - Replace

Comments: New passenger vans are to be purchased in 2023 per information provided, to replace the aging green shuttle vans. Plan to replace at the approximate interval shown below.

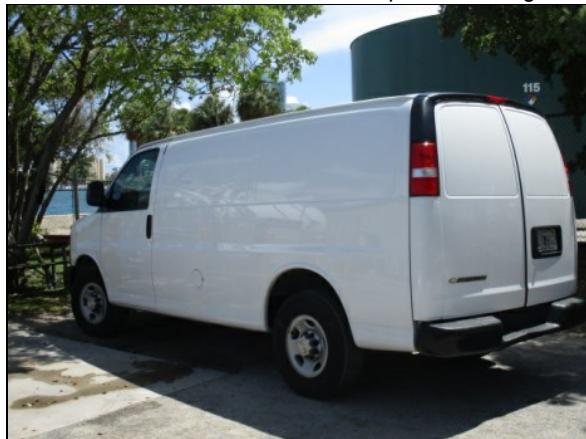
### Comp #: 2197 Chevrolet Cargo Van - Replace

History: \$30,879 in 2017 ( (was being repaired at time of inspection)

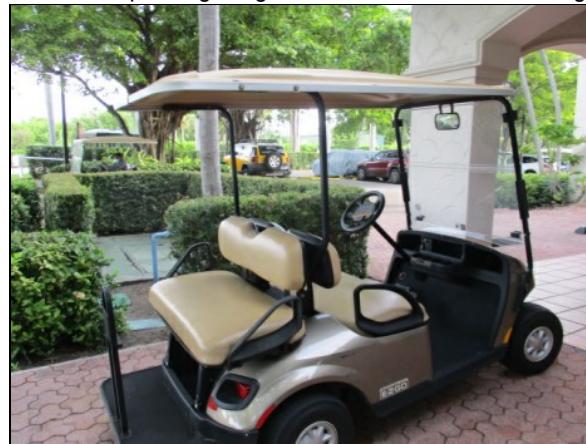
**Comp #: 2197 Golf Carts - Replace****Quantity: Numerous Carts**

Comments: FICA utilizes a fleet of golf carts for various purposes throughout the island. All carts are reportedly leased, not owned, and lease costs are included in the annual Operating budget. No need for Reserve funding at this time.

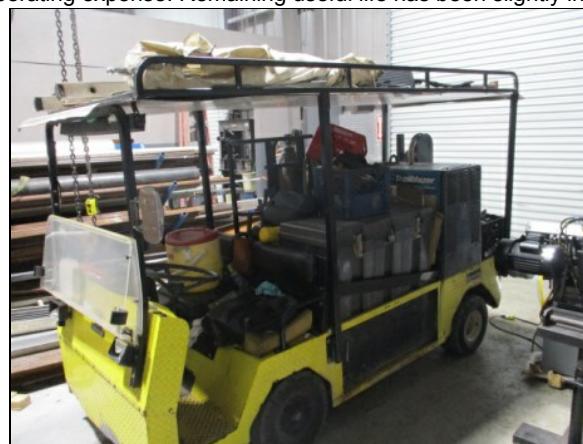
**Comp #: 2199 Damage Control Cart - Replace**

History: To be replaced in 2023 for approximately \$15,000 per information provided.

Comments: Cushman Titan HD cart with welding equipment attached. Used for miscellaneous repair projects at landings, etc.

Reported to have been purchased in 2013. Cost shown is primarily for the gas-powered cart itself; equipment on board would reportedly be replaced as an Operating expense. Remaining useful life has been slightly increased at the request of Management.

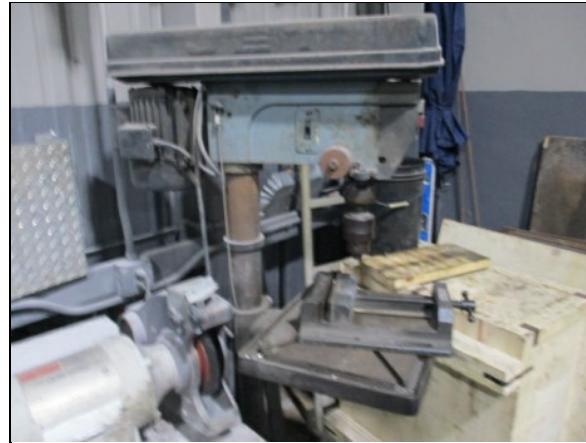
**Comp #: 2199 Drill Press - Replace**

Comments: Drill press replaced in 2017 for \$12,000. Useful life reduced at the request of Management.

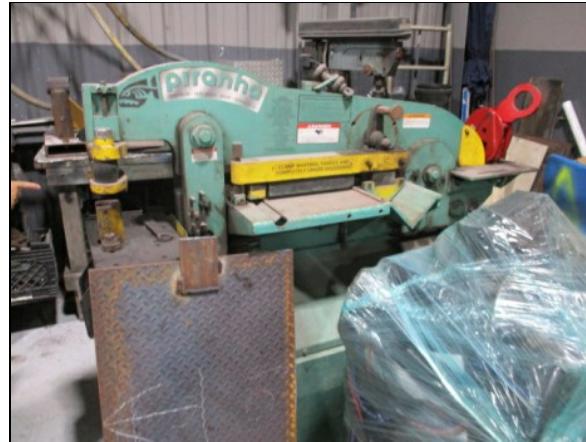
**Comp #: 2199 Ironworker - Replace**

History: To be replaced in 2024 per information provided. (No recent cost estimate given.)

Comments: This machine is a Piranha P50 ironworker, reportedly purchased in 2005. Remaining useful life decreased at request of management.

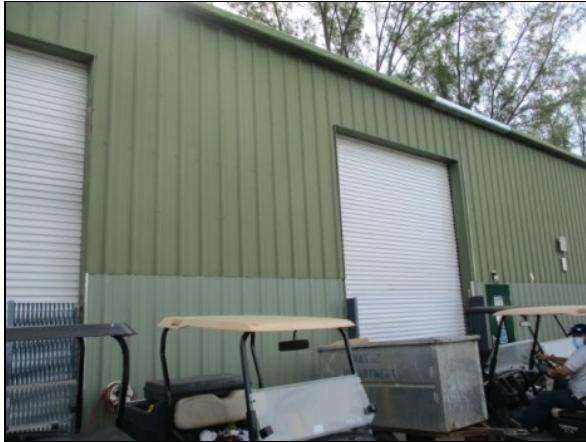
**Comp #: 2343 Maintenance Bldgs - Repair/Refurb****Quantity: (2) Buildings**

Comments: According to management, all of these buildings (Parcel 8) are technically owned by the developer, but FICA pays for maintenance and repair. Expected to eventually be turned over to FICA. The larger maintenance building is roughly 220'x30', metal frame. This building contains maintenance bays and misc. mechanical equipment. The smaller building is roughly 100'x20' and contains staff kitchen, break and bathroom areas, as well as some admin offices. Both structures were originally intended to be temporary according to management, but have now been in place 20+ years with no predictable timeframe for replacement with more permanent structures. An allowance for ongoing repair and refurbishment projects is recommended here, to be used as needed on interior furnishings, painting, roof repair, and equipment replacement. Maintain records of any substantial projects and adjust schedule and amount of allowance as needed during future updates.

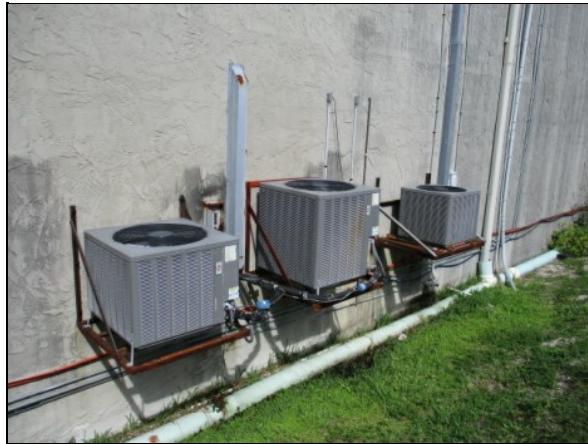
**Comp #: 2519 HVAC Systems - Partial Replace****Quantity: (7) Total Systems**

Comments: Some appeared to have been replaced recently as of 2022 inspection. Mix of ages and conditions. This component represents an ongoing allowance for replacement of several systems at a time.

Typically Rheem split systems, but also (2) smaller ComforMatic min-split systems.
