**Fisher Island Community Association, Inc**

***Fisher Island, FL***

Report #: 24275-9

**RESERVE STUDY**  
**Update "With-Site-Visit"**

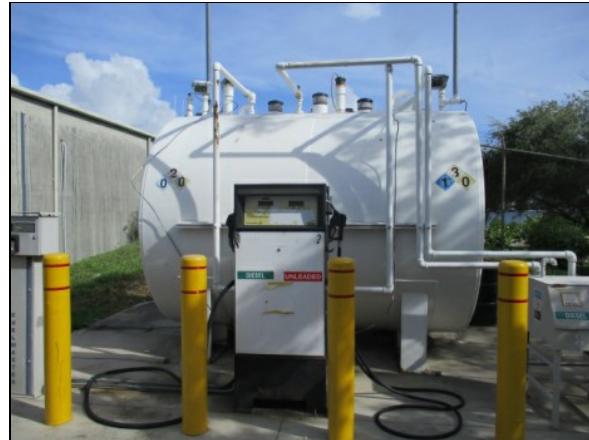
Comments: Fuel tank is split internally to have a 2,000 gallon capacity for gas and 2,000 gallons for diesel fuel. Above-ground, and should be painted periodically to protect from the elements. Long useful life expected if properly maintained and serviced. Purchased and installed in 2009 according to records provided. Cost includes Fuel Master Plus fuel key system and Veeder Root system, which controls and checks status of system/functions.

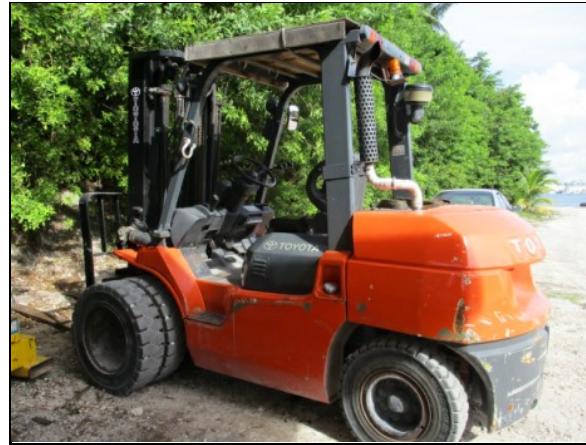
Comments: A lightly used forklift was purchased in 2017-2018 and was reported to be in good working order at time of inspection.

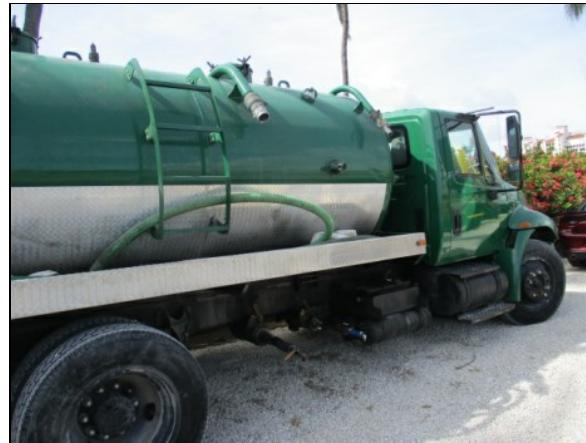
Comments: The vacuum truck is an International brand, showing 8.175 hours of runtime and 2005 manufacture date. The tank itself is reportedly new. Used for cleaning up of oil/lube spills and other messes at ferries and landings. Used a few times per week, according to Management.

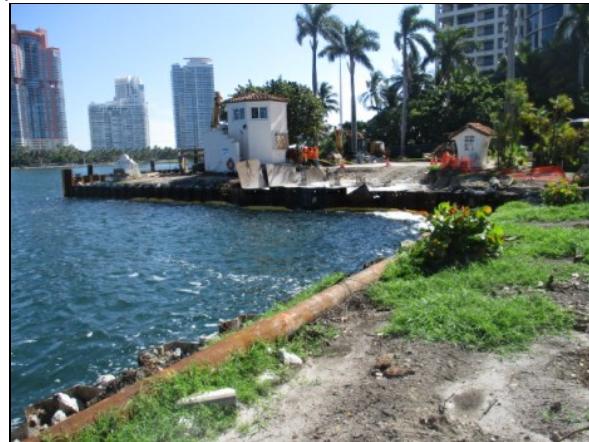
**Comp #: 2903 Ramp Lifts/Controls - Replace**

Comments: Area was under construction as of 2022 inspection; assumed to have a similar set of dolphin clusters and fender piles as the other locations upon completion.

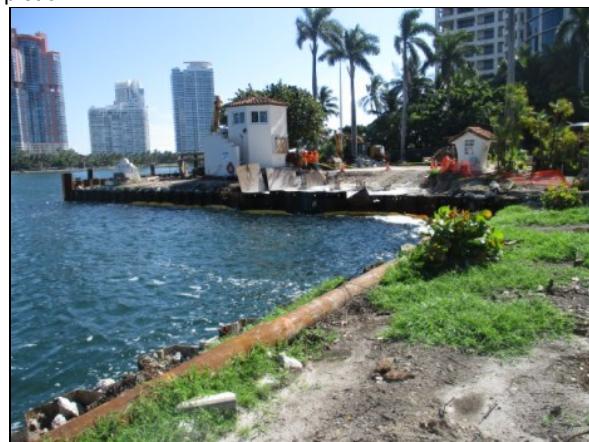
**Comp #: 2905 Dolphin/Fender Piles - Replace**

Comments: Area was under construction as of 2022 inspection; assumed to have a similar set of dolphin clusters and fender piles as the other locations upon completion.

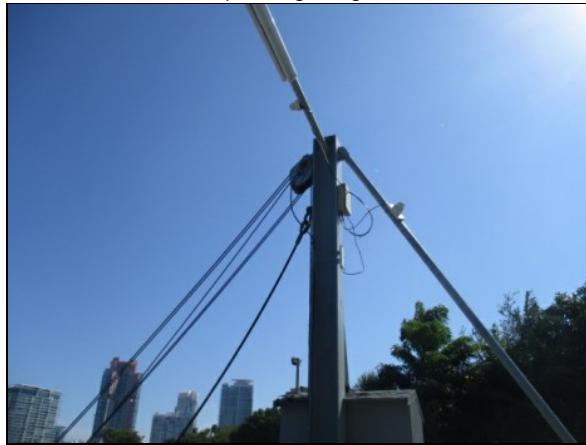
### Comp #: 2902 Ramp Motors & Cables - Repair/Repl.

Comments: There are (2) electric motors for each ramp, which retract or let out cables to raise and lower the vehicle ramps. Motors are reportedly rebuilt or replaced at roughly 3 year intervals (approx \$6,000/motor) and cables as-needed (approx \$7,000 per side). All costs are reported to be included in the Operating budget. No recommendation for Reserve funding at this time.

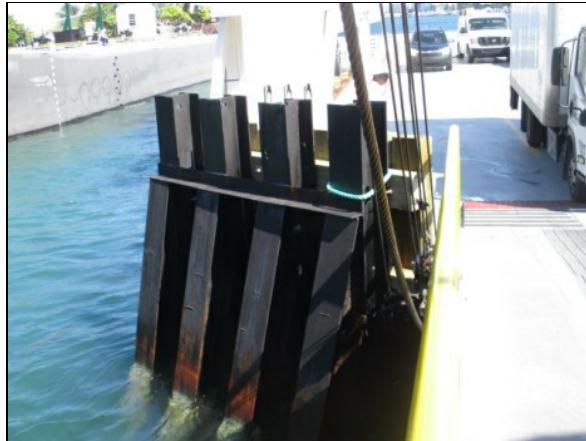
### Comp #: 2906 Dolphin/Fender Piles - Replace

Comments: Two sets of dolphins at the landing ramp. Plan to replace at the approximate interval shown here.

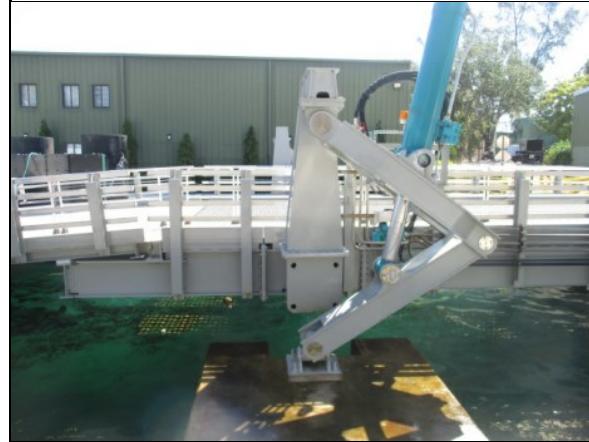
**Comp #: 2903 Ramp Lifts/Controls - Replace**

Comments: All equipment installed new with wharf construction in 2020. Observed to be in good, functional condition at time of inspection.

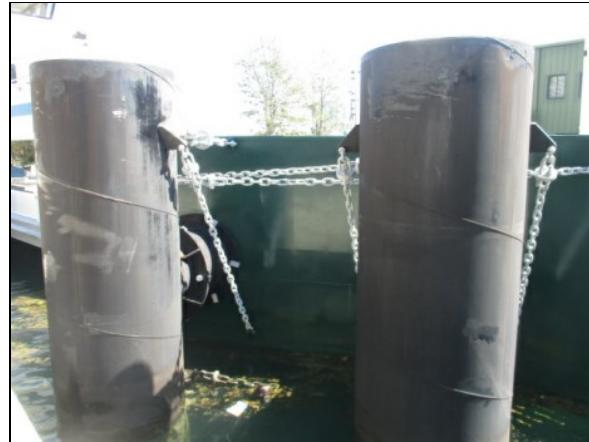
**Comp #: 2905 Dolphin/Fender Piles - Replace**

Comments: (4) sets of dolphins at landing ramp, plus (8) fenders. All installed new in 2020 during construction project.

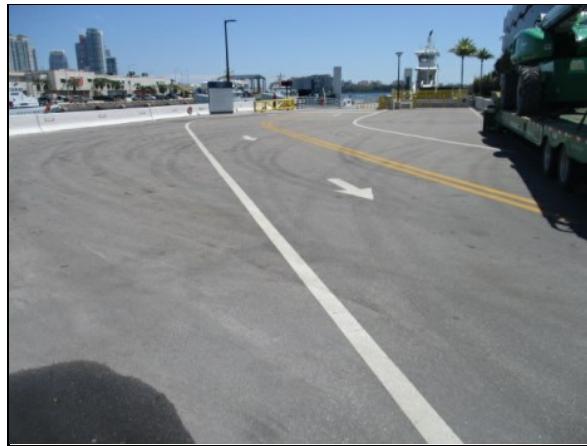
**Comp #: 2123 Asphalt - Seal/Repair**

Comments: Asphalt does not exhibit any signs of prior seal-coating. May not have been done at any point, or has deteriorated completely.

In many cases, we believe that an asphalt seal-coat can provide both a protective and/or aesthetic benefit to a property. However, there are instances where the expense of a project can outweigh the potential benefits a seal-coat may provide. As such, based on our evaluation of both client precedence and anticipated return on investment, we do not recommend that seal-coating be conducted for this property. However, the client should consult with a qualified vendor related to benefits of application. This component can then be re-evaluated (and/or funding added) during future Reserve Study updates based on the most current information and recommendations available at that time.

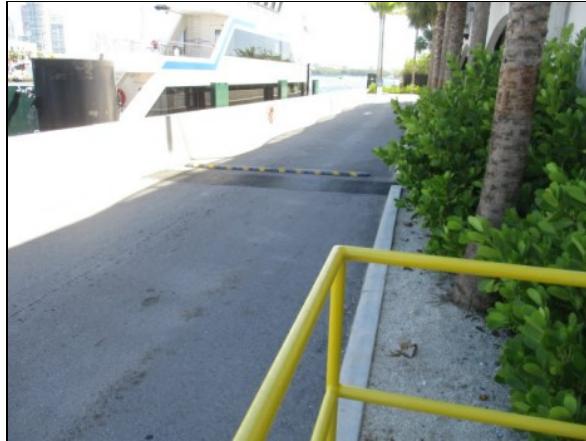
Good condition: Asphalt pavement determined to be in good condition typically exhibits a consistent appearance with uniform coloring and relatively smooth texture with only light to moderate signs of wear or age. If present, cracking and raveling or other signs of wear are sporadic in nature, and asphalt is still up to aesthetic standards for the development. No unusual signs of wear considering the age of the asphalt surface.

As routine maintenance, keep roadway clean, free of debris and well drained; fill/seal cracks to prevent water from penetrating into the sub-base and accelerating damage. Even with ordinary care and maintenance, plan for eventual large scale resurface (milling and overlay of all asphalt surfaces is recommended here, unless otherwise noted) at roughly the time frame below. Take note of any areas of ponding water or other drainage concerns, and incorporate repairs into scope of work for resurfacing. Our inspection is visual only and does not incorporate any core sampling or other testing, which may be advisable when asphalt is nearing end of useful life. Some communities choose to work with independent paving consultants or engineering firms in order to identify any hidden concerns and develop scope of work prior to bidding. If more comprehensive analysis becomes available, incorporate findings into future Reserve Study updates as appropriate.

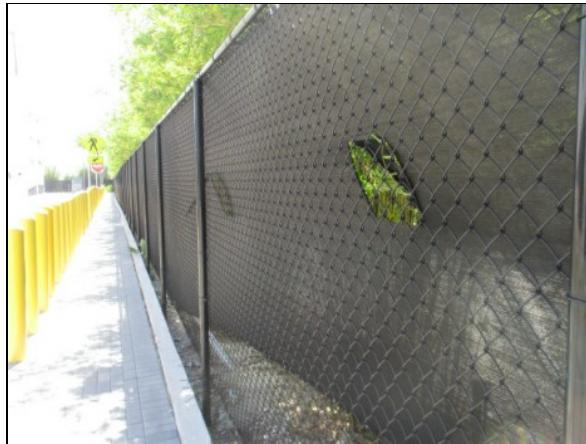
**Comp #: 2143 Chain Link Fencing - Replace****Quantity: Approx 640 LF**

Comments: Good condition: Chain-link fencing determined to be in good condition typically exhibit tight fabric and stable, upright posts. If present, vinyl coating on links is thick and providing good protection. No observed or reported concerns with appearance and curb appeal.

Chain link fencing generally has lower aesthetic value than other materials, so remaining useful life is mostly based on functional/structural conditions evident, although aesthetic appearance and priority is also considered. Inspect, clean, and repair regularly as-needed through general maintenance/Operating funds. Even assuming ordinary care and maintenance, replacement will be needed at longer intervals. As such, plan to replace at the approximate interval below based on conditions evident at the time of inspection. Remaining useful life may be partially extended through mesh replacement as opposed to comprehensive replacement (including framework), which will also be at a lesser cost. This component should be re-evaluated during future Reserve Study updates based on the most current conditions and information available at that time.

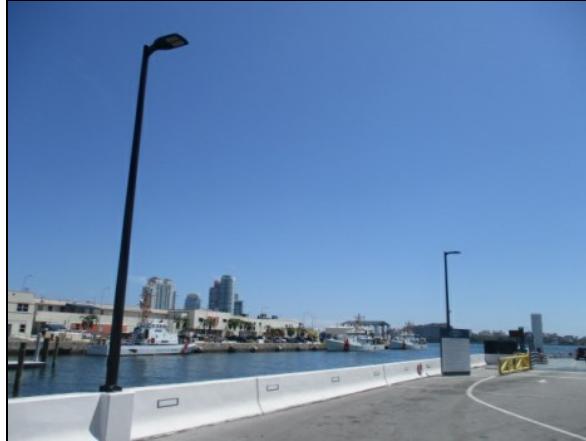
**Comp #: 2175 Site Pole Lights - Replace**

Good condition: Pole lights determined to be in good condition typically exhibit good surface finishes with only minor, normal signs of wear. Fixtures are intact and clear with no unusual signs of age. Style is consistent and appropriate for local aesthetic standards.

Observed during daylight hours; assumed to be in functional operating condition. As routine maintenance, inspect, repair/change bulbs as needed. Best to plan for large scale replacement at roughly the time frame below for cost efficiency and consistent quality/appearance throughout Client. Replacement costs can vary greatly; estimates shown here are based on replacement with a comparable size and design, unless otherwise noted. We recommend consideration of LED fixtures or other energy-saving options whenever possible.

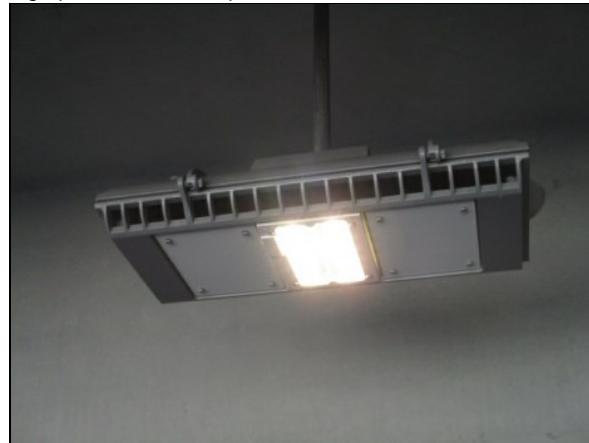
**Comp #: 2305 Garage Lights - Replace**

Comments: Good condition: Garage lights determined to be in good condition typically exhibit only minor, routine signs of wear and age. All appear to be functioning with no unusual conditions observed or reported.

Garage lighting has a lower aesthetic priority but is important for safety. Should be inspected regularly to ensure that all areas are adequately lit. Fixtures are typically high-output and sometimes have shorter life expectancies due to constant usage. Individual replacements should be considered an Operating expense. If available, an extra supply of replacement fixtures should be kept on-site to allow for prompt individual replacements. Based on evident conditions and/or past repair/replacement history provided during this engagement, we recommend that the Client plan for comprehensive replacement at the approximate interval shown below. Replacement should be coordinated with exterior painting projects whenever possible. We recommend consideration of LED fixtures or other energy-saving options whenever possible.

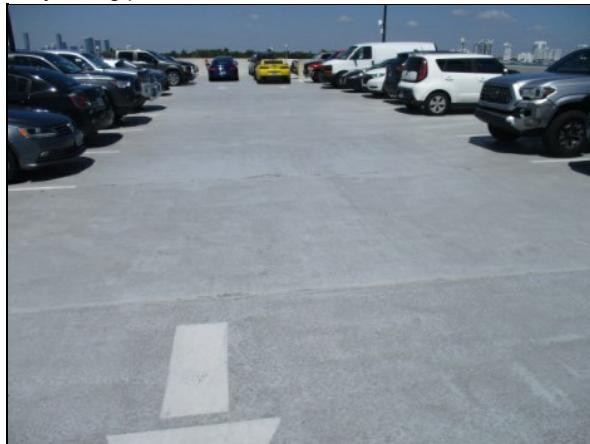
**Comp #: 2315 Vehicular Decking - Repair/Re-coat****Quantity: Approx 35,300 GSF**

Comments: Good condition: Coatings determined to be in good condition typically exhibit generally uniform texture and color with little or no cracking, bubbling/blistering, peeling or other apparent physical deterioration. Coating is uniform and apparently providing adequate coverage to deck surface. Deck appears to be generally skid-resistant.

Should be inspected on a regular basis (at least once a year) to identify any maintenance/repair issues. Keep any potted plants elevated off the surface of the decks. Unless otherwise noted, specific brand/type of decking product in place was not confirmed. Deck coatings lose thickness each year due to wear, ponding water and exposure to the elements. If more than the topcoat is allowed to wear off, the surface may still appear to be in 'good' condition to the untrained eye, but waterproof integrity may be compromised. Concrete decks must be waterproofed to protect against concrete deterioration, spalling, etc. If decks do not drain water effectively, additional sloping may be needed to prevent ponding water and accelerated deterioration. Whenever possible, decks should ideally be re-coated at the same time as building exterior painting or other exterior waterproofing projects to obtain better pricing and promote more consistent aesthetic standards. Sealant/caulking should be carefully applied at transition from deck to wall surfaces and around any railing penetrations, drains, etc.

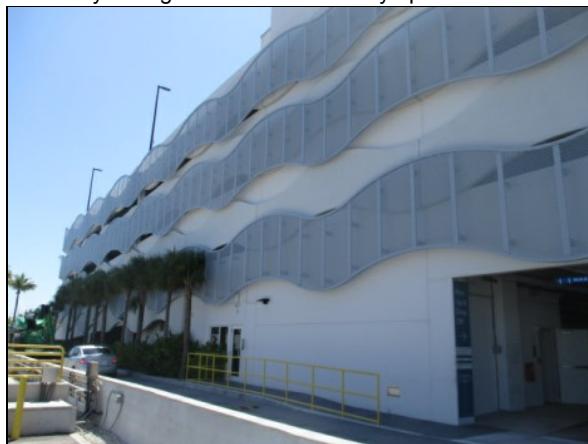
Comments: Good condition: Painted exterior surfaces determined to be in good condition typically exhibit consistent, attractive color and texture with no unusual or significant signs of wear or deterioration. Appearance is good and upholding the aesthetic standards of the development.

There are two important reasons for painting and waterproofing a building: to protect the structure from damage caused by exposure to the elements, and to restore or maintain good aesthetic standards for curb appeal. As routine maintenance, we recommend that regular inspections, spot repairs and touch-up painting be included in the operating budget. Typical paint cycles can vary greatly depending upon many factors including; type of material painted, surface preparations, quality of material, application methods, weather conditions during application, moisture beneath paint, and exposure to weather conditions. During our inspection, we attempted to measure/quantify sealant around window and door frames, but additional sealants may be present in the building envelop which should be replaced at time of painting/waterproofing project. Proper sealant/caulking at window and door perimeters and other "gaps" in the building structure are critical to preventing water intrusion and resulting damage. The general rule of thumb is that sealant/caulking should be in place wherever two dissimilar building material surfaces meet, such as window frame to concrete structure junctions. For best results, the Client may want to consult with a paint company representative, building envelope specialist and/or structural engineer to specify the types of materials to be used and define complete scope of work before bidding. In our experience, cost estimates for painting and waterproofing can vary widely, even when based on the same prescribed scope of work. Estimates shown here should be updated and revised as needed based on actual bids obtained or project cost history during future Reserve Study updates.

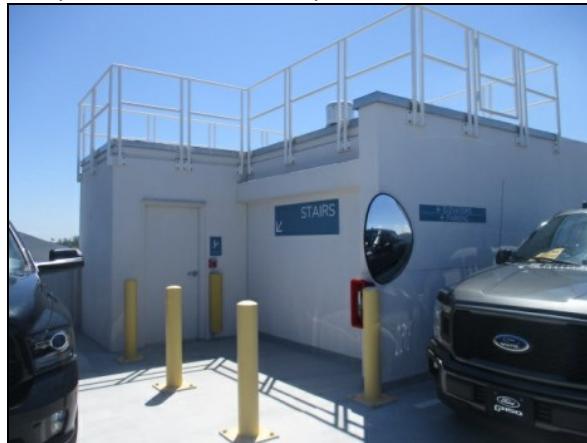
**Comp #: 2367 Windows & Doors - Replace**

Good condition: Windows and doors determined to be in good condition typically exhibit only minor, routine signs of wear and age. Frames appear to be intact with no significant pitting or other surface wear. All moving parts appear to be functional, and glass appears to be clear and free from damage.

Unless otherwise noted, this component refers only to common exterior windows and doors. All are assumed to have been compliant with applicable building codes at time of installation. Inspect regularly for leaks and cracks around frame and repair as needed. Clean tracks and ensure hardware is functional to prevent accidental damage during opening/closing. With ordinary care and maintenance, useful life is typically long but often difficult to predict. Many factors affect useful life including quality of window currently installed, waterproofing details, exposure to wind and rain, etc. Individual windows and doors should be replaced as an Operating expense if damaged or broken. We recommend replacement at the approximate interval shown below based on consideration of installation/replacement dates, evident conditions, and/or our experience with similar Clients. Unless otherwise noted, cost estimates are based on replacement with current impact-resistant models.

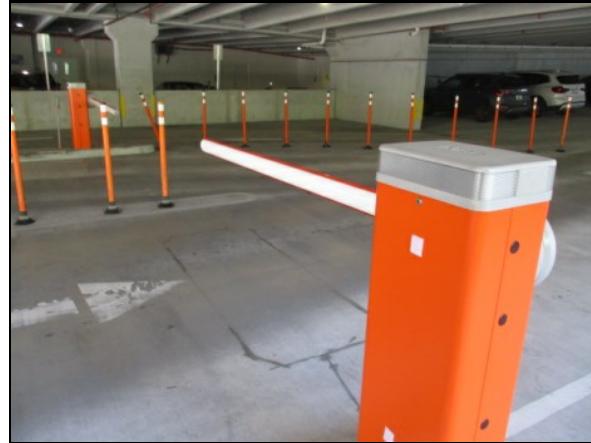
**Comp #: 2511 Barrier Arm Operators - Replace****Quantity: (3) Operators**

Comments: "Nice" brand. No model number noted at time of inspection.

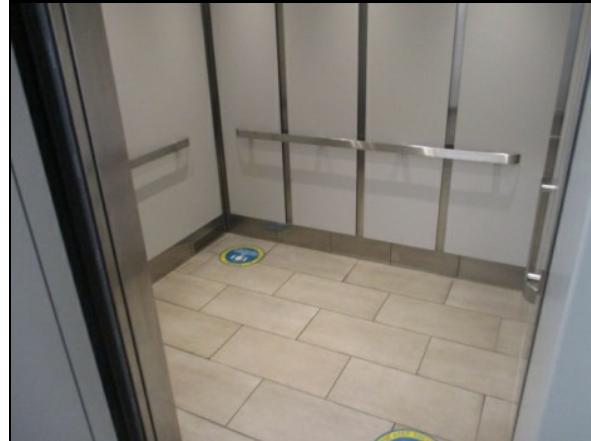
Comments: Good condition: Elevator cabs determined to be in good condition typically exhibit, clean, intact finishes and fixtures with no significant wear or abuse, vandalism, etc. Flooring, wall paneling and lighting are of a design quality appropriate for the standard of the community.

This component recommends budgeting for periodic remodeling of the elevator cab interior to ensure good physical condition and maintain aesthetic standards of the property. Timing of this elective project is ultimately at the discretion of the Client, but ideally should be coordinated with mechanical modernization to minimize downtime. Cost can vary greatly depending upon chosen design, and our estimates assume remodeling to a similar standard as currently in place. If higher quality standards are being considered, cost estimate increases may need to be incorporated into future updates. A general allowance based upon our experience and consultation with elevator vendors is shown below for budgeting purposes, but any new information or cost estimates should be incorporated into future Reserve Study updates when known.

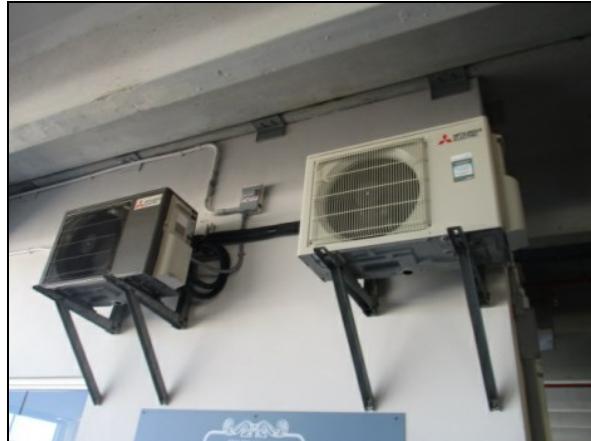
**Comp #: 2522 HVAC Systems - Replace**

Comments: All ductless/mini-split systems, assumed to be in functional condition.

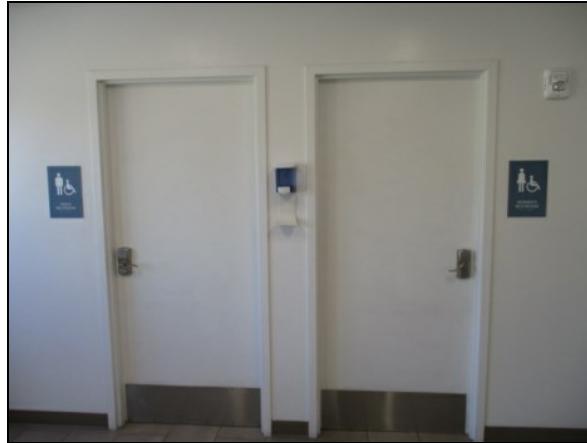
Good condition: Bathrooms determined to be in good condition typically exhibit clean, attractive countertops (and cabinetry, if present). Fixtures all appear to be functional and in good aesthetic condition. Flooring and wall finishes show only minor, routine signs of wear and age. Overall, appearance and design aesthetic is good and appropriate for the standards of the community.

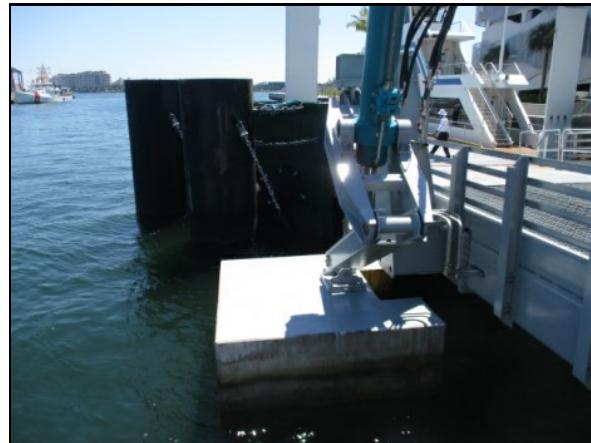
**Comp #: 2903 Ramp Lifts/Controls - Replace**

Comments: All equipment installed new with wharf construction in 2020. Observed to be in good, functional condition at time of inspection.

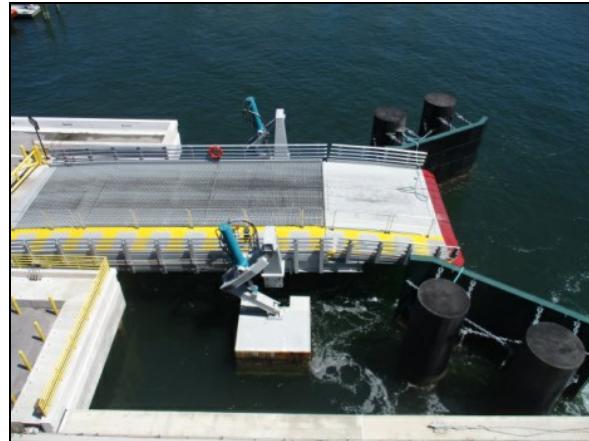
Comments: (2) sets of dolphins at landing ramp, plus (3) fenders. All installed new in 2020 during construction project.

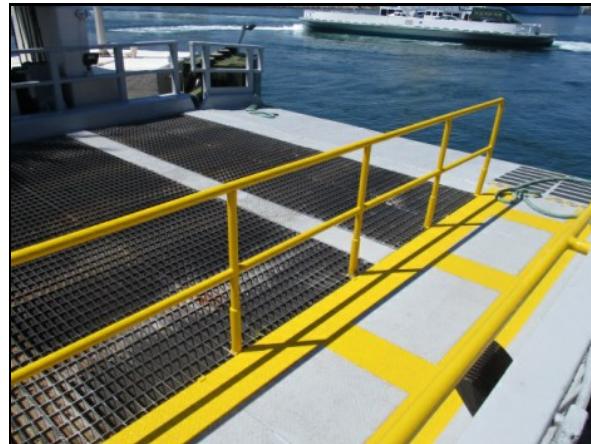
Comments: Each landing has a steel ramp that raises and lowers as needed to allow transfer. VP of Transportation reports that ongoing repairs are made as needed as an Operating expense. Framework is generally preserved and new steel added or reinforced to ensure stability. No predictable interval for major repairs. Grating has reportedly been replaced entirely only once over 30 years, and spot repairs are done on-site by staff. Continue to address on an ongoing basis and keep track of repair expenses. If a pattern of larger expenses develops over time, additional line items for repairs should be incorporate during future Reserve Study updates.

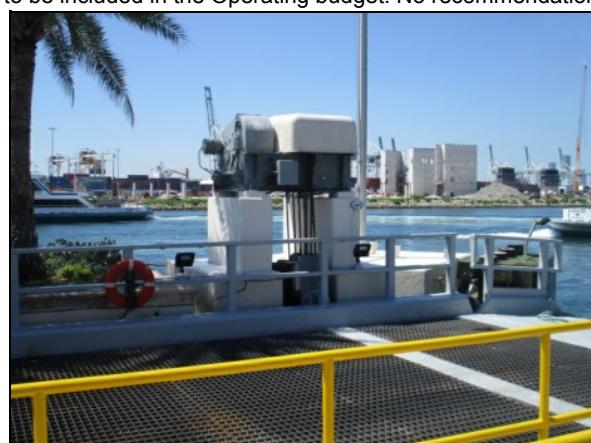
Comments: There are (2) electric motors for each ramp, which retract or let out cables to raise and lower the vehicle ramps. Motors are reportedly rebuilt or replaced at roughly 3 year intervals (approx \$6,000/motor) and cables as-needed (approx \$7,000 per side). All costs are reported to be included in the Operating budget. No recommendation for Reserve funding at this time.

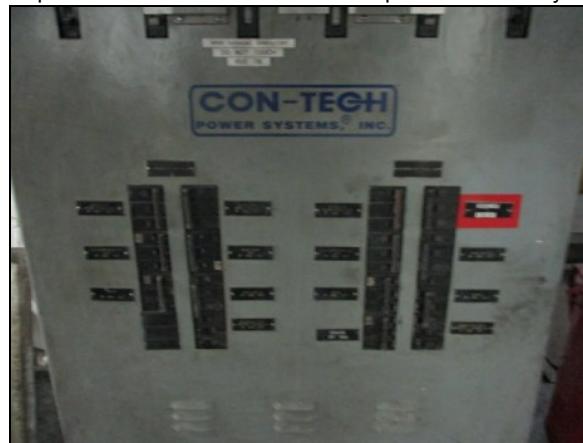
**Comp #: 3004 Electrical Panel (Flmgo) - Replace**

Comments: VP of Transportation reports that the electrical distribution panel on this ferry was replaced around 2010.

Useful Life:  
15 yearsRemaining Life:  
2 years

Lower estimate to replace

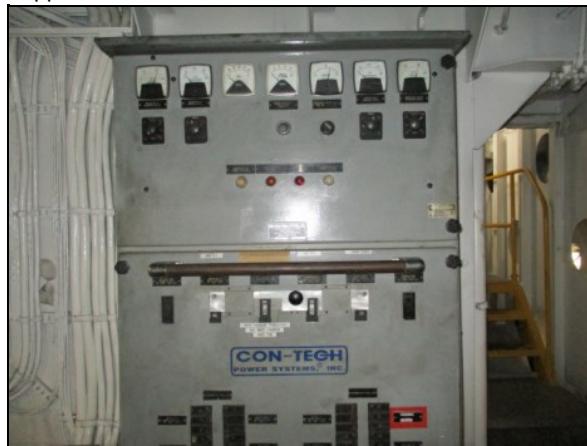
**Comp #: 3004 Electrical Panel (Heron) - Replace**

Comments: The Heron panel was not replaced in 2010 when others were done and is shown here due to difference in remaining useful life. Expect to repeat at the approximate interval shown below.

**Quantity: (1) Electrical Panel**Useful Life:  
15 yearsRemaining Life:  
9 years

Lower estimate to replace

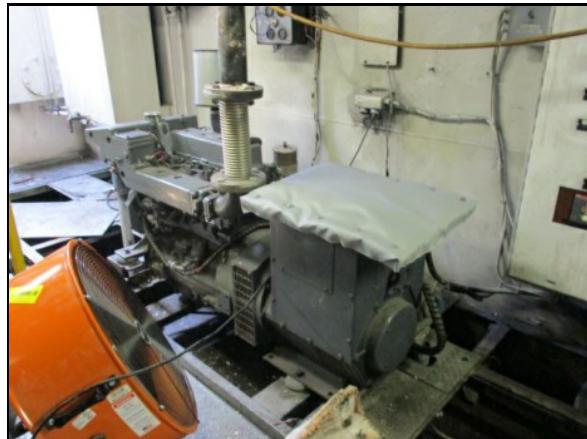
**Comp #: 3006 Fire Pumps - Replace**

Comments: (1) 20 HP pump per vessel. Should be inspected and tested regularly to ensure good function. Plan to replace at the approximate interval shown here.

**Quantity: (4) 20 HP Pumps**Useful Life:  
10 yearsRemaining Life:  
4 years

Lower estimate to replace

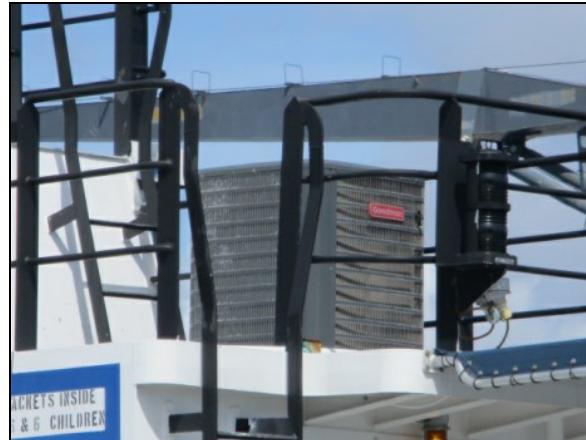
**Comp #: 3010 Ferry AC Units - Replace**

History: Per information provided, 2 of 6 AC units replaced in 2020

Comments: Each ferry boat has two 2-ton air conditioners. The units at the Pelican were replaced in 2008 according to records provided, and again most recently in 2014. The units at the Heron and Eagle were replaced in 2011 according to records provided. Flamingo units were not listed specifically, but were assumed to have been replaced around the same time. All would be replaced as an Operating expense according to Management.

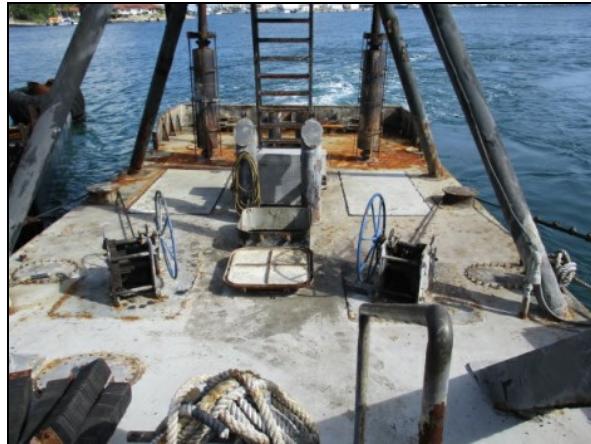
### Comp #: 4000 Tugs & Barges - Replace

According to FICA management, within the next few years FICA plans to construct a new ferry landing on the mainland which will have a roll-on, roll-off ramp similar to the existing ferry landings. At that point, commercial and construction traffic will be able to use that service, eliminating the need for the tug and barge service. As such, we are not listing funding recommendations for these assets at this time. This component should be re-evaluated if the proposed development does not take place, or is delayed beyond the next few years. Until that time, continue to service and maintain these vessels as needed in order to prolong their service life.
