# Shoreline Inspection Report

## FICA Shoreline Assessment

*Fisher Island,  
Miami-Dade County, Florida*

August 2023

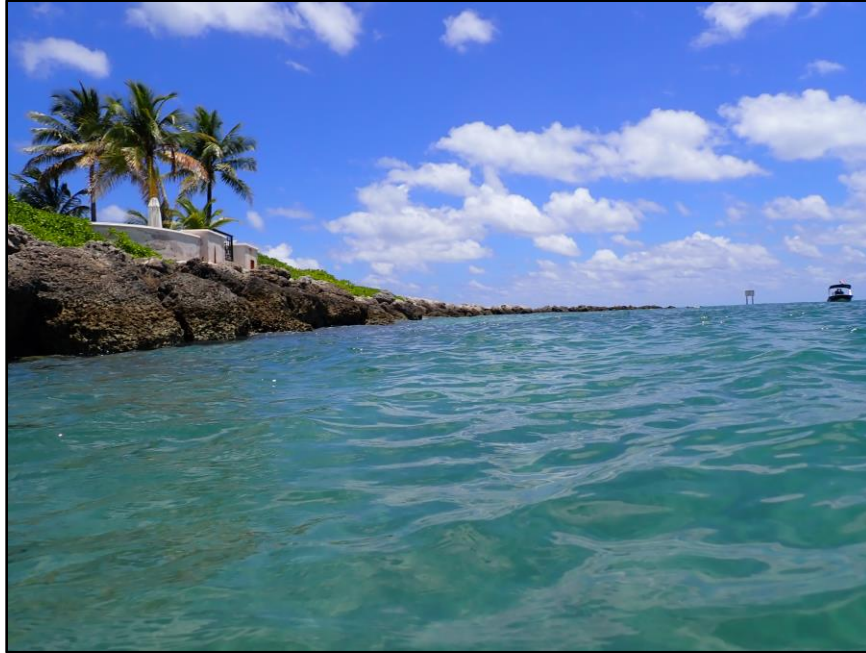
**Photo 1: General view of Section 1 breakwater, looking southeast**

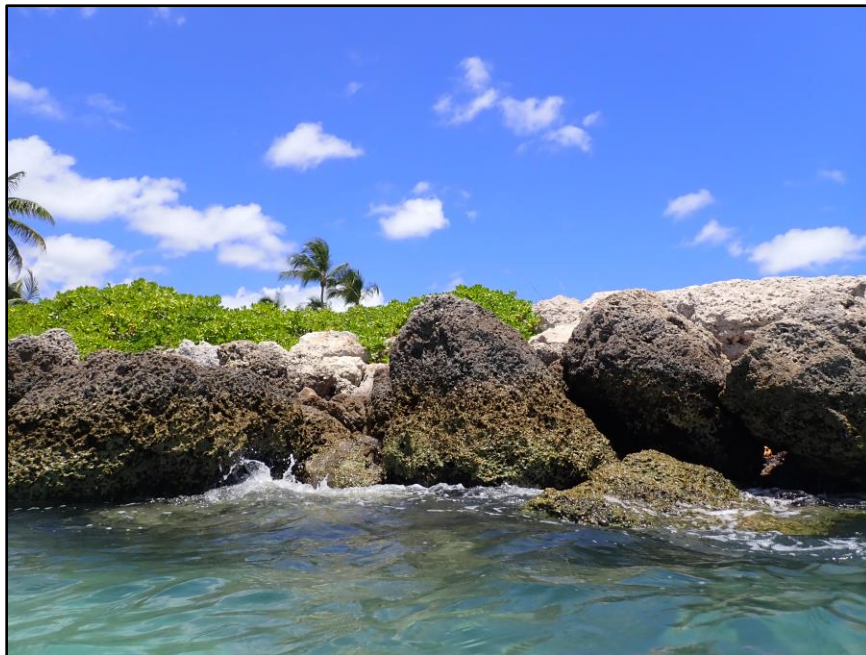
**Photo 2: Typical 2-6 ft diameter rip rap along Section 1**

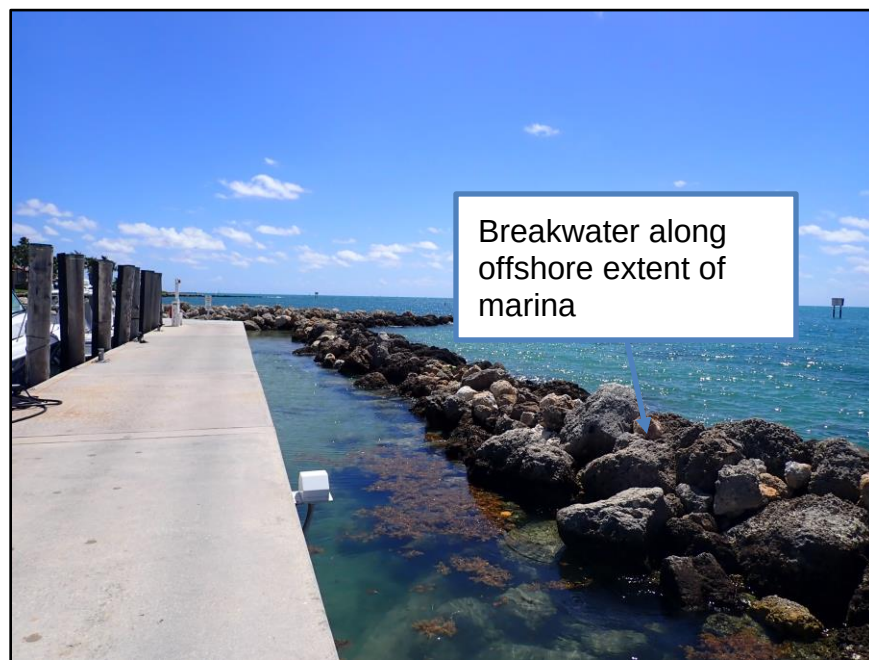
**Photo 4: Section 2 breakwater along offshore side of Guest Marina, looking east**

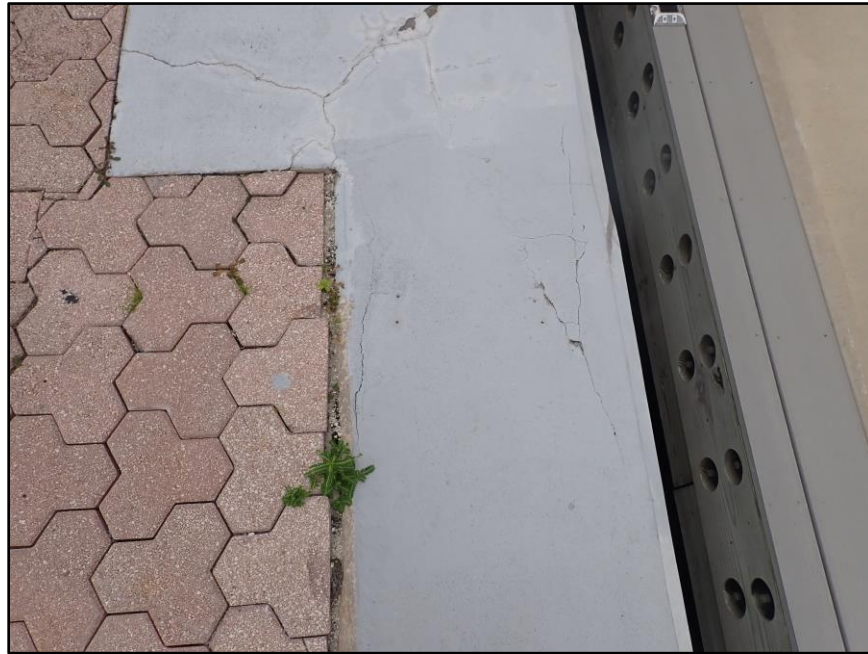
From STA 0+00 to approximately STA 2+60, the cap measured approximately 24 in. wide. At STA 2+60, the cap extends an additional 18 in. inshore, for an approximately 42-in. wide cap. This continues until STA 3+20, where the offshore edge steps in approximately 18 in. to return to a 24 in. wide cap. The cap width is constant at 24 in. for the remainder of the section.

**Photo 6: Section 3 increase in cap width at approximate STA 2+60**

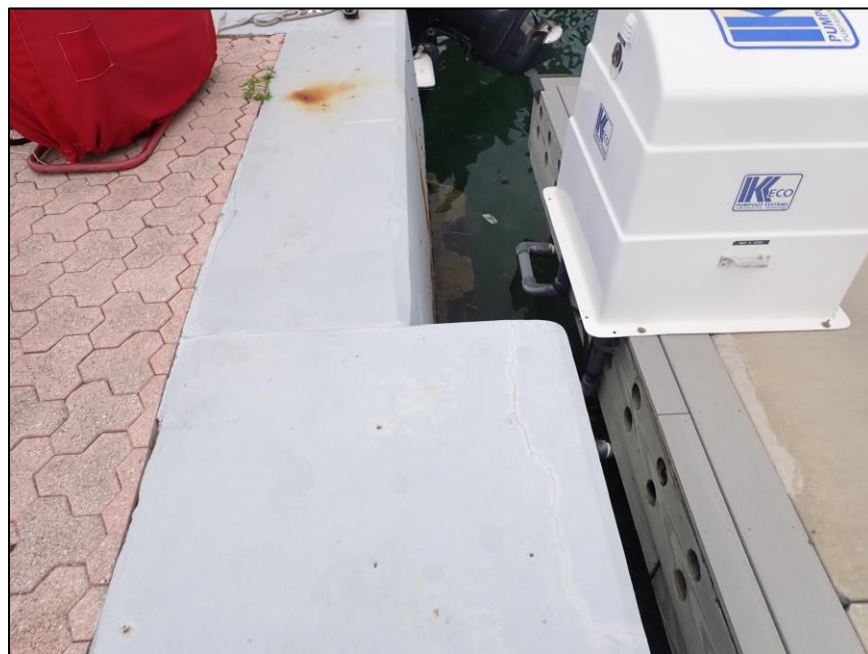
**Photo 7: Section 3 reduction in cap width at offshore face, at approximate STA 3+20**

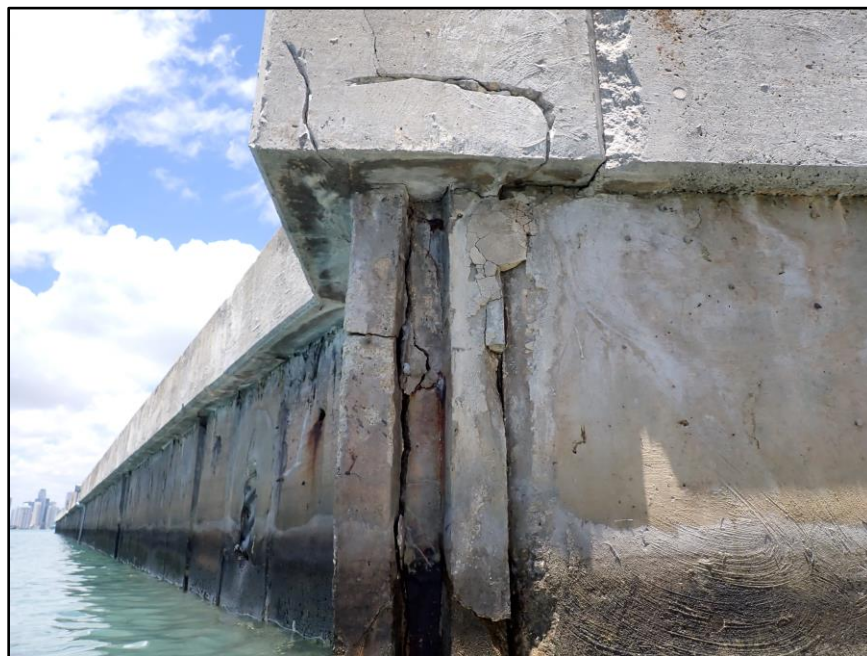
**Photo 10: Eastern termination of Section 4 concrete sheet pile showing tongue-and-groove construction**

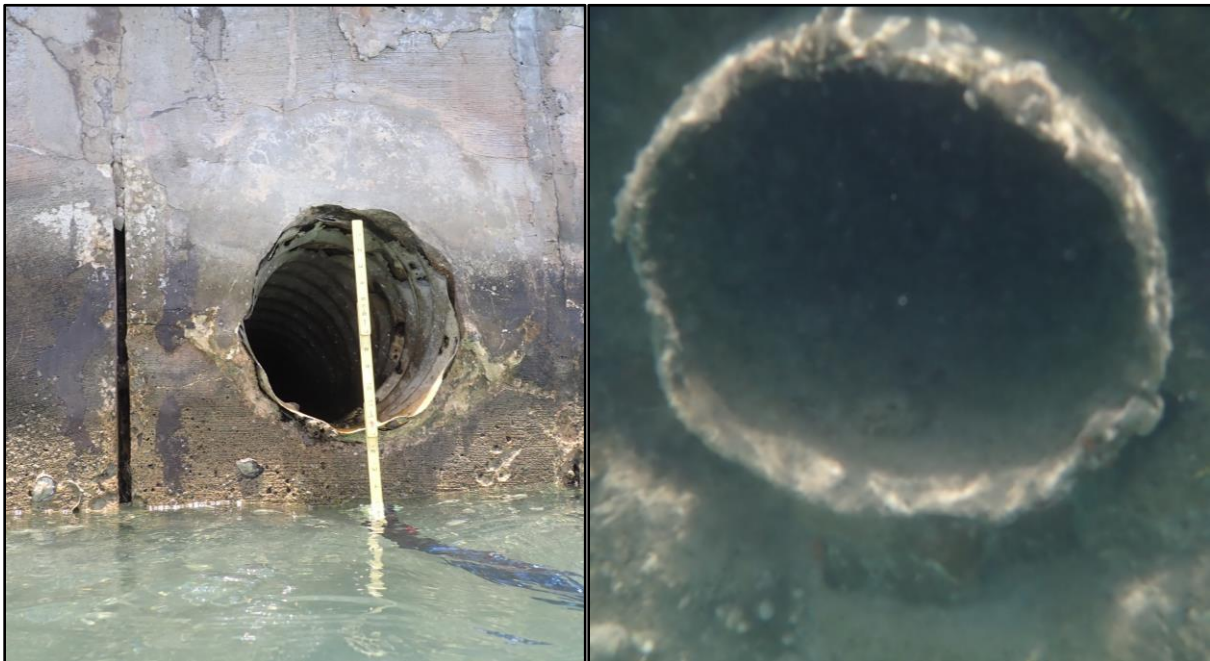
The concrete cap measured 24-in. wide and 16-in. deep with an 8-in. soffit overhang beyond the concrete panels. Two 14-in. diameter corrugated metal outfalls were present above the waterline at STA 0+25 and STA 1+52. One 10-in. diameter corrugated metal outfall was present below the waterline at STA 4+09.

**Photo 12: Typical corrugated metal outfalls at Section 4: 14 in. at STA 1+52 (left) and 10 in. at STA 4+09 (right)**

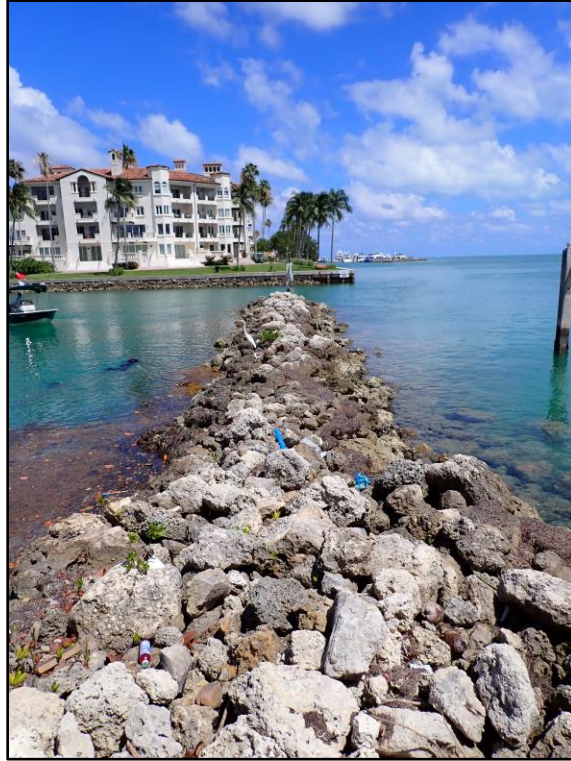
**Photo 14: STA 2+80 view of Section 4 Southwest jetty at outlet of harbor**

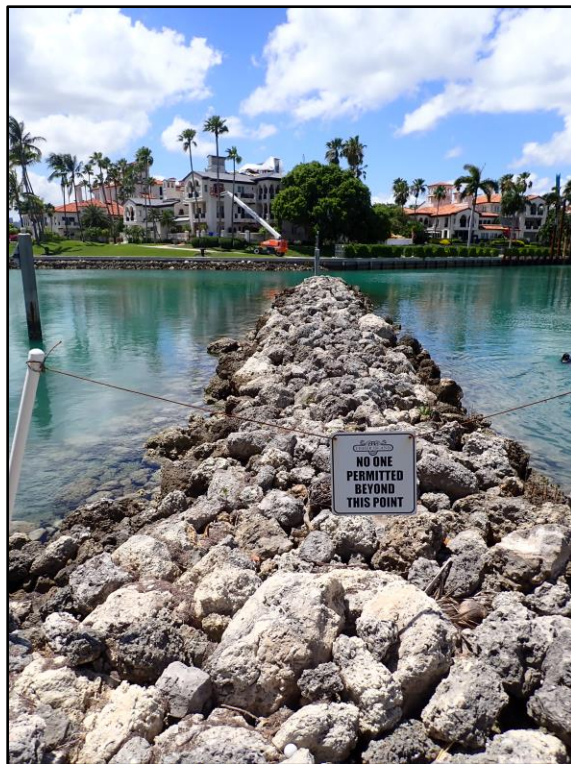
**Photo 15: STA 2+60 view of Section 4 Northeast jetty at marina basin**

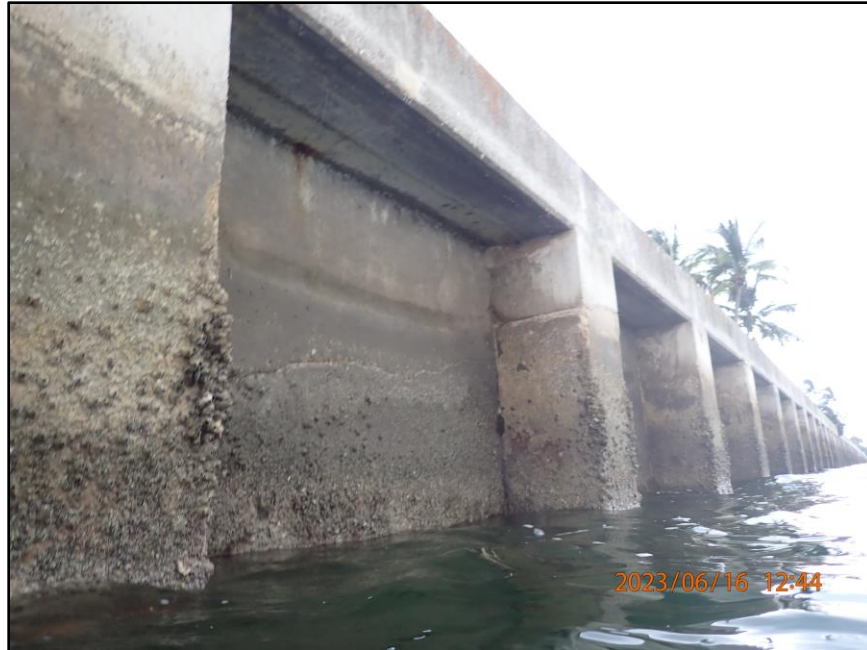
**Photo 16: Typical view of Section 6 bulkhead construction**

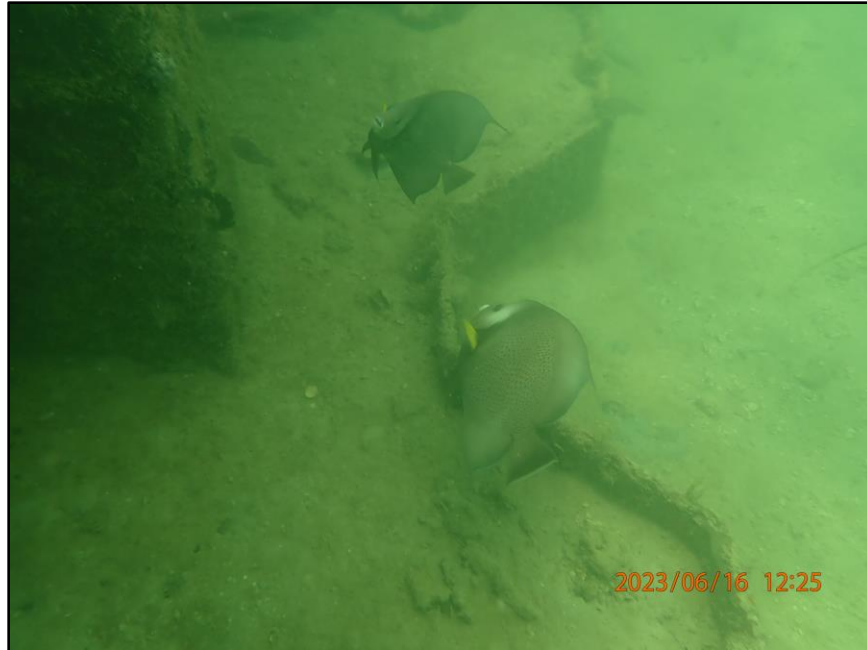
**Photo 18: Steel sheet pile toe wall along the base of the Section 6 bulkhead**

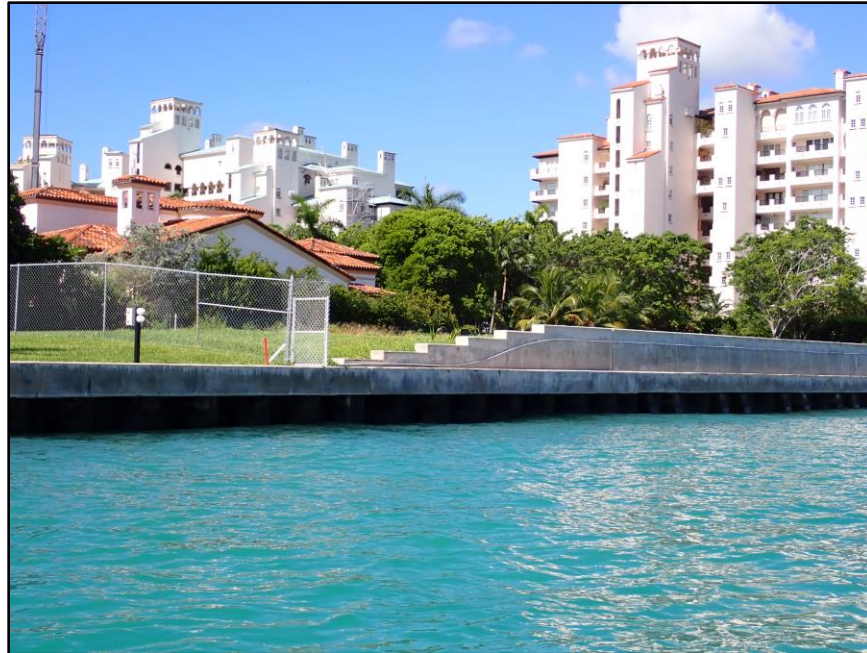
**Photo 21: Stepped stem wall at interface between Sections 8 and 9**

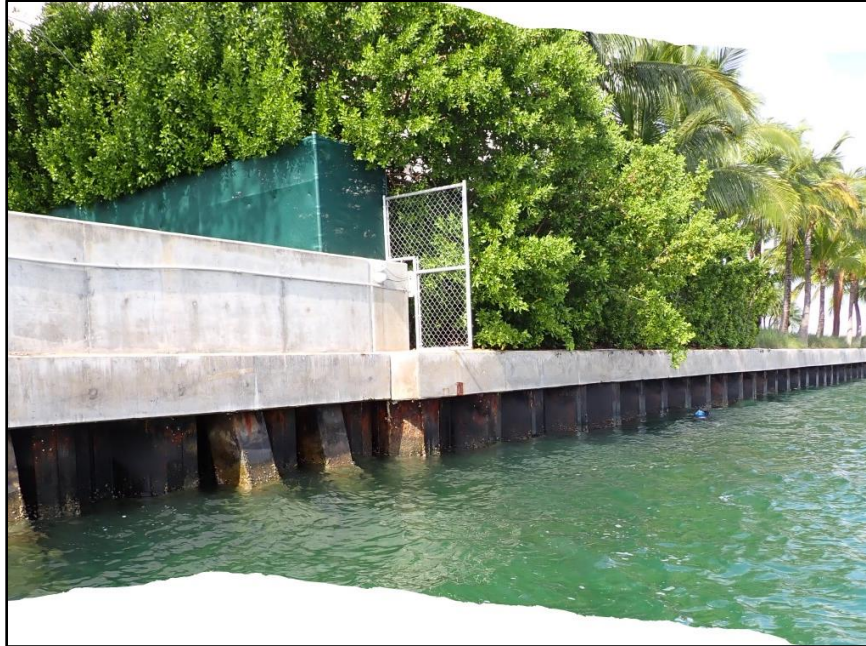
**Photo 22: Section 8 stem wall termination and construction change at STA 3+09, looking southwest**

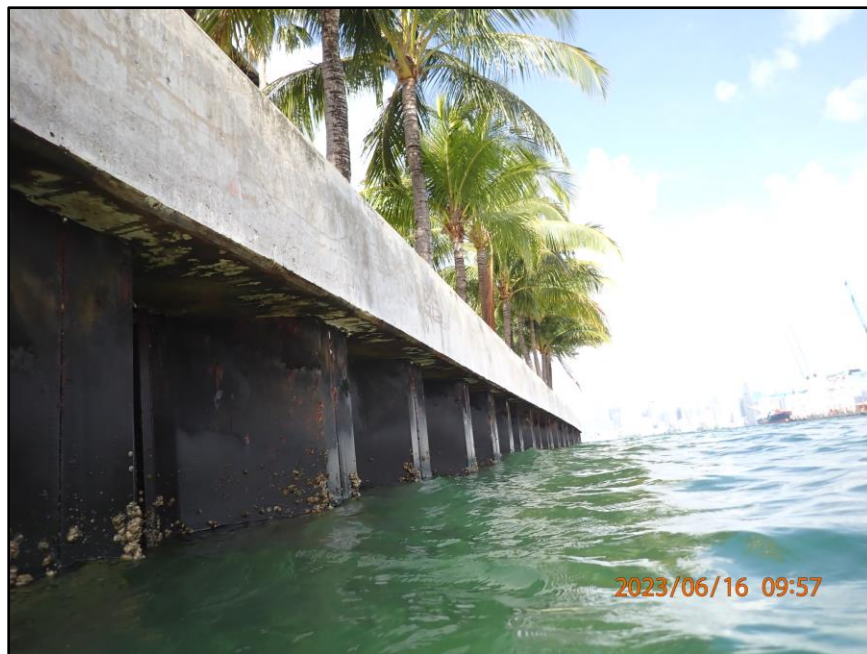
**Photo 23: Typical view of Section 8 bulkhead, STA 3+09 to STA 6+64, facing west**

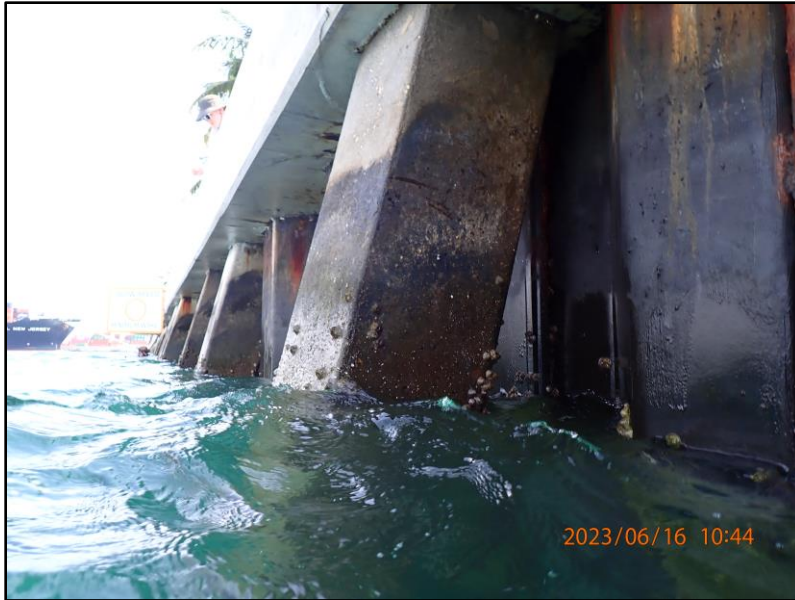
**Photo 24: Typical view of Section 8 bulkhead, STA 6+64 to STA 11+69, facing north**

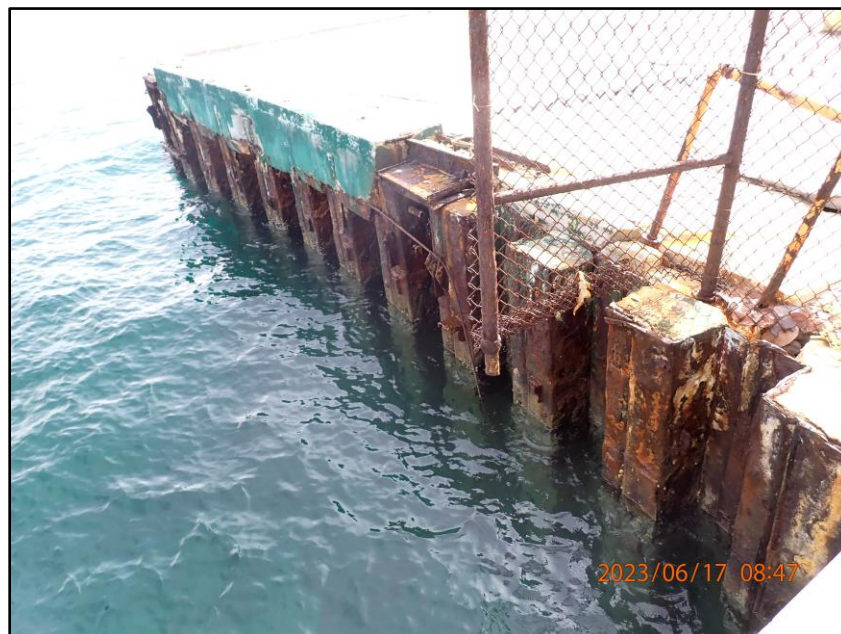
The 45 linear ft bulkhead located to the northeast of the basin running north-south was included in the inspection. This length of bulkhead is comprised of aging steel sheet piles with intermittent sections of deteriorated concrete cap remaining. Original construction plans were not found; therefore, the original sheet pile section, date of construction, and lateral support design are not documented.

**Photo 30: Typical view of northeast of Section 10 ferry basin bulkhead**

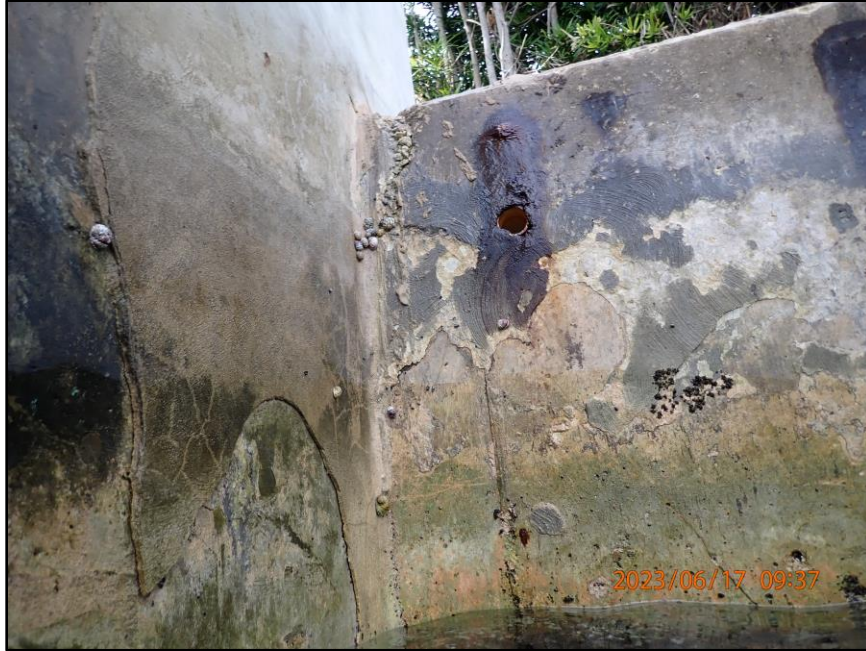
**Photo 31: Section 11 change in concrete cap construction at STA 0+84 interface**

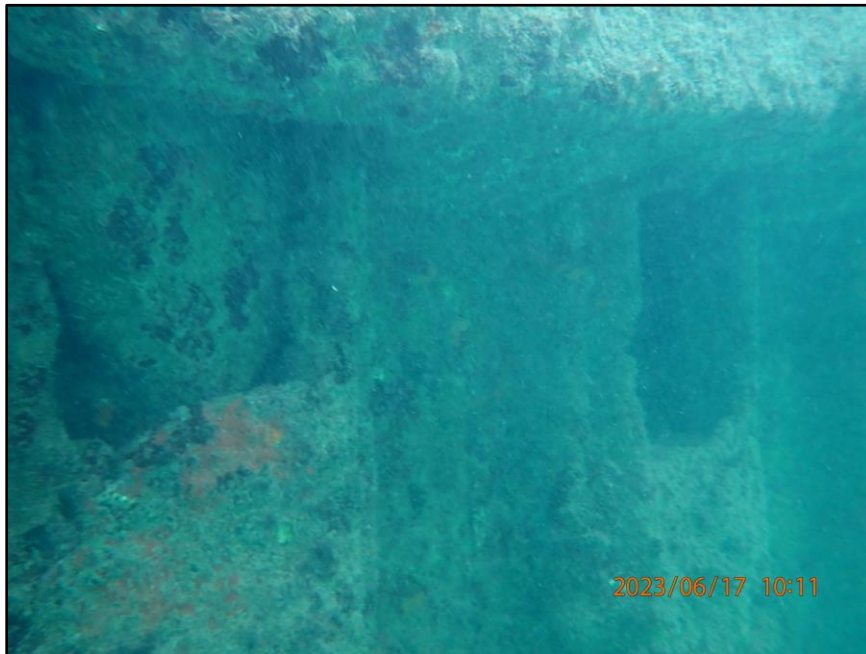
**Photo 32: Derelict bulkhead steel sheet piles visible within Section 11 ferry basin**

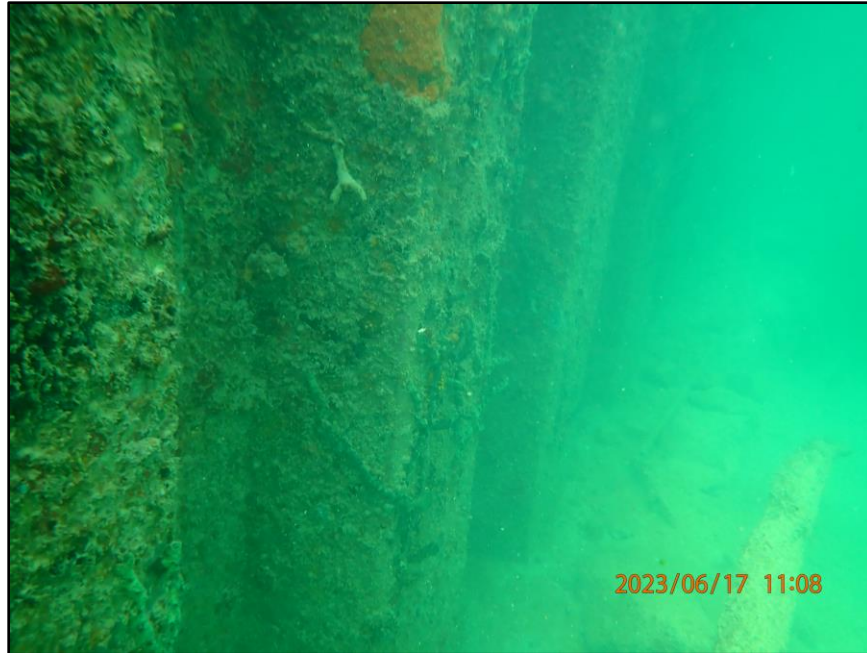
**Photo 33: Original steel sheet piling along Section 11 northern bulkhead, STA 5+80 – 9+60**

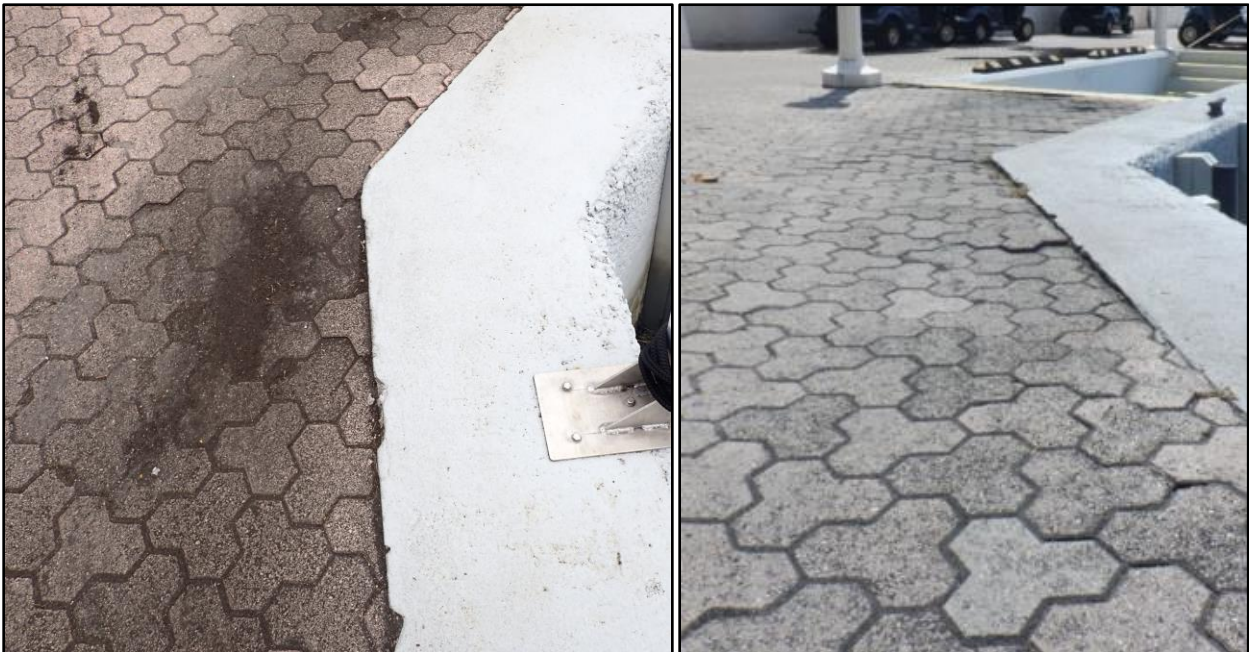
- Intermittent areas of subsidence and settlement of the pavers were observed along the backside of the bulkhead between Station 55+00 and 59+00, with more significant settlement up to 3" deep from Station 75+25 to 57+90.

**Photo 54: Minor settlement of the pavers STA 4+70, 2023 (left) and 2019 report (right)**

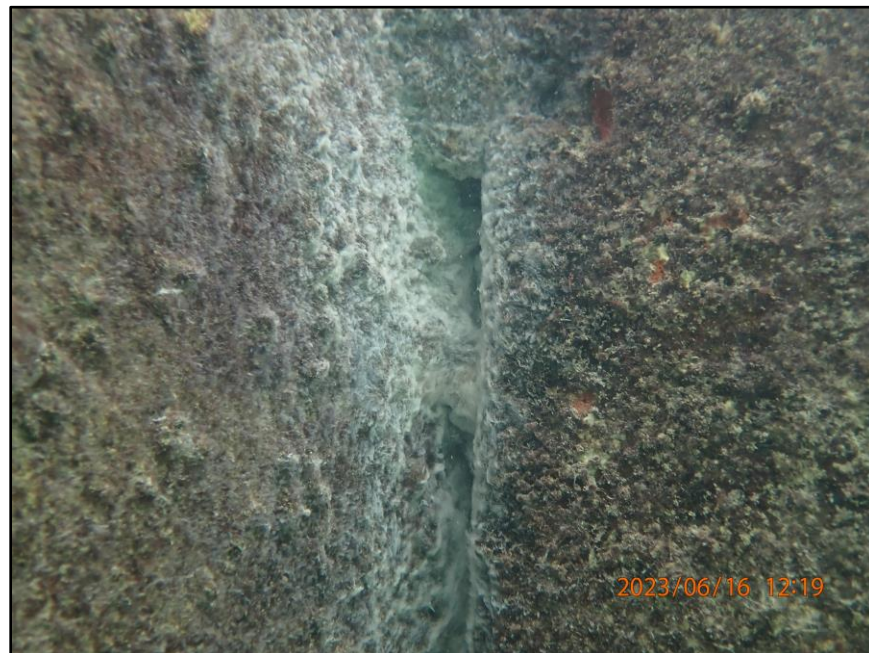
**Photo 68: Typical evidence of freshwater intrusion at the pile panel interface**

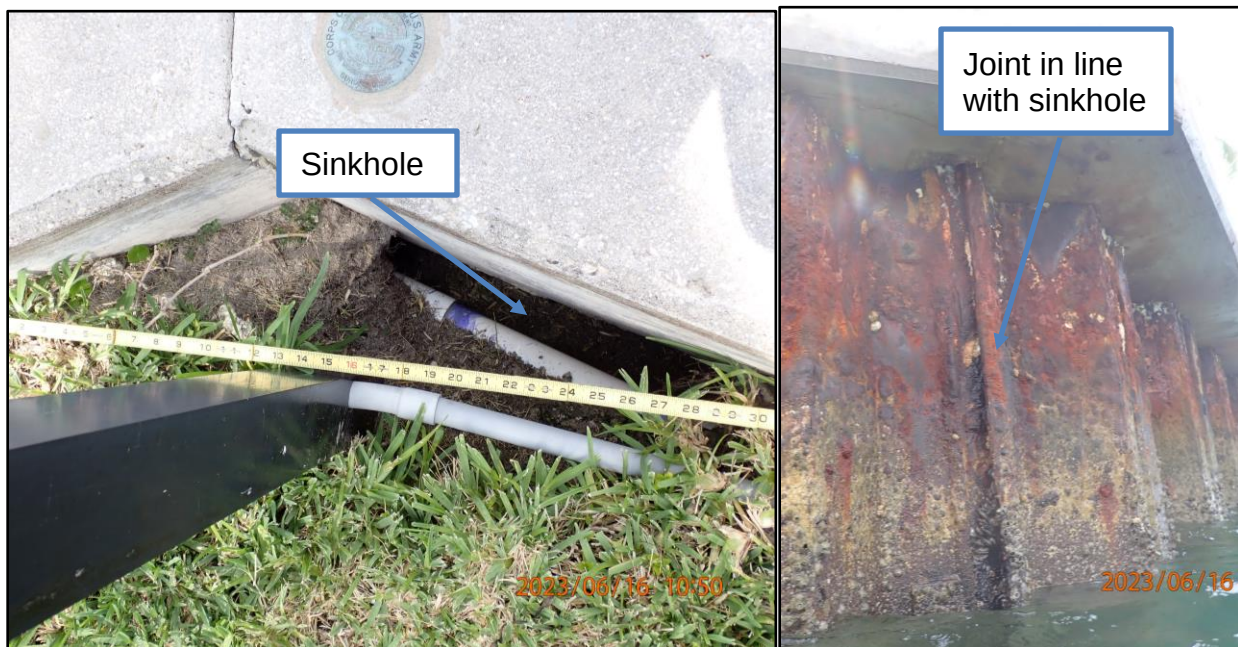
**Photo 73: STA 12+18 Sinkhole and in line joint at corner of bulkhead**

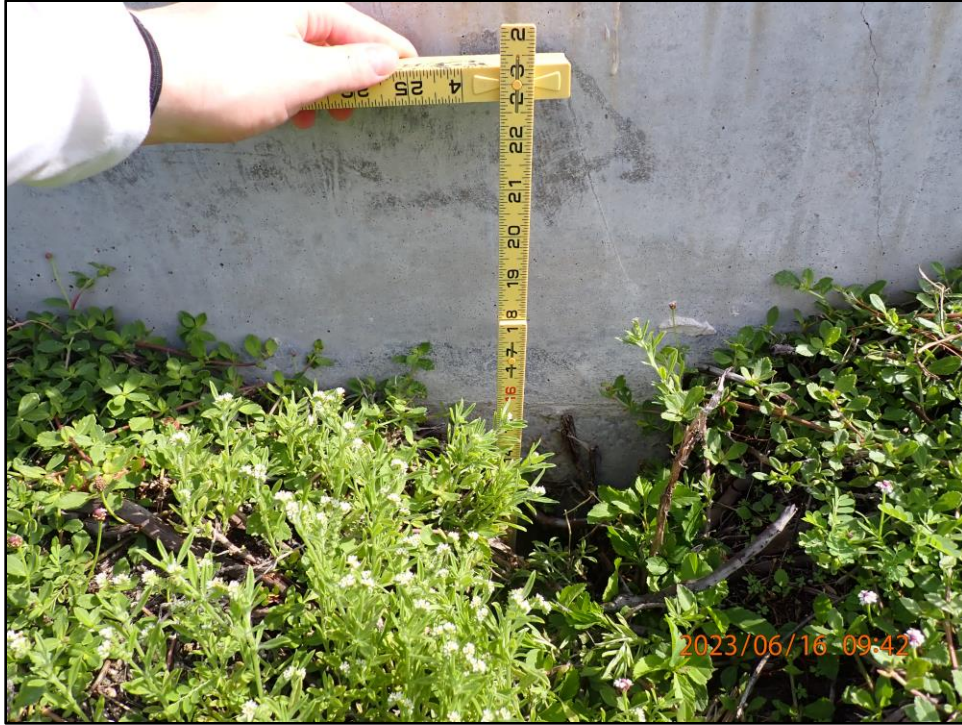
**Photo 77: Typical view of Section 8 sinkhole**

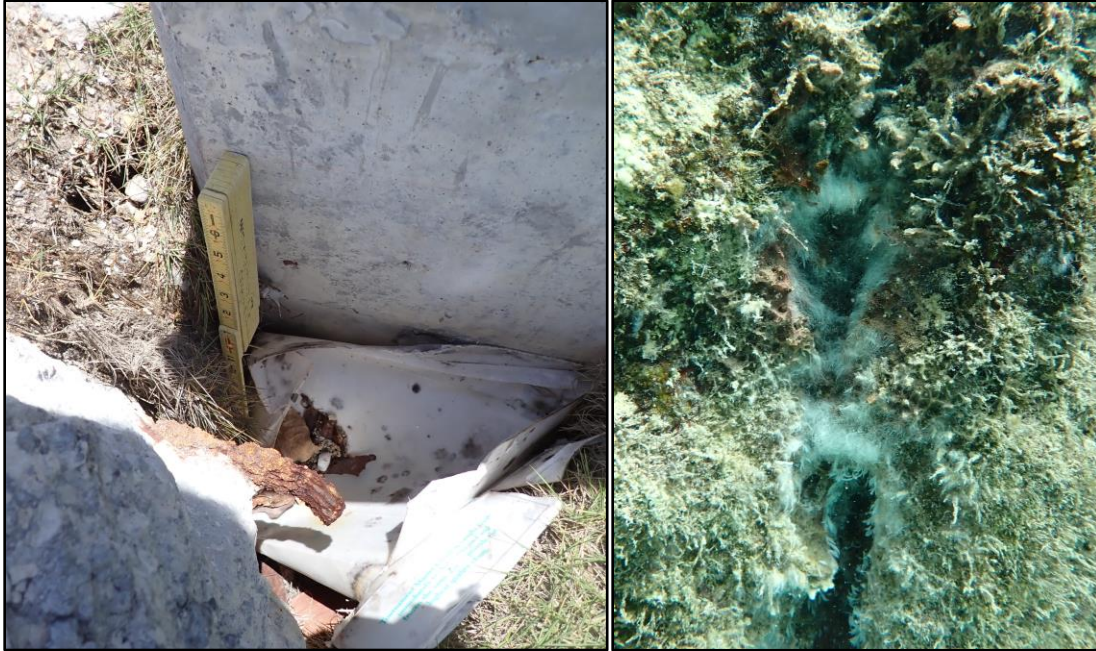
**Photo 95: Sinkhole at northeastern termination (STA 2+90) with signs of freshwater intrusion visible at the in-water portion of the joint**

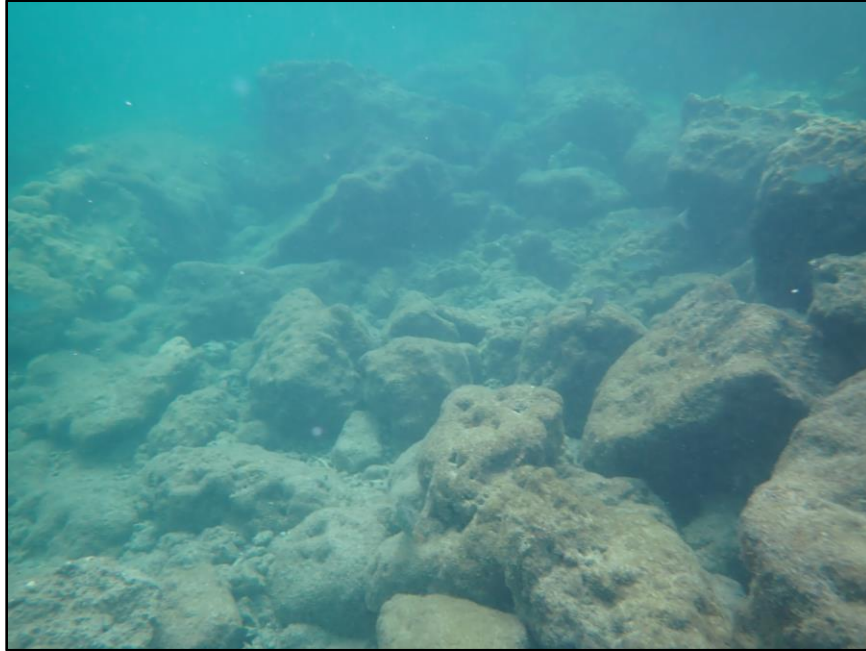
**Photo 103: Below water riprap in line with above water steeper grades indicating movement of the stones from their original position**
