# Shoreline Inspection Report

## FICA Shoreline Assessment

*Fisher Island,  
Miami-Dade County, Florida*

August 2023

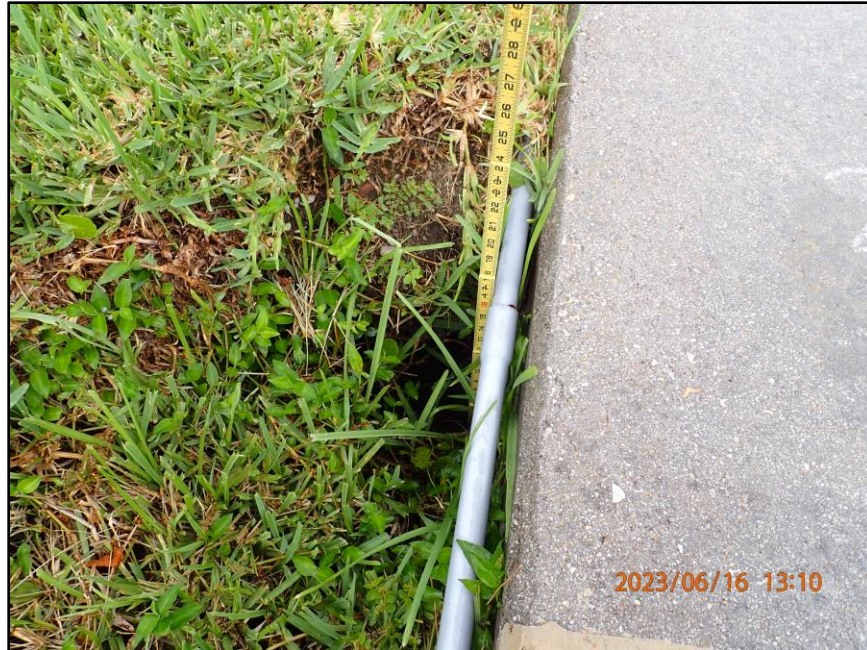
**Photo 69: Typical upland sinkhole**

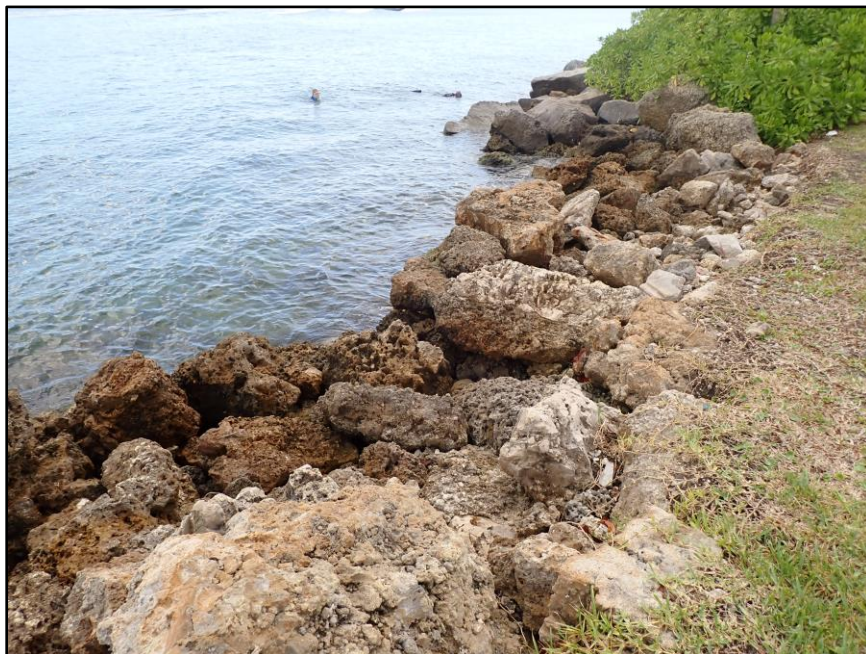
**Photo 104: Localized areas of minor erosion of the upland fill**
